Asset Management: Evaluation of Old Insulators

Fábio Frutuoso
Sediver
Brasil

Damien Lepley
Sediver
France

This article presents a technical approach to asset management in transmission lines, focusing on the evaluation of the longevity of toughened glass insulators withdrawn from service after more than 40 years of operation in humid tropical environments in Brazil.

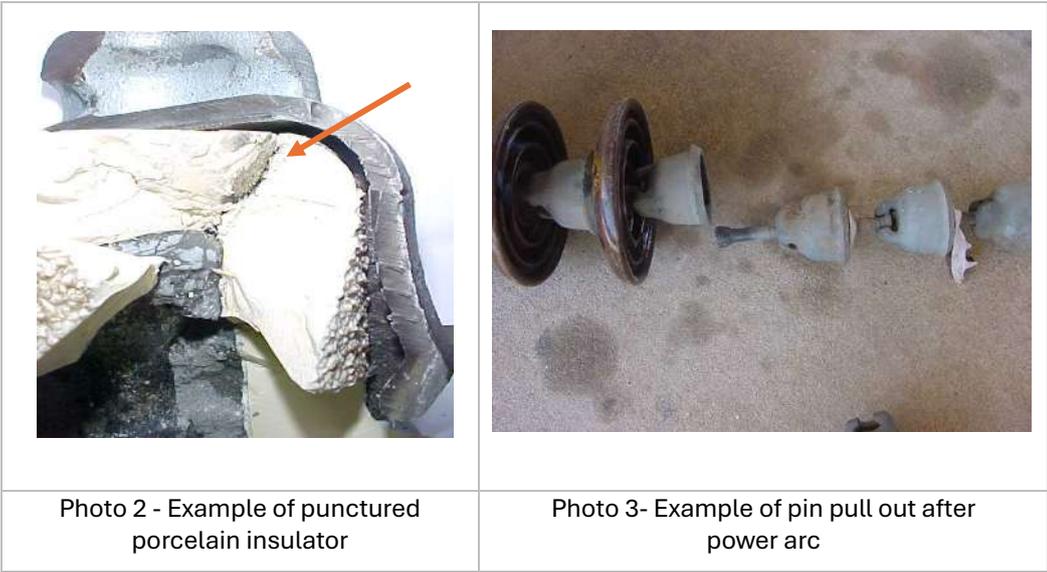
Porcelain insulators feature a microstructure that includes inherent porosity, which can lead to the development of intergranular cracks. These cracks may progress to internal punctures, as illustrated in Photo 2. When a punctured porcelain insulator is submitted to a power arc, it can result in severe mechanical failure, such as a pin pull out. This phenomenon is illustrated in Photo 3.

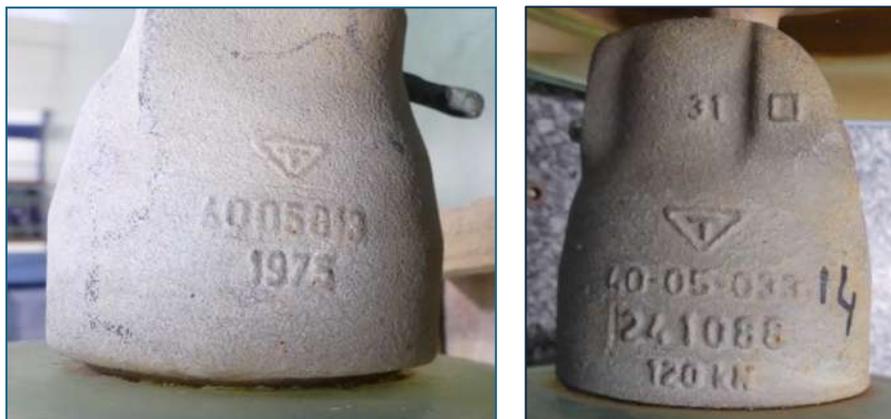
Photo 7 – Insulator with gap (1975) and without gap (1988)

A gap of approximately 3 mm was observed at the cap-to-glass interface in all insulators manufactured prior to 1988.

Note: In Brazil, until late 70's, Toughened glass insulators were produced with a gap at the base of the cap, as shown in photo 7 below, to prevent contact between the glass and the dielectric. Starting in the 1980s, a new product was developed in collaboration with R&D in France without gap.

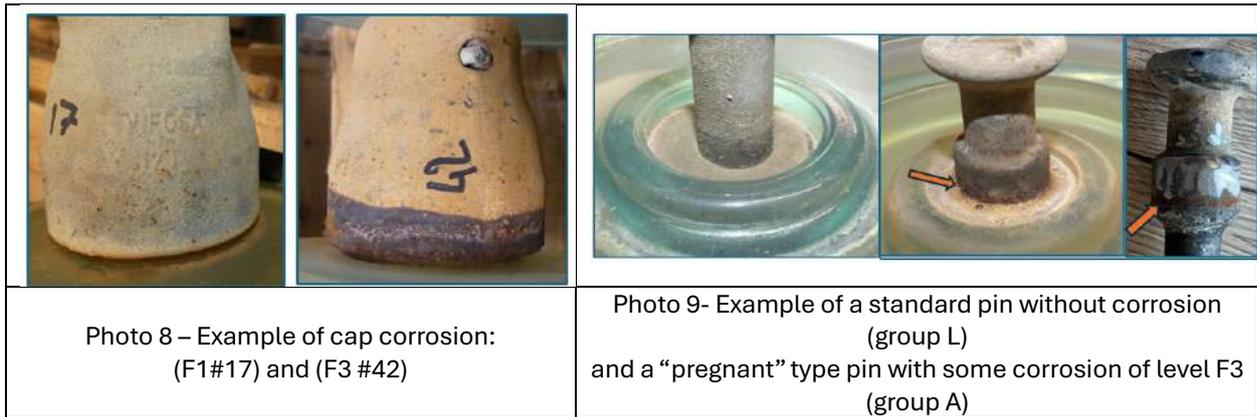
The corrosion assessment was classified using table 3 based on the document CIGRE Brazil TB B2.03 002 « Insulators in Service Evaluation Criteria », where only 3 corrosion levels F1, F3 and F5 were considered. Table 5 below presents the results obtained.

During visual inspection, Group A and Group G insulators were identified featuring a “pregnant pin” design. As illustrated in Photo 10, this pin looks like a conventional pin type with zinc sleeve; however, instead of the sleeve, the pin features a steel overthickness.

This design was specifically developed to improve the mechanical resilience of the insulator in the event of a power arc, situation that can be particularly critical for 500 kV insulator sets, which were historically installed without adequate arcing protection.

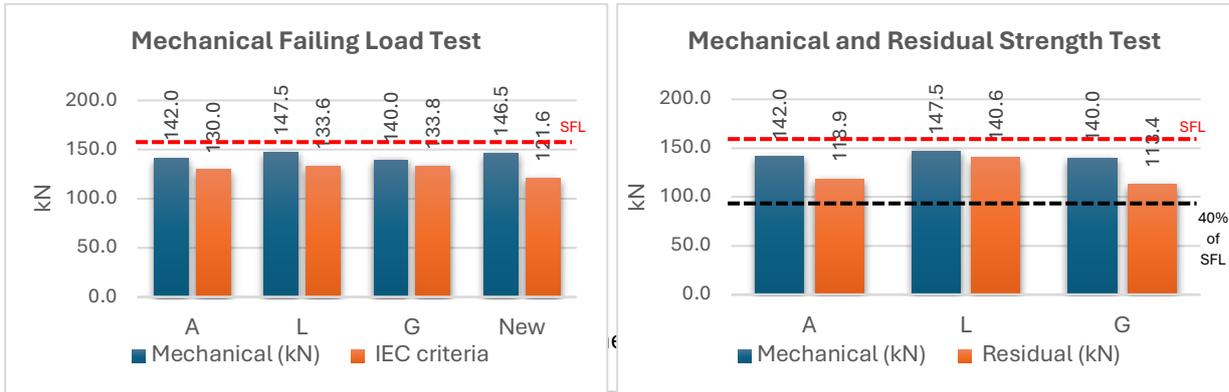
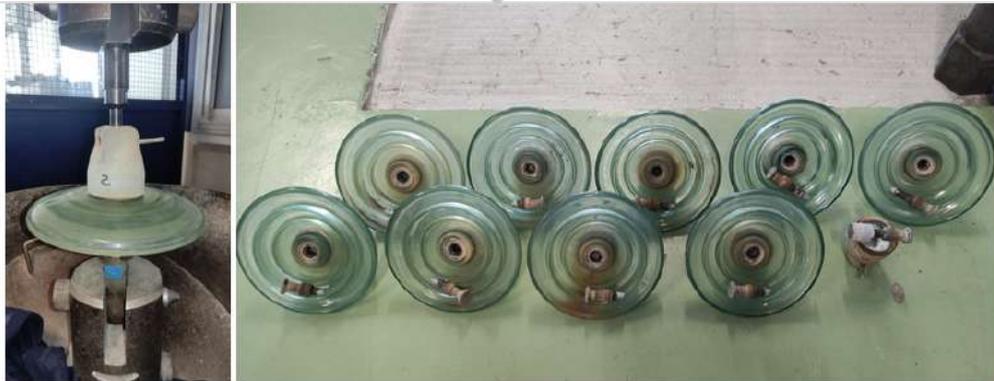
Photo 11 – Illustration of the result of the mechanical failing load test

The mechanical results obtained on samples from groups A, L and G are detailed in table 5, figure 4 and photos 11 and 12 below. In the mechanical failing load test graph, there is a comparison between mechanical results and IEC criteria. For information, in figure 4 where there is a comparative result between mechanical failing load test and residual strength test, the maximum mechanical stress expected in service is indicated (40% of the SFL).

The mechanical results of the tested insulators of groups: A, L and G, met the evaluation criterion indicated in the IEC 60383-1/2023 standard.

The ANOVA results indicate that there are no statistically significant differences between the groups. When comparing the mechanical performance of aged insulators with that of a new insulator the results show no meaningful variation also. The insulators removed from service did not exhibit any signs of mechanical degradation or ageing.

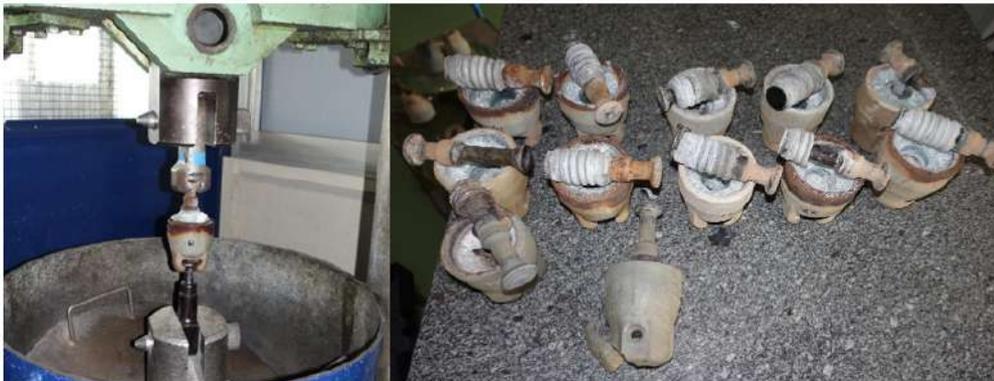
Photo 12 – Illustration of the result of the residual strength test

Residual mechanical strength refers to the maximum mechanical load reached by a cap and pin insulator having a damaged dielectric part.

In this test, the evaluation criterion of the IEC 60383-1/2023 standard was not adopted due to the number of samples for each group being tested. However, all the results were far above the normal working conditions and the maximum load during, and construction and maintenance defined in the Brazilian standard ABNT NBR 5422/2024 [15] (respectively 40% and 60 % of the specified failing load guarantee of the insulator)

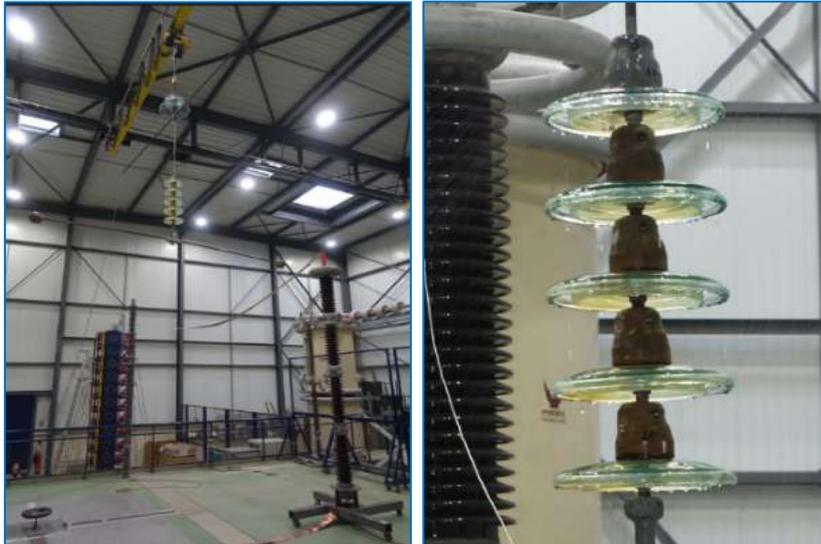
Photo 13 – Dry lightning impulse voltage test and one of the short strings during the wet power frequency test

After more than 40 years in service the results on unwashed samples still met the values specified in the manufacturer's catalog.

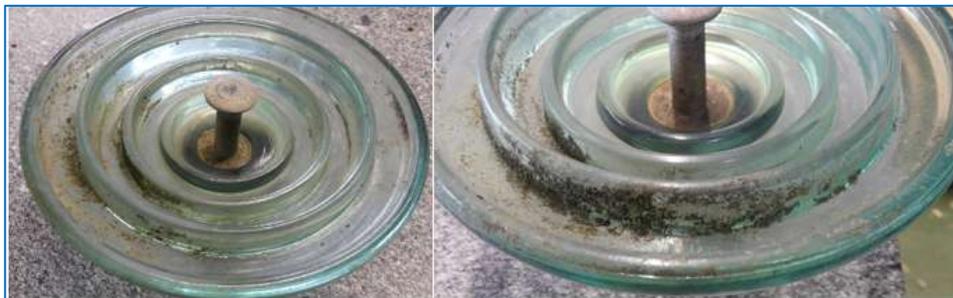
Photo 15 – Sample 4L2 (CUR=0.8) and 5L11 (CUR=0.9) with heterogeneous pollution

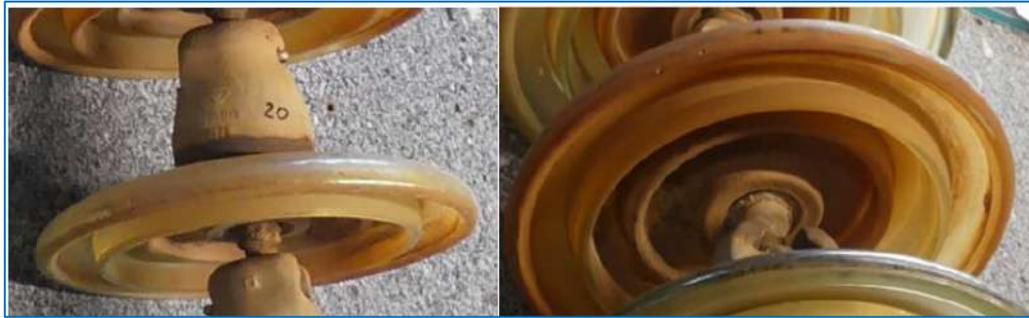
Photo 16 – Sample 8G20 (CUR=1.3) and 6G47 (CUR=2.0)

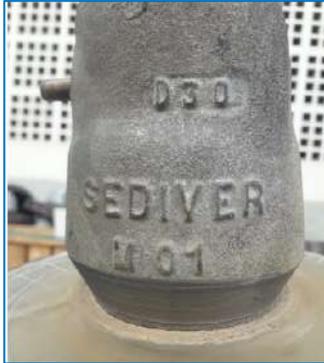
Corrosion at the cap/dielectric interface is mainly related to corrosion due to electrical activity/arcs because of existing GAP at the interface.

Photo 17 – Example of the cap machined to simulate a reduction of the metal thickness due to corrosion effect.

It should be noted that, from a mechanical standpoint, the insulator is not at risk, as the lower part of the cap in contact with the dielectric shell does not serve any mechanical function.

This conclusion is supported by tests simulating degradation in this region through machining for which the mechanical test results were equivalent to those obtained on new insulators.

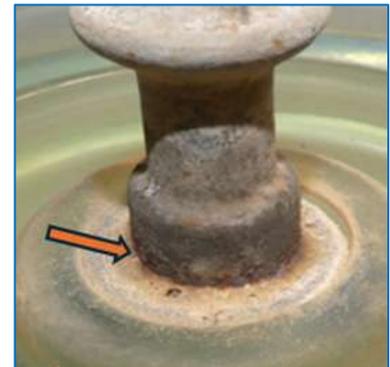
The loss of galvanization in the pin region on the samples does not compromise the mechanical integrity of the insulator.

The observed corrosion is superficial and located linked at the over thickness section of the pin, specifically at the interface with the cement. No signs of electrical activity or leakage current were detected. ESDD measurements confirmed low pollution conductivity, and both the insulator design and string dimensioning were adapted to the environmental conditions of the transmission lines.

Photo 18 – Example of the corrosion observed in the over thickness of pregnant pin.
