SMART INSULATORS

Technical Update since the introduction in 2018

Jean Marie George
SEDIVER

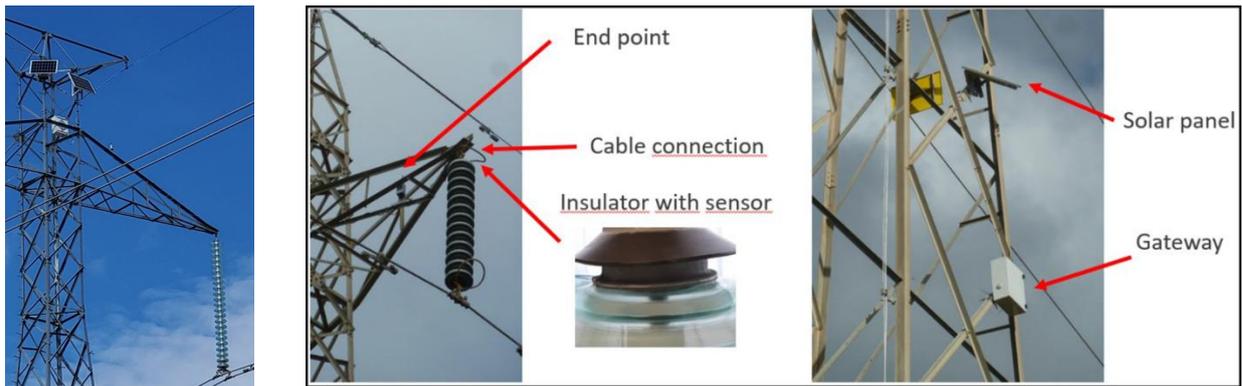
Figure 1: initial SEDIVER Smart system

From the very early stage of development, SEDIVER decided to design a device with a sensor built in the insulator itself (and not added separately afterwards), with a collector of leakage current at the base of the cap rather than using the technology of the Rogowski coil. The main reasons for this choice were the necessity for the Rogowski technique to amplify the signal substantially, and it is by nature not compatible with a DC application. With the built in leakage current collector, there is a stainless-steel ring directly applied at the base of the cap which forces any leakage current to be seen (figure 1 and 2) by the system.

one Gateway in a limited geographical region. The Gateway itself was communicating through GSM and the data transferred to our server. The data was then analyzed and presented for the end user with 2 levels of alarms one being a warning explaining that something is happening, the second being a warning of risk of flashover. These limits are based on the pollution performance of the given type of insulator in its given environment with respect to the knowledge, tests, and field data from the SEDIVER database. Figure 1 shows the initial set of equipment from the insulator string to the gateway as installed in the field in its early stage of development.

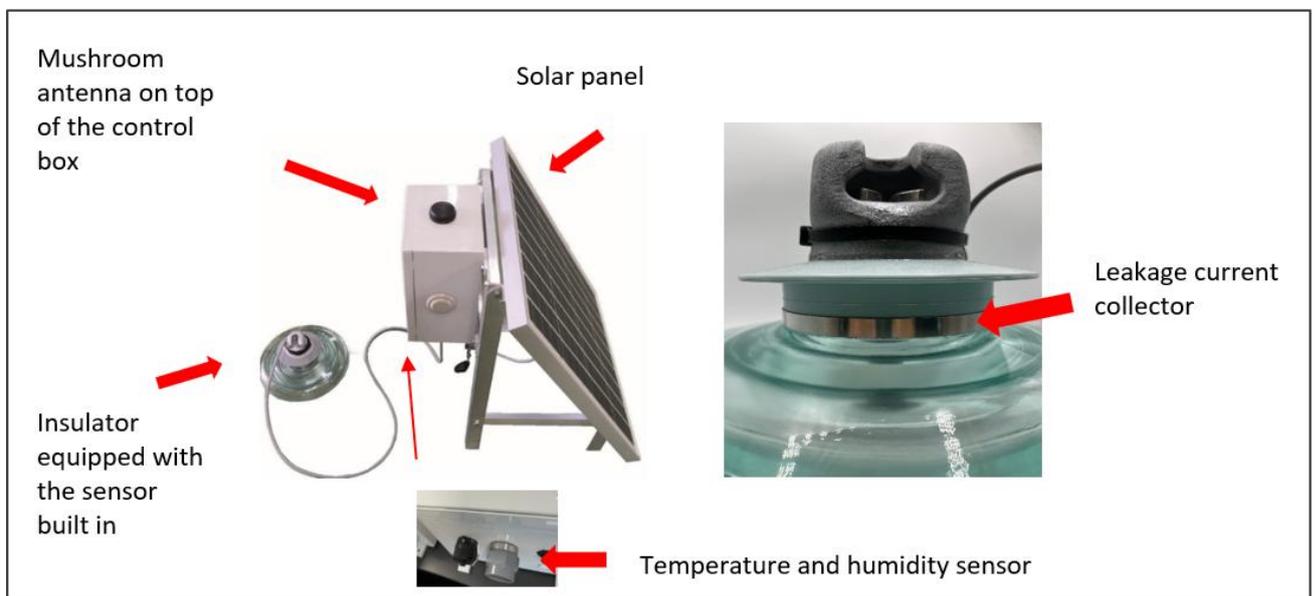
Figure 2: SEDISMART V5.1 system and detail of the leakage current collector

The lessons learned from the early years can be summarized below and have led to the evolution of the system up to the current version generation V5.1 as shown in figure 2:

- b. Going to a GSM system, the antenna was modified to reduce the impact of wind. A mushroom antenna was then adopted as shown in figure 2.
- c. Taking advantage of the simplification, an energy management study was engaged resulting in the possibility to use a much smaller solar panel (one small unit versus 2 large panels before) and optimized electronic components. The buffer in energy available is better and the risk to see a solar panel damaged by strong winds is reduced. The current version takes approximately 2 mA to 3 mA compared to several 100mA previously.

The insulator which contains the sensor is part of the tower and contributes normally to the insulation of the line. Therefore, there is no change in spacing of the string, and the leakage distance of the Smart unit is fully part of the insulation itself, with couplings, ratings, shape identical to the rest of the string. Also, the installation of the sensor is customized to each specific case with the same insulator than the model used on the line.

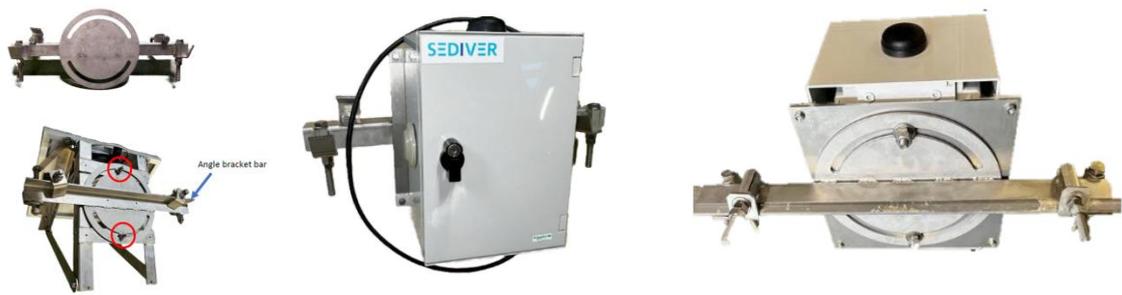
Figure 3: example of base mounting system (brackets for solar panel and base for control box)

The installation of the control box and the solar panel is made thanks to a universal stainless-steel base which can adapt to any type of lattice tower (figure 3). If the system needs to be installed on a tubular pole a customized solution will be proposed.

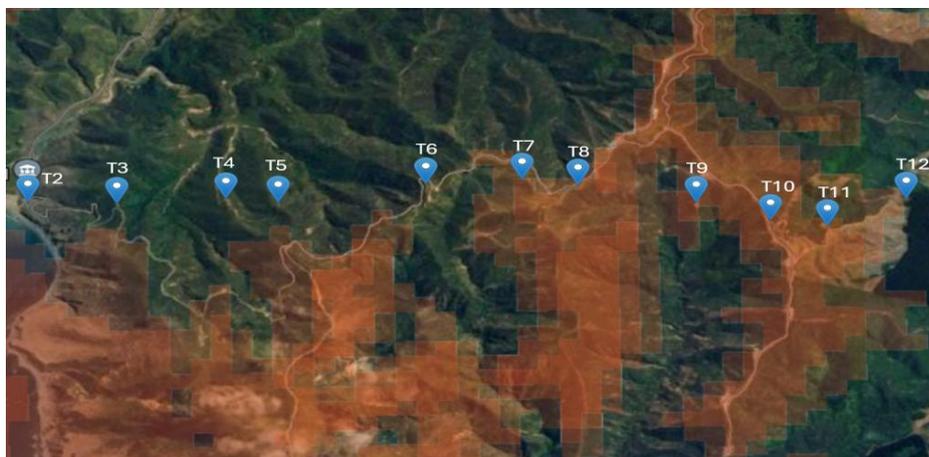
Figure 4: Diagnostic enabling the selection of the optimum communication provider and set of frequencies.

These can vary among providers and the optimum choice will be made for the specific location after a diagnostic is being made along the route of the line as shown in an example in figure 4.

Tower #	2	3	4	5	6	7	8	9	10	11	12
Provider 1	Red	Red	Red	Red	Red	Yellow	Yellow	Yellow	Green	Green	Green
Provider 2	Red	Red	Red	Red							
Provider 3	Red	Red	Red	Red	Yellow	Green	Green	Green	Green	Green	Green
Provider 4	Red	Red	Red	Red	Red	Yellow	Yellow	Yellow	Green	Green	Red
Provider 5	Yellow	Yellow	Yellow	Yellow	Green	Green	Green	Green	Green	Green	Yellow

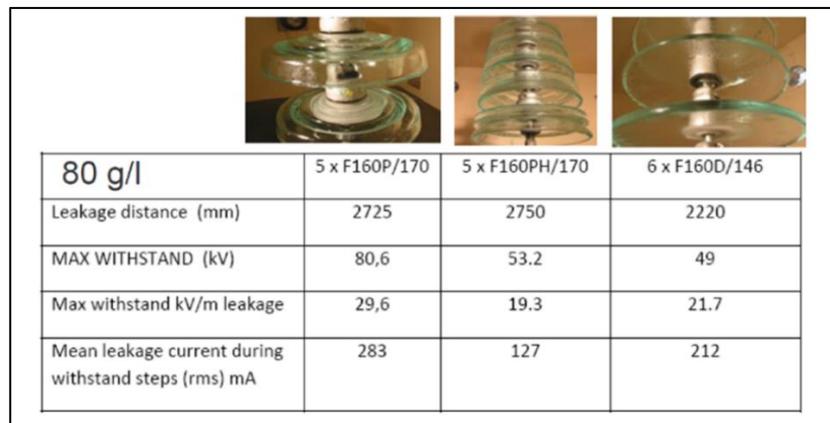
Figure 5: relative limits under 80g/l salt fog test conditions of 3 different profiles [3]

The SEDISMART device is intended to provide a diagnostic when the pollution is reaching a level where severe dry band arcing can take place and initiate a flashover. This critical stage is not the same for all insulators and depends on the shape and profile of the insulator. As an example, salt fog tests performed on 3 different shapes of insulators have shown that the value of the critical leakage current can vary in large ranges [3]. Figure 5 below shows that in salt fog conditions an outerib profile (middle) will flashover at 66% of the capacity of a string of fog types (left) while the maximum current is 45% less than the maximum leakage current which a string of fog type can take. This clearly demonstrate that making a diagnostic of pollution severity based on leakage current values requires the knowledge of the expected limits of each profile being used for each insulator string design. SEDISMART provides warning levels which differ as a function of the type of insulator being monitored.

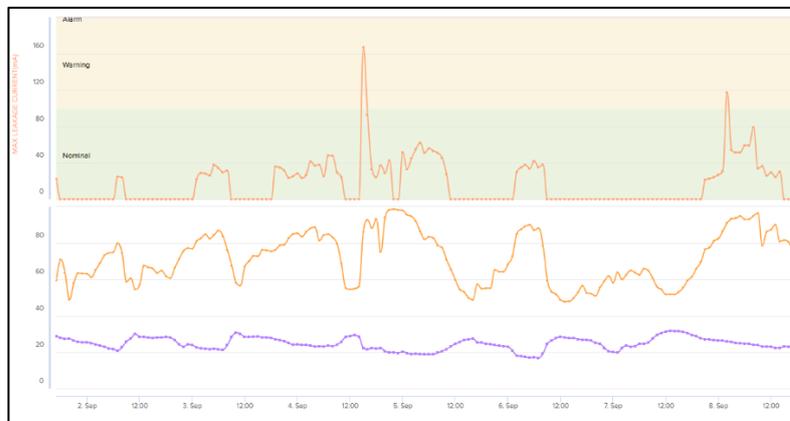
Figure 6: screenshot of the remote monitoring view of a SEDISMART near a coast over a 3-day period. Leakage current (top) follows the evolution of humidity (middle) at a relatively stable temperature (bottom).

As mentioned earlier the leakage currents are generated under critical conditions such as salt fog or clean fog and/or high humidity local conditions. To monitor these parameters all together and in real time, the SEDISMART is equipped with a temperature and humidity sensor fitted underneath the control box as shown in figure 2. As a result, the control screens available remotely will display all three parameters simultaneously (besides several additional parameters such as battery voltage level and solar panel voltage, number of events....). As can be seen from figure 6, the leakage current follows nicely the evolution of humidity in the surrounding environment of the tower equipped with the SEDISMART.

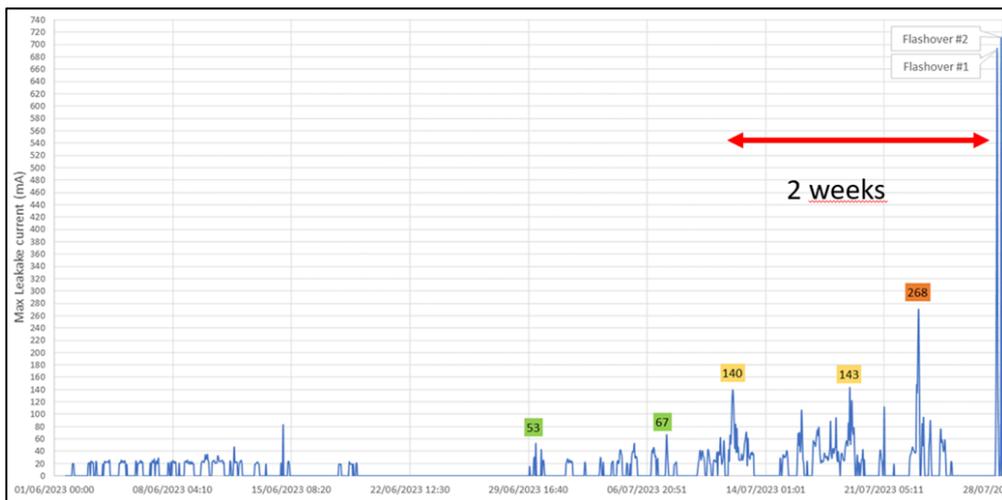
Figure 7: records of sustained activity leading to a flashover

The criticality of the activity on the insulator needs to be considered in its dynamics and not only through the prism of leakage current intensity. This can be seen for example with figure 7 where a sustained level of activity gave some suspicious signs of warning. This finally led to a flashover 2 weeks after the initial warning was sent from the system. For more than 10 days consistent currents including some relatively intense partial arcing were monitored. The maximum current prior to flashover was approximately at 268mA. This can be compared to figure 8 where even higher currents (approximately 320mA) did not lead to the same scenario mostly because it was an isolated event while in figure 7 we see clearly steady activity with repeated peaks of current.

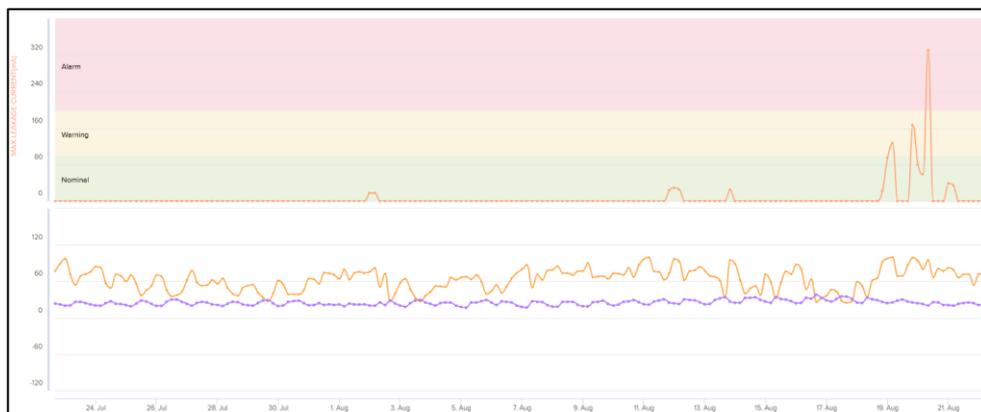
Figure 8: sequence of events over a month of monitoring with an isolated harmless high current event

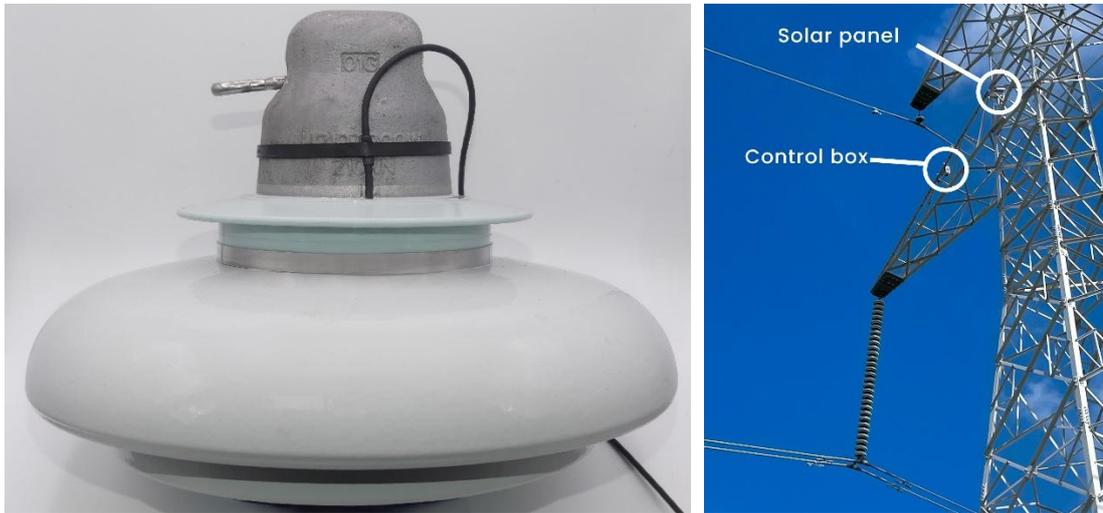
Figure 9: SEDISMART on a coated glass insulator (left) and installed on a string (right with white circles locating the control box and solar panel)

can be too short for a good diagnostic based only on critical currents. However, a silicone surface can be degraded and eroded largely before a flashover takes place and the SEDISMART considers that the monitoring of a silicone coated insulator needs to integrate the level of currents corresponding to sustained conditions leading to a change in the condition of the surface. SEDISMART does exist for silicone coated glass insulators as shown in figure 9.

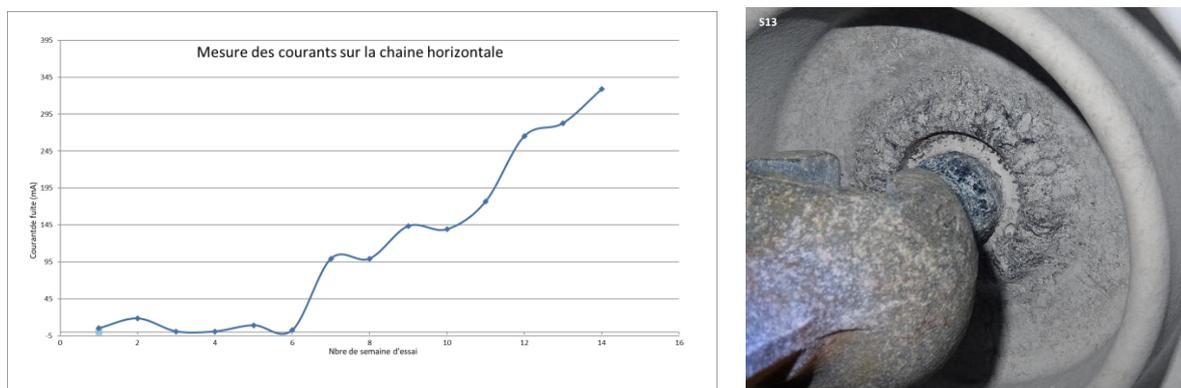
Figure 10: Escalation of leakage current on a HTM surface losing progressively its hydrophobicity and starting subsequently localized erosion on a coating during the 2000h multi stress test.

Many polymer insulators or silicone coated insulators have been found with severe erosion but no flashover. The definition of a warning level for HTM should therefore take into consideration the beginning of surface degradation rather than current levels reaching a near flashover level. To provide this level SEDIVER took as a reference the leakage current levels found in laboratory tests such as a 2000h multi-stress test which is considered today as a reference for testing the aging of silicone coated insulators. Figure 10 shows how leakage currents are escalating once the hydrophobicity is decreasing and erosion starts for a given type of silicone coating. Based on such data we would consider a value of 100mA to be the trigger for a warning.

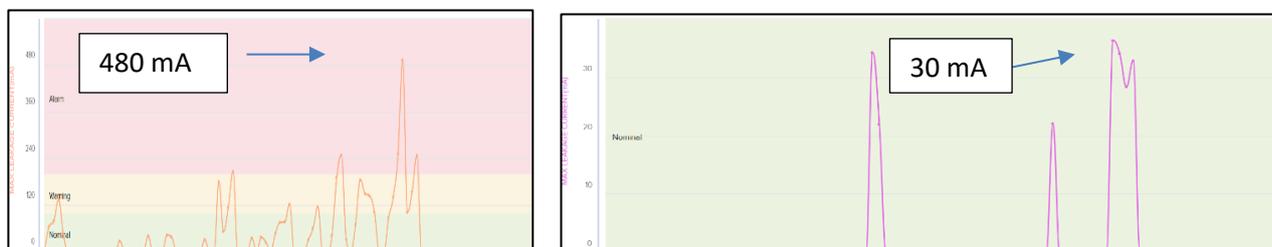
Figure 11: Comparative leakage currents between a silicone coated glass insulator (right side graph with approx. 30mA) and a non-coated insulator (480mA at the left side graph) as measured with SEDISMART on strings in a heavy pollution coastal environment. Relative Humidity above 80% during these events.

Figure 11 shows an example of leakage currents recorded with the SEDISMART in a coastal environment classified as heavy according to IEC 60815 [1]. It is also interesting to compare the level of activity monitored simultaneously on a naked glass surface insulator which was positioned in the same environment during a specific pollution event.
