10377
B2 OVERHEAD LINES
PS3 CLIMATE CHANGE AND EXTREME WEATHER EVENTS

High Voltage Suspension Insulator String Designs for Extreme Weather Events

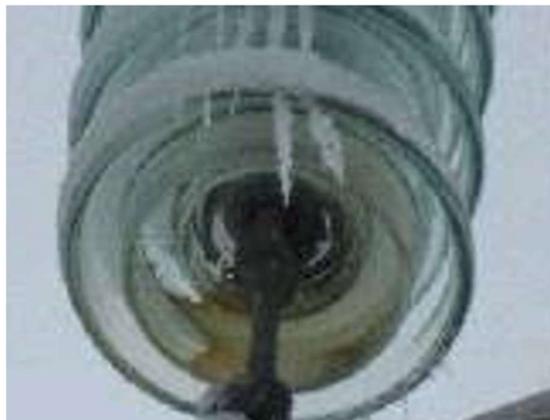
Figure 1- Insulator string exhibiting ice bridging

Typically associated with coastal environments with sea-spray or salt-fog, atomized salt in the air affects the performance of insulators as it accumulates into a conductive pollution layer. But a perfect storm of conditions has led to pollution-induced flashovers in North America's Great Lakes region on transmission lines running parallel to major highways. These occur predominantly in the spring during thawing and freezing periods. During the day, temperatures rise above freezing, melting ice and snow on the towers, crossarms, and insulator strings. With the fall back below freezing at night, dripping meltwater forms icicles bridging across the dielectric of one insulator to the adjoining unit below (Figure1). This is not an issue in clean environments [4], however, next to heavily salted highways where salt has been atomized into the air through the circulation of vehicles on the roadway, the mixture of salt and meltwater forms conductive paths across the insulator string.

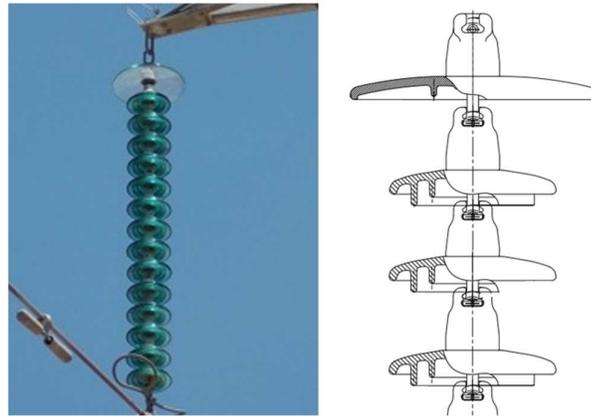
mute related flashovers on V-strings [6]. Bird mute aside, in clean environments, there exists a more cost-effective solution, easily retrofitted onto cap & pin I-strings: the use of open-profile insulators on the cold/tower side of the string serving to shield 10-inch standard profile or 11-inch fog-types below (Figure 4). Climate change effects migration patterns. For any utility facing an increased threat to their assets' reliability due to bird mute, bird guards are a proven solution.

Figure 4- Open profile insulator installed as a bird guard above standard profile insulators.

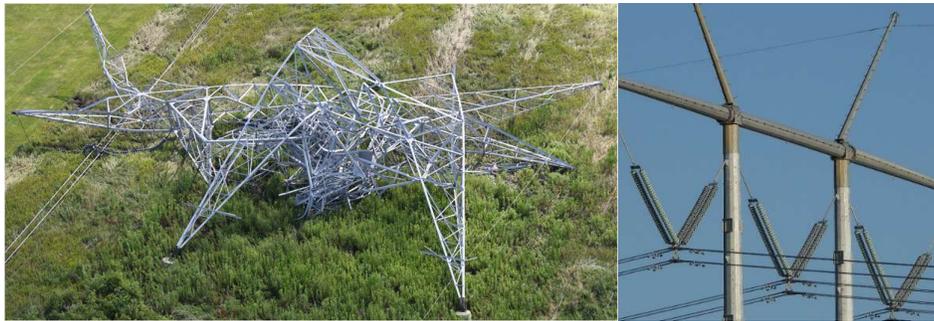
Figure 12- 765kV structure located in Illinois destroyed by tornado in 2024 (left). On the right, replacement structure with silicone coated toughened glass insulators

Another factor contributing to the recovery speed was the use of toughened glass insulators with an inherent binary nature where the dielectric can only exist in one of two well-defined states; fully intact or completely shattered. This differs from porcelain or composite insulators capable of hiding internal defects without any visual evidence of a fault, and in ComEd's case, would require electrical testing, especially in the case of live-line work. But a visual inspection provides infallible data on the conditional performance of a toughened glass insulators, and as such, additional testing or inspections were not required.
