## AGEING AND DEGRADATION MECHANISMS OF SILICONE POLYMERS USED FOR OUTDOOR ELECTRICAL INSULATION

Jean Marie George, Sandrine Prat and Fabien Virlogeux  
SEDIVER, France  
jmgeorge@sediver.com

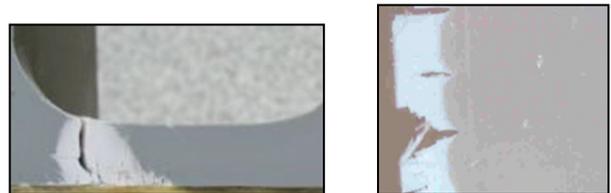
**Figure 5:** degradation resulting from acid attack. (Left: 345kV USA coastal application, nitric acid less than 10 years in service. Right: 230V petrochemical environment, sulphuric acid attack, Saudi Arabia after 7 years in service).

The erosion phenomenon can be slowed down or reduced to a certain degree with ATH fillers (keeping in mind that some environments will still be harsh enough to degrade even these compounds). Other ageing mechanisms have been seen but not clearly explained yet. In some cases the silicone has become brittle with an increase in hardness. When bending sheds, such cracks can propagate easily through what appears to be a mineral layer. Over time these changes can lead to open cracks in the rubber housing resulting in a complete failure of the insulator. Figure 5 describes such degradations found in service and initiated from acids on the surface of the silicone.

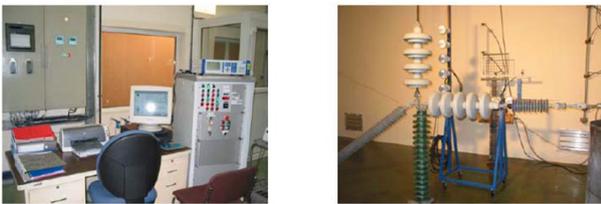
**Figure 9:** 2000h multi-stress ageing test

Like for silicone rubber used in composite insulators, coatings can be made with silicone containing various fillers for increasing the resistance to erosion or none at all. (quartz or ATH fillers are commonly used among manufacturers). As an example (among a large diversity of test protocols established for accelerated ageing tests) interesting results can be found from a 2000h multi-stress test (figure 9) combining UV, rain, salt fog, humidity, voltage on a weekly cycle performed according to a specification from TERNA (Italy) [7] A clear discrimination appears between various coatings including coatings made with different types of ATH (figure 10).

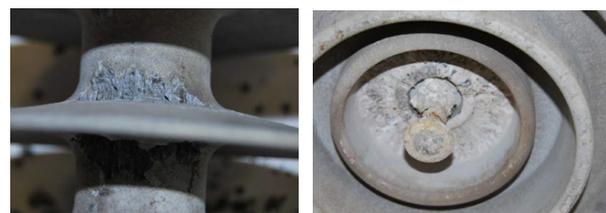
**Figure12:** condition of the insulators after 5 years in the test station (USCD= 66mm/kV) (\*)

Silicone coated insulators have been installed in a variety of test stations around the world. Among those, samples installed in Koeberg (RSA) have shown how a coating can be aged after 5 years in operation in very harsh conditions. Pollution levels up to ESDD=1mg/cm<sup>2</sup> were recorded with no flashovers during the five years of evaluation. Silicone composite insulators were tested simultaneously as shown in figure 12. Erosion is important on the composite and meets all the conditions for being removed despite still being hydrophobic overall. Comparatively and while the silicone coated glass insulator shows also areas of erosion, especially around the pin, the hydrophobicity is globally preserved (reduction near the pin and still very good all around the insulator skirt). In the current condition of these insulators, and unlike the polymer insulator there is no operational risk since the pollution performance is preserved and the erosion only opens the surface to normal glass underneath.
