Aging Infrastructure Evaluation
The Evaluation of Aged High Voltage Ceramic Suspension Insulators- A
Synthesized Analysis of In-Service Insulator Aging Assessments

A. MATTE	J.M. George
Sediver	Sediver
Canada	France

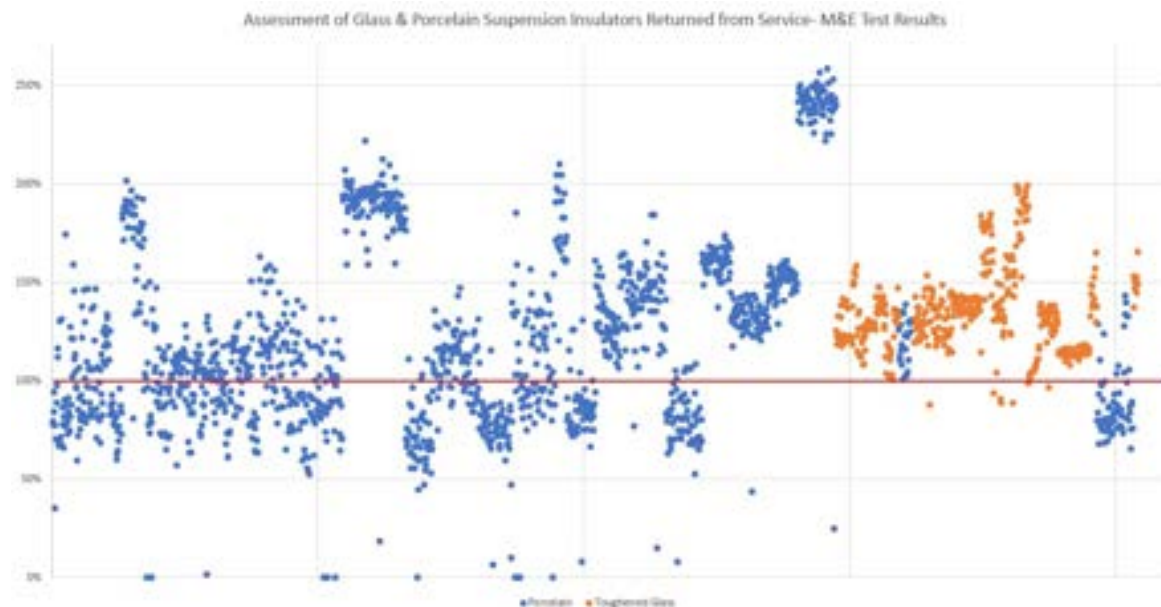
Figure 1A- Porcelain & toughened glass insulator M&E test results. Blue datapoints represent porcelain samples while toughened glass insulators are shown in orange. The horizontal axis represents individual sample number, not timeline.

Figures 1A & 4 distinguish the datapoints between glass and porcelain with the Figure 1A displaying the disparity of results across all individual samples while Figure 4 focuses on the samples based on the number of years in service, though again here disparities in performance are noticed with far fewer toughened glass insulators proportionately failing to meet their rating than the porcelain populations. All toughened glass insulator failures below rating were attributed to failures of the metal components and not the dielectric. Additionally, virtually all failures were from a single manufacturer, proving, as with porcelain, variances exist in terms of quality between the various glass insulator manufacturers.

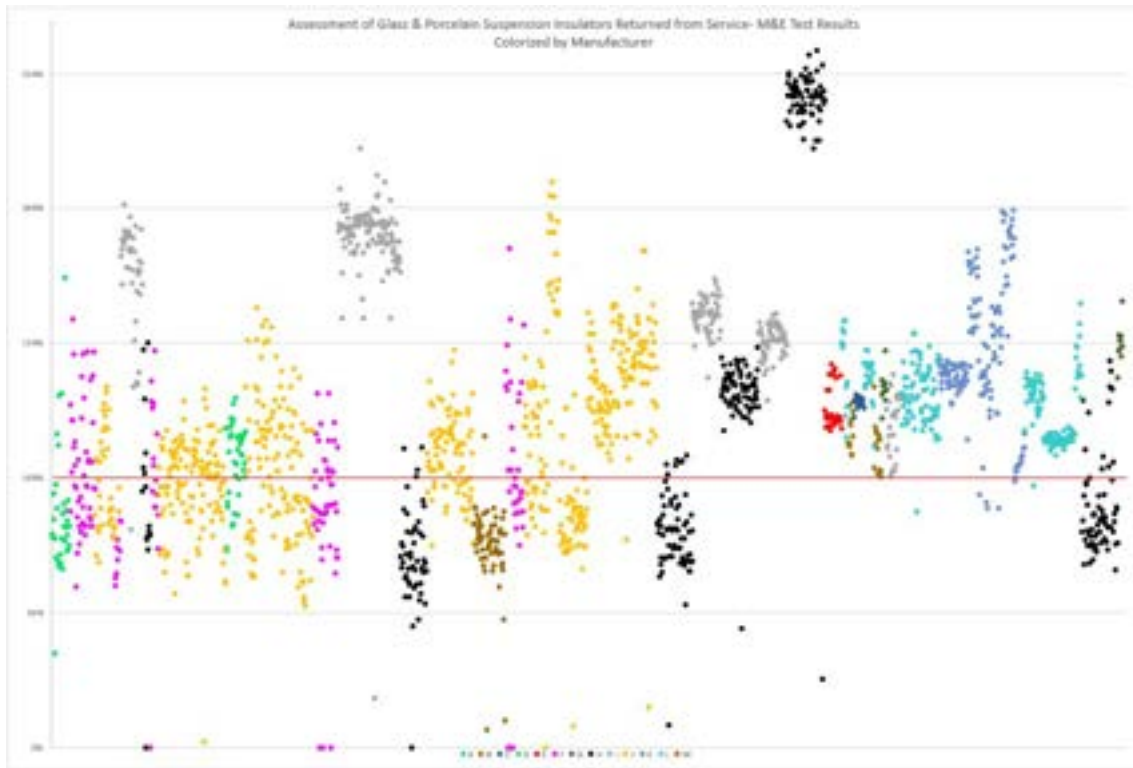
Figure 1B- Porcelain & toughened glass insulator M&E test results with unique colorization for each manufacturer included in the study. The horizontal axis represents individual sample number, not timeline.

In all, over a dozen manufacturers are represented (six glass manufacturers and seven porcelain manufacturers). The oldest insulators were manufactured in the closing days of the First World War in 1918, while in comparison, the youngest population spent only a single year in service and was manufactured over a hundred years later. With samples from all decades in between, this study's data represents much of the high voltage transmission insulator industry's very existence. All samples included in our synthesis are represented in Figures 1A & 1B where the red horizontal line represents the normalized rating at 100% of an insulator's M&E rating with any datapoints falling below failing to meet their rating. All points above the red line exceeded their M&E rating during testing. Figures 1A & 1B do not take into account years in service. Porcelain samples are represented in blue while toughened glass units are shown in orange in Figure 1A while in Figure 1B individual manufacturers are represented through unique colorization of datapoints attributed to each manufacturer's insulators included in the study.

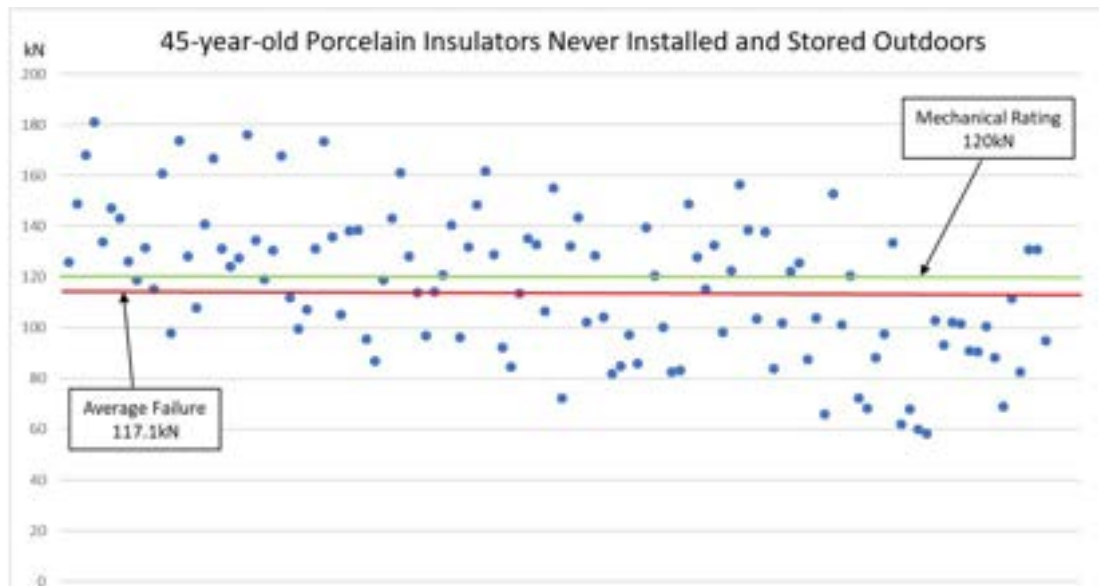
Figure 2 – M&E test results on unused porcelain insulators after 45 years in outdoor storage. The horizontal axis represents individual sample number, not timeline.

Figure 2 displays the result of an aging assessment conducted on 45-year-old 120kN porcelain insulators which were leftover construction spares. Never installed and stored outdoors, these insulators were subjected only to the thermal stresses associated with weathering Canadian summers and winters. An assessment of these units was requested upon the utility's initiation of the transmission line's insulator string rehabilitation as it was hoped they could be used in the replacement project. But as can be seen in the graph, nearly half the population failed to meet the insulator model's electromechanical rating during testing, resulting in the disposal of the inventoried units. Testing was conducted following CSA C411.1-16's electromechanical failing load test in-line with all other populations included in this study.

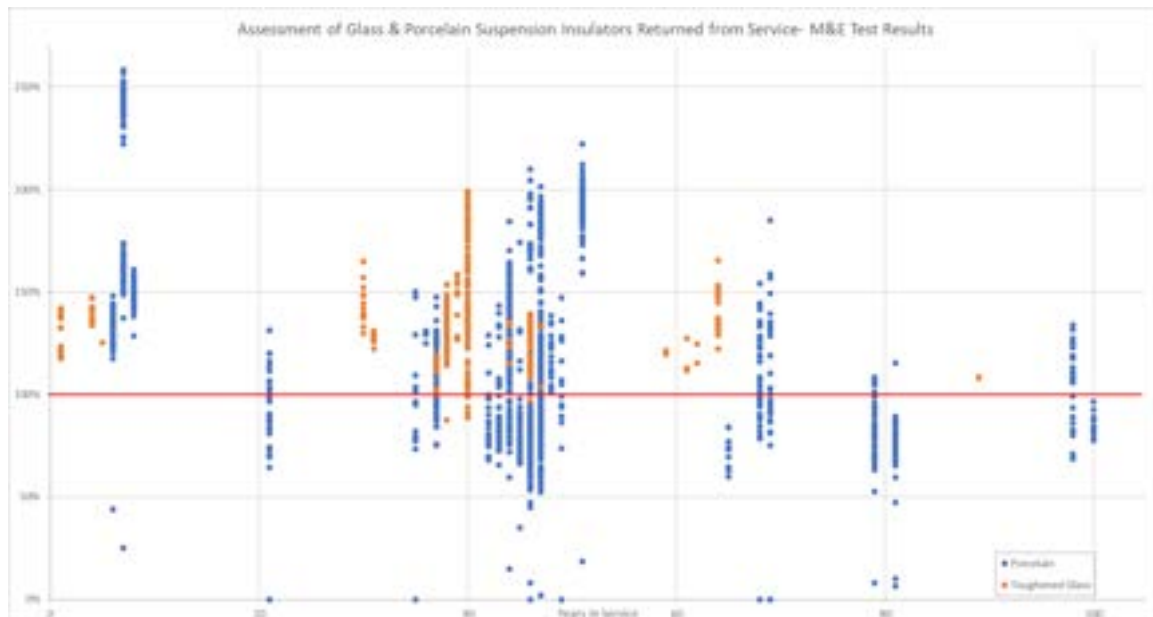
Figure 4- M&E test results as a function of age for both porcelain and glass insulators. Porcelain units are represented in blue while toughened glass insulators are shown in orange.

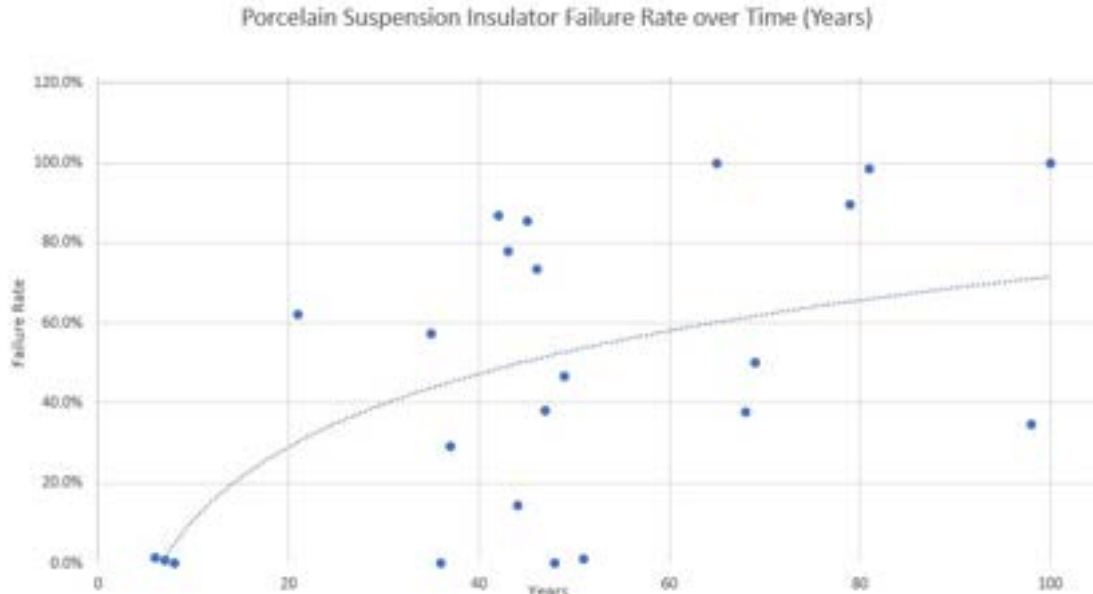
Figure 5- Porcelain insulator failure rate over time (approx. 1500 samples included in analysis)

Interestingly, across the over 1,500 porcelain samples included in our study and depicted in Figure 5 below, we note a total failure rate of approximately 1% for insulators with less than 20 years in service. Looking beyond that, however, it's noted insulator

populations remaining in service beyond 45 years have an approximate 50% chance of not meeting their M&E ratings with significant proportions of the populations exhibiting punctured dielectrics during M&E failing load testing and a failure rate which increases with time.

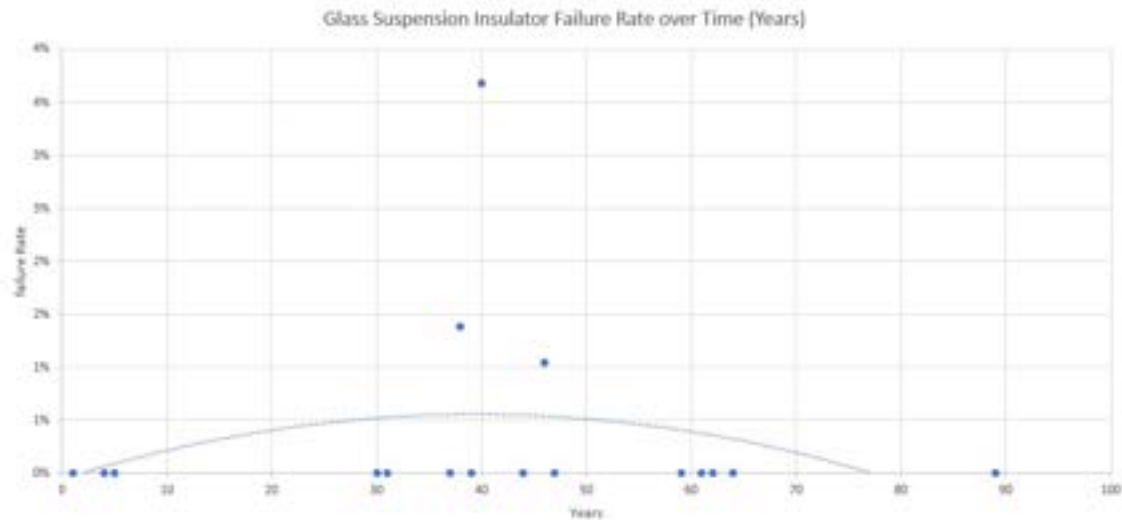
Figure 6 – Toughened glass insulator failure rates over time (approx. 500 samples included in analysis)
DISCUSSION

Comparatively, the data from toughened glass insulator population assessments are shown in Figure 6. Though, similar to porcelain, a few failures were noted for units beginning at approximately 40 years in service, all failures were associated with the metal components. This contrasts with porcelain where most failures were attributed to the dielectrics. Still, this represents little in statistical terms. The result is a nearly flat projected failure rate of approximately 1% across the nearly 90 years analyzed. No exponential increase was noted for glass insulator failure rates confirming the absence of aging of the glass dielectric itself.
