**B2 - Overhead lines**  
**PS 2 – Latest Techniques in Asset Management,  
Capacity Enhancement, Refurbishment**

**Overhead line insulators in operating constraints under severely polluted  
conditions: the benefits of silicone coated glass insulators and their  
application at the PG&E Diablo Canyon Nuclear Power Plant**

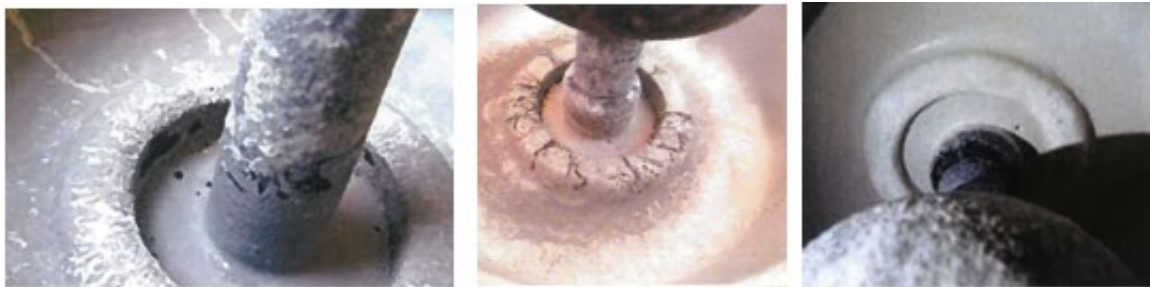
Figure 4: Examples of visuals of silicone coated glass insulators using different chemistries of coating after the 2000h test.

sequence is shown in Figure 3 and consist of a 2000h multi-stress test. It is an interesting test since it shows a clear ability to discriminate best performers (Figure 4).

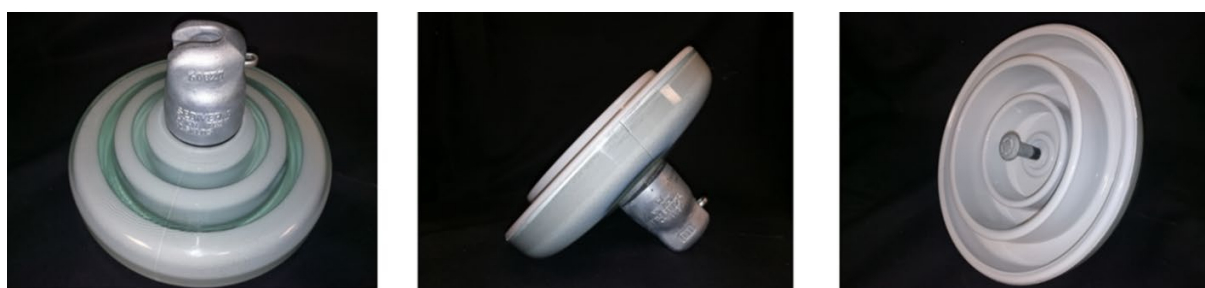
Figure 6: Under coated glass insulators

Nevertheless, either for salt fog conditions or with solid layer pollution an abundant set of test results is clearly showing the extremely interesting performance of silicone coated insulators. Figure 5 shows the performance of non-coated glass insulators relatively to fully coated or under coated glass insulators. The latter (Figure 6) is an option which is gaining popularity since it combines very good pollution performance, easier handling, shipping and packaging conditions. Pacific Gas & Electric is using undercoated glass insulators as a standard feature today for their polluted areas across the grid (Figure 7).

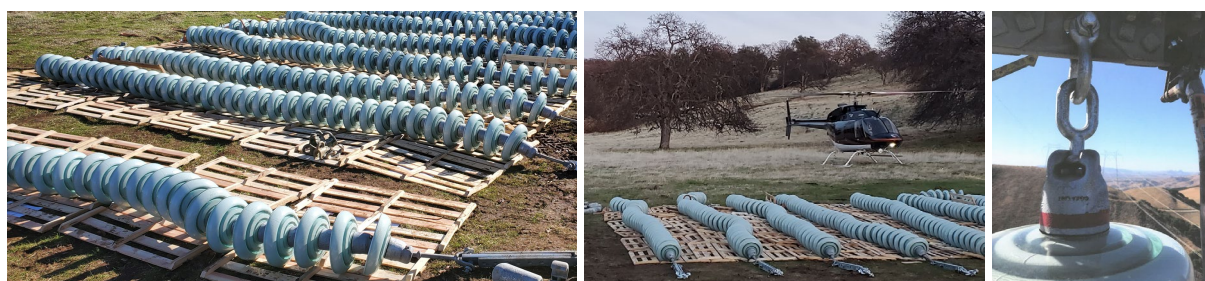
Figure 7: Example of under coated glass insulators installation at PG&E

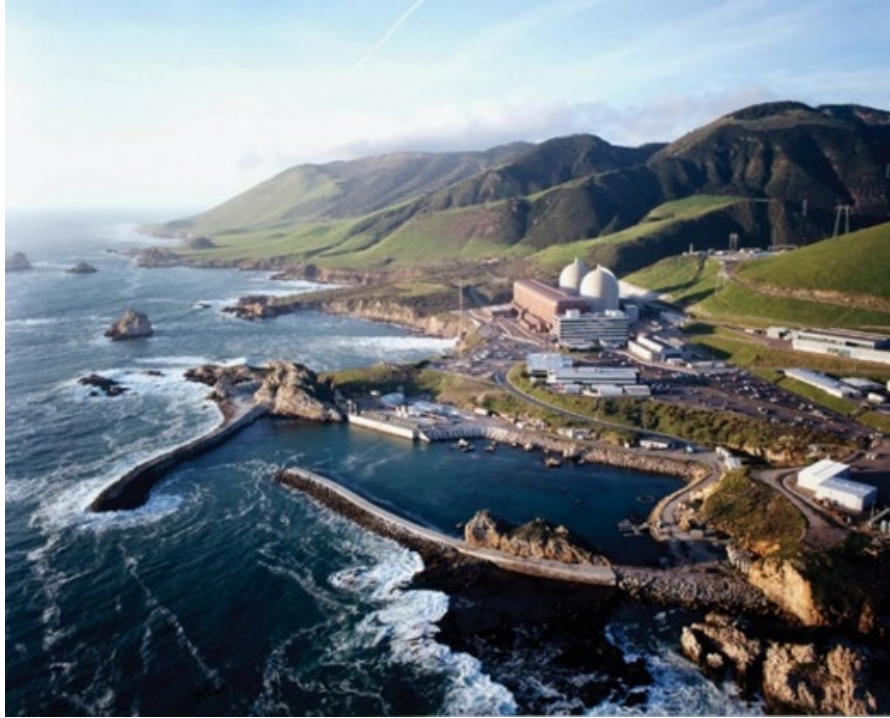
*Figure 8: DCP nuclear generation station is located directly on the Pacific coast*

DCPN (Figure 8) was commissioned by PG&E in the mid 1980's with two 500kV overhead lines extending out from the generators and turbine building to deliver power. Since the plant's inception, DCPN would wash insulators and other equipment regularly, and as a result, had not experienced a pollution related flashover for nearly 3 decades. However, in the years of 2012 to 2014 DCPN saw an elevated number of flashover incidents at the station which resulted in loss of generation. Identified causes included insulator contamination, inadequate insulator leakage distance, and equipment not designed to withstand the harsh coastal environment. It is
