THE CHALLENGE

FLASHOVERS DUE TO ICE BRIDGING IN COLD CLIMATES

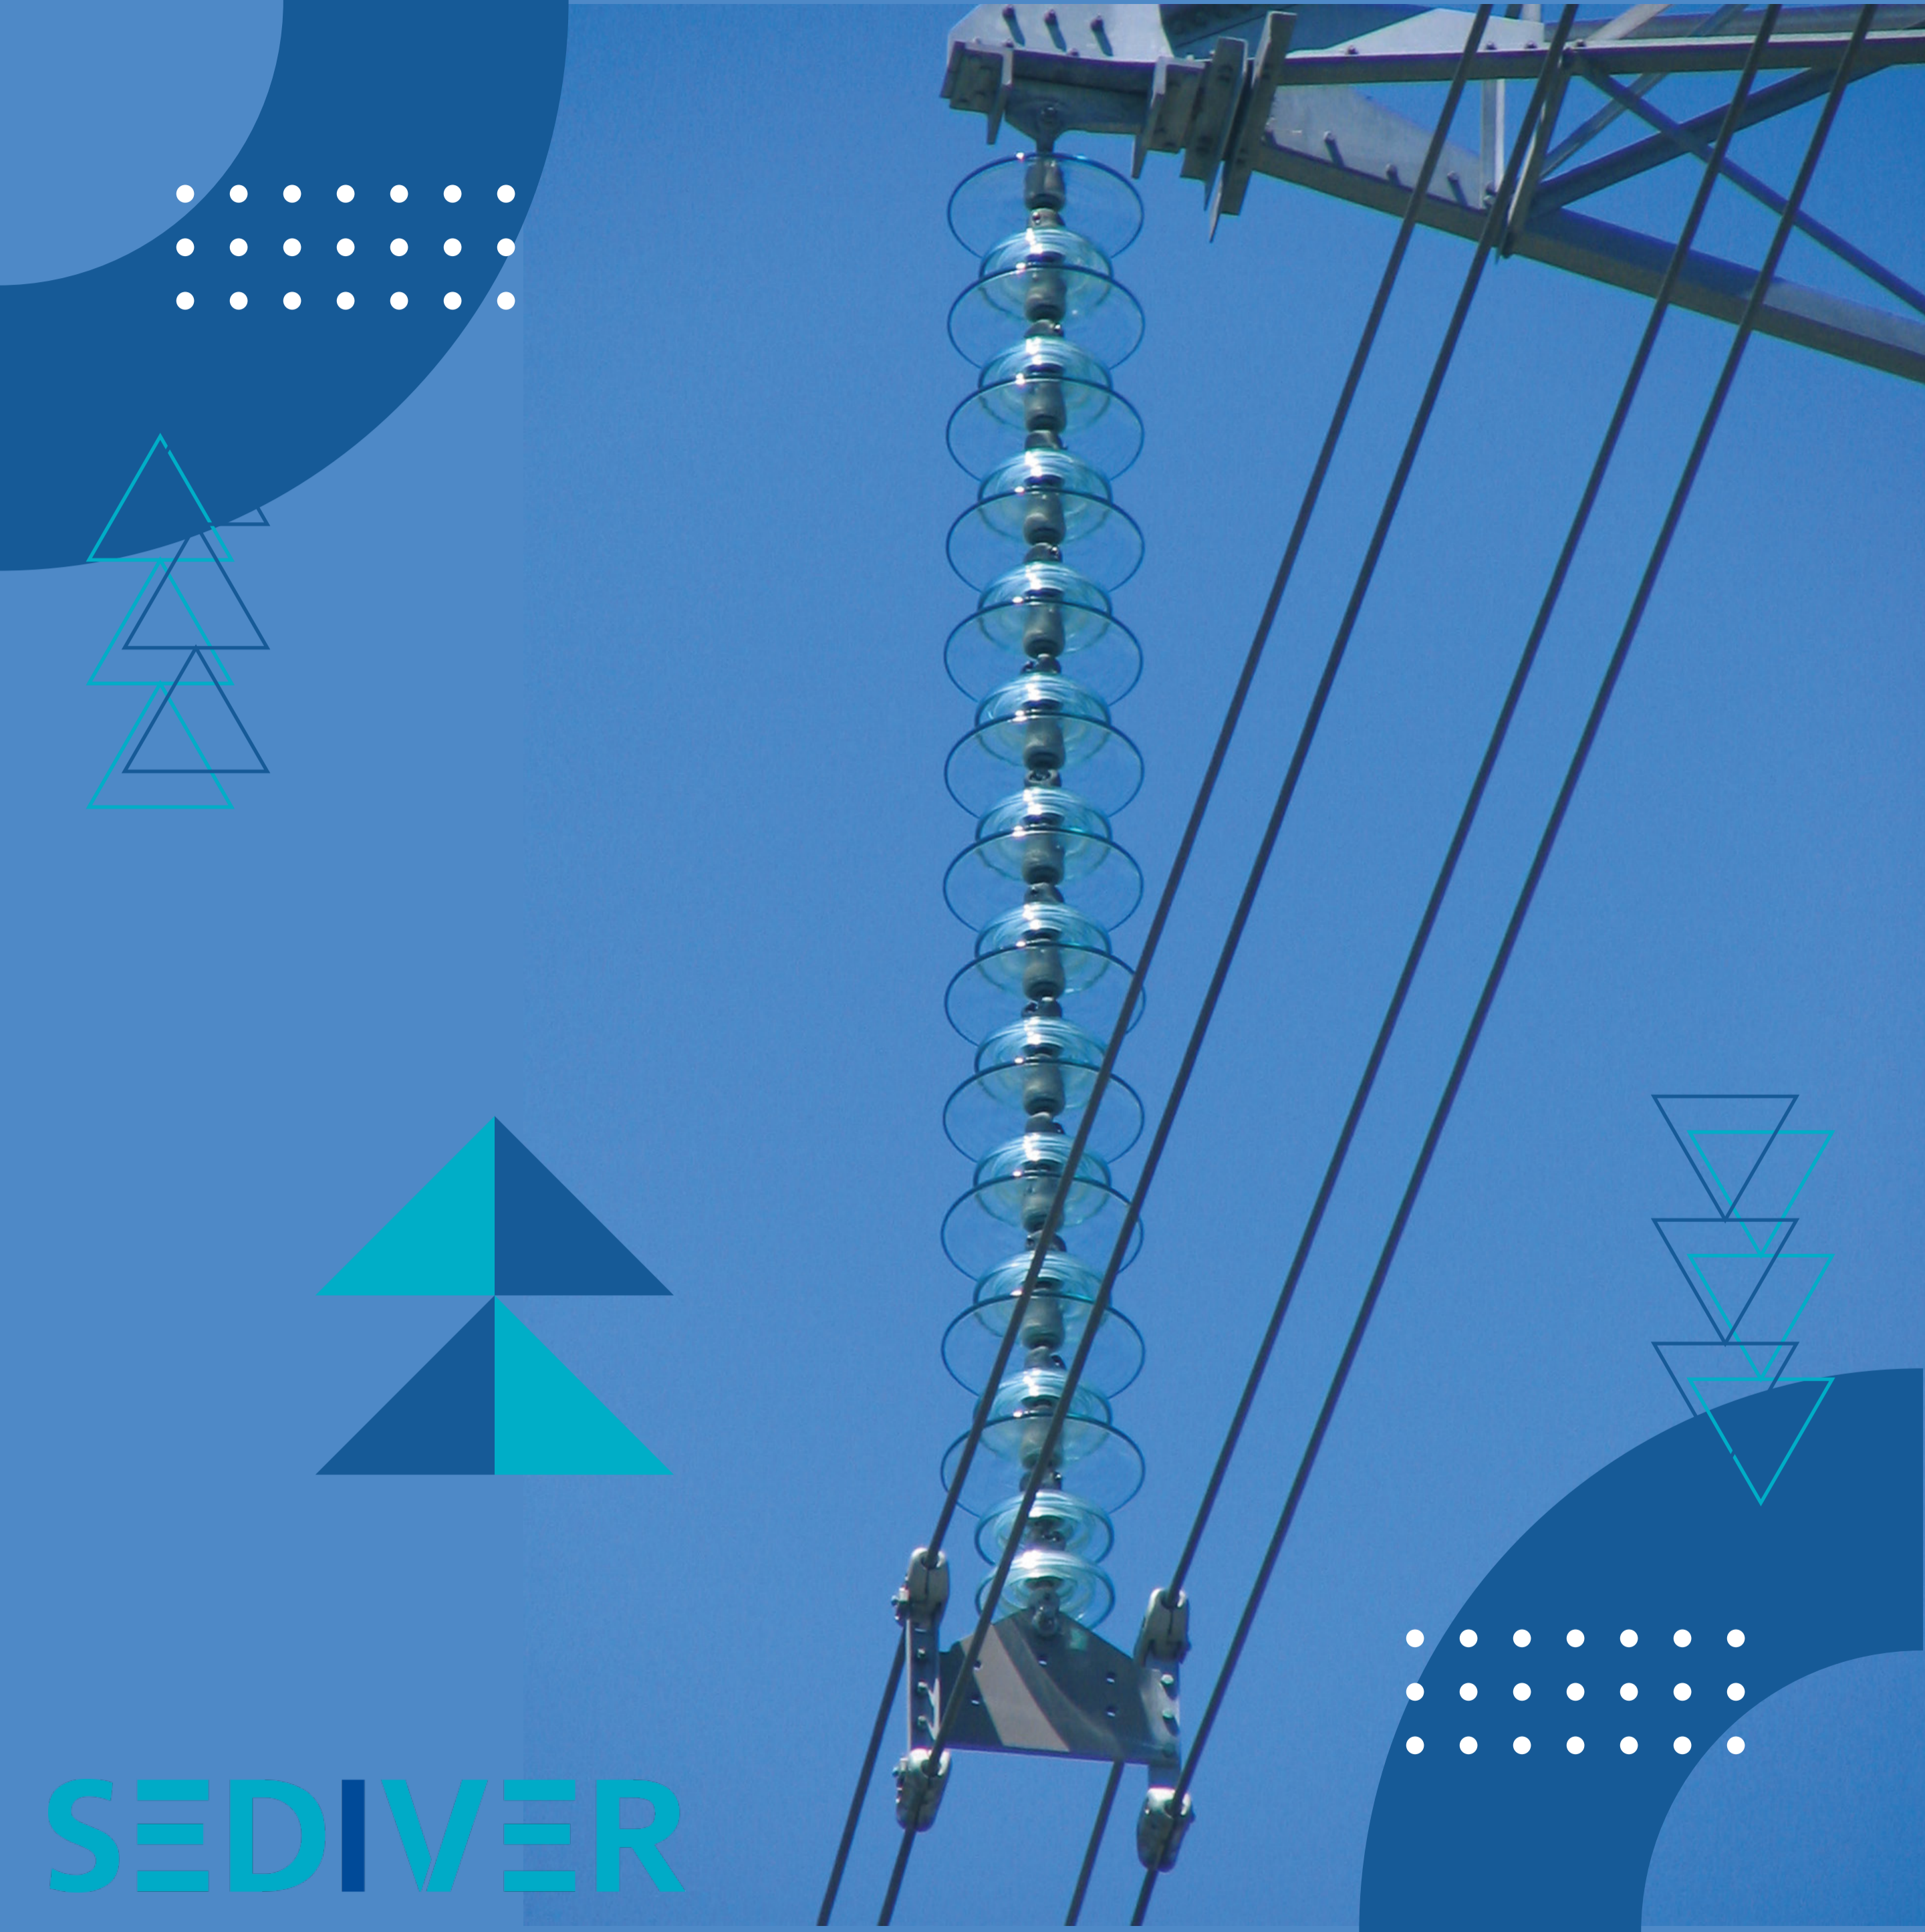
Our customer in Canada was experiencing an issue called ice bridging, when polluted icicles melt, creating vertical “bridges” between insulators that can cause flashovers. Extensive testing determined that the optimal solution would be to alternate different insulator diameters on each vertical string.
