Mitigation of severe contamination problems on overhead lines
without the need for composite insulators

Jean Marie GEORGE

SEDIVER

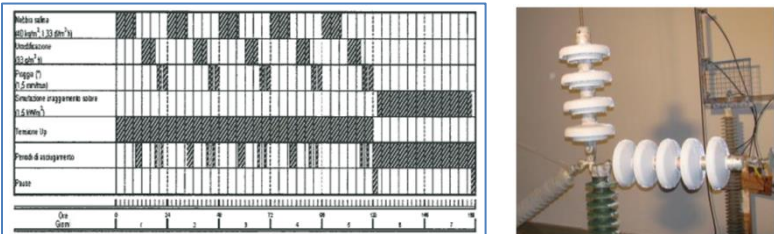
Figure 1: Typical 2000h multi-stress ageing test (TERN) performed in the Sediver Research Center (Saint-Yorre, France). The test combines UV, high humidity and salt fog, rain, USCD= 20mm/kV.

Qualification tests such as the 2000h cycle described in **figure 1** are considered to be a good screening tool for the selection of coatings. Optimum chemistries of silicone coatings have been defined through this test (among other qualification tests), and it was established that the most effective coating is one containing ATH (Alumina Tri Hydrate).

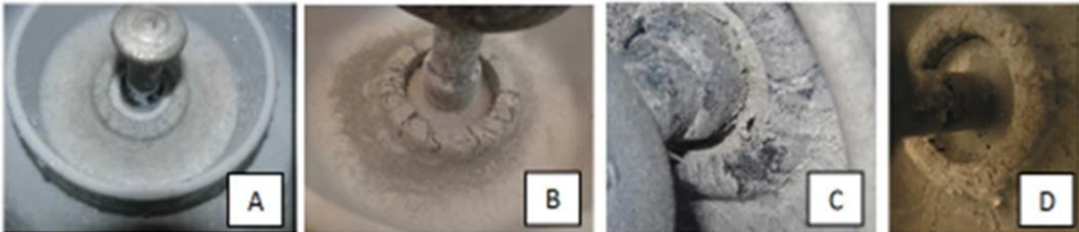
A: polymer 1 ATH type a B: polymer 2 ATH type b C: polymer 2 ATH type c D: polymer 2 quartz filler

Figure 2: Variety of erosion patterns as a function of chemistry of the silicone coating

Figure 2 shows a variety of results in this test with different types of coatings. It can be noted that while some RTV coatings with no fillers are being used in substation with success, the same material would suffer extensive erosion in an electric field corresponding to the geometry of a suspension cap and pin insulator. This section of the insulator surface will be the most severely challenged during the life of the insulator, and hydrophobicity will decrease primarily there as shown in **figure 3**.

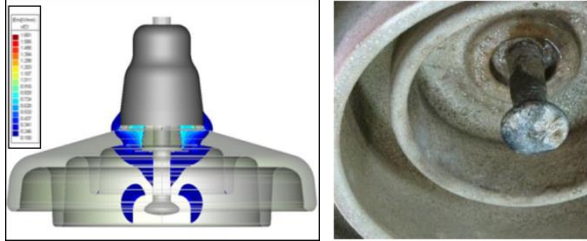
Figure 3: Electric field around the pin of a suspension cap and pin insulator

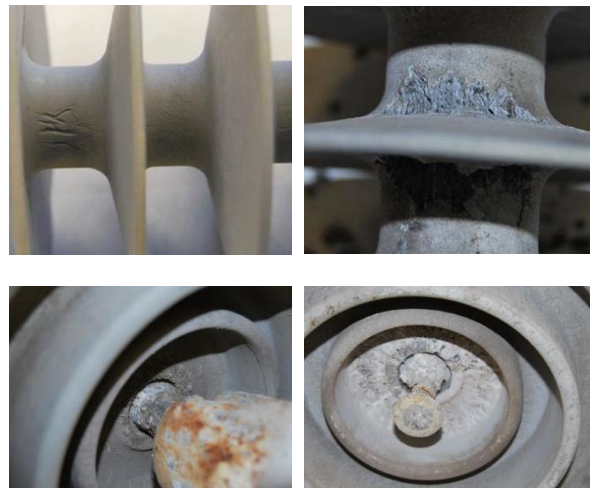
Figure 4: Comparative ageing pattern between a silicone coated composite insulator and an equivalent string of silicone coated toughened glass insulators.

As a benchmark, a comparison between silicone composite insulators and a string of Sediver silicone coated toughened glass insulators was made with the same creepage distance in the same location over a period of 5 years in the Koeberg test station in South Africa where the harsh local conditions are known for a strong acceleration of the ageing process of insulators. The results in **figure 4** show explicitly the benefits of a coated insulator which does not pose a threat to the reliability of the line compared to a polymer insulator which condition after 5 years would require an immediate replacement.

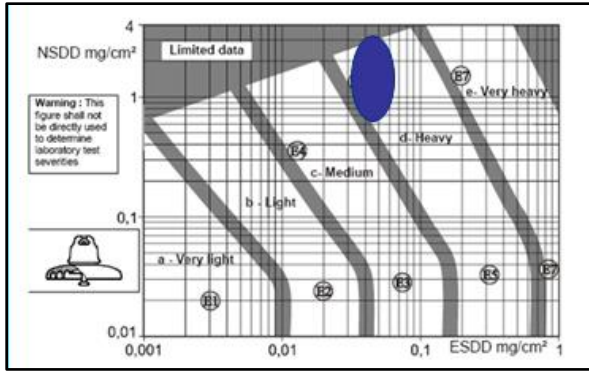
Figure 7: pollution chart

Another example is coming from Qatar where silicone coated toughened glass insulators were installed in semi desertic conditions in 1996 on a 220 kV line. The local utility (Kahramaa) was facing flashovers on their old lines and regular washing was implemented until silicone coated glass insulators were installed. Samples have been removed for evaluation after 19 years in service and tested in the Sediver Reseach Center laboratories (St Yorre and Bazet laboratories, France). The level of pollution is given in **figure 7**, and the overall aspect of the units is shown in **figure 8**.

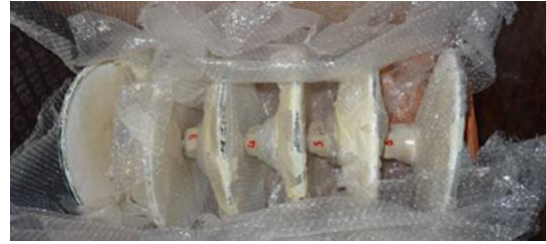
Figure 8: overall aspect of the insulators

It must be noted that the surface of the coating was damaged mostly because of handling during removal, but surface tears and damages were most likely existing in service, and it did not alter the performance of the insulators. **Figure 9** shows the hydrophobicity in some areas of the insulator surface, and the contact angle measured shows a super hydrophobic condition which is the result of the ageing of the polymer itself. This phenomenon (explained in an earlier publication at ISH 2015 by Sediver) is normally harmful for a composite insulator since this change will result in increased hardness and cracking of the housing to finally lead to moisture ingress. For a coated glass insulator this has no consequences other than increasing the hydrophobicity itself.

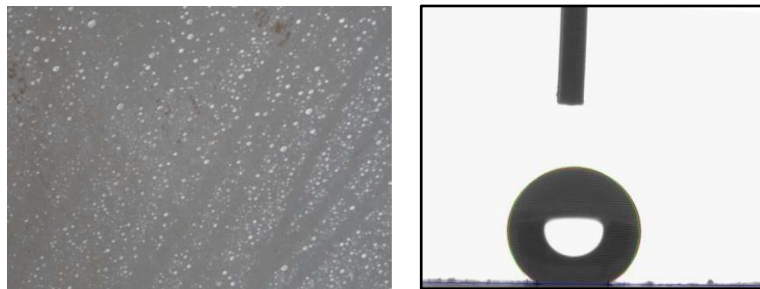
Figure 9 : super hydrophobic condition of the surface and contact angle (142°)

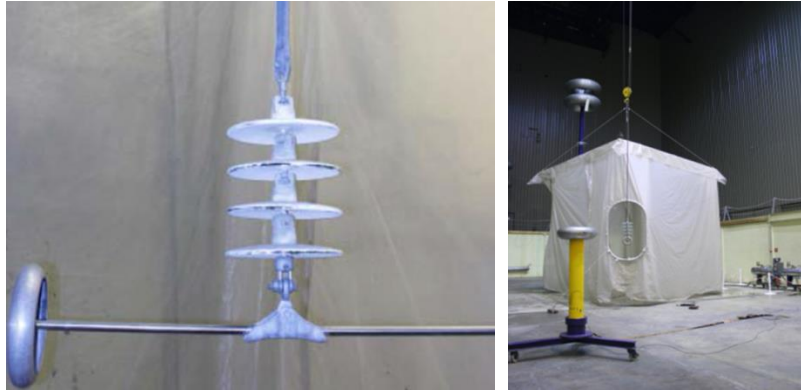
ESDD=0,1 mg/cm² NSDD=0,1 mg/cm² (string of 4 units)	U50 (kV)
Actual units with pollution from site on coated units after 19 years	210 kV
Artificial pollution on non-coated string	72 kV

Figure 10: pollution test and results

In addition to these observations, a comparative pollution test was performed on the samples removed from the line using a clean fog method and compared to non-coated new insulators on which a similar level of pollution (ESDD/NSDD) had been applied. The test method was a rapid flashover method, and the results are shown in **figure 10**.

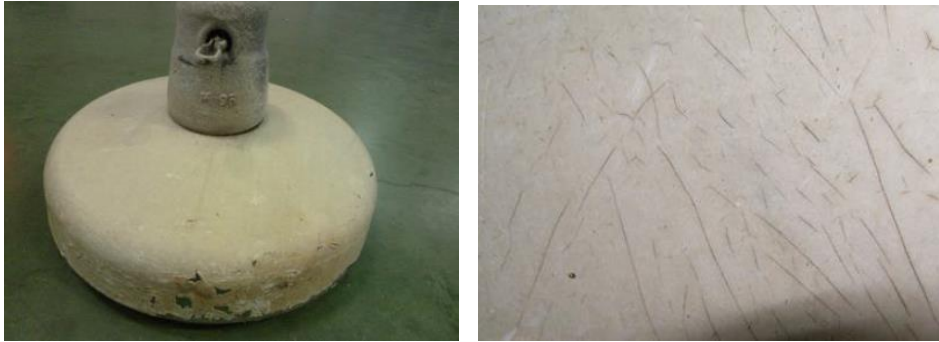
Figure 12: Silicone coated toughened glass insulator after 18 years in service

Silicone DC toughened glass insulators have been successfully in service in harsh coastal conditions on the DC link between Italy and France and a sample removed from a string after 18 years in service in Corsica is shown in **figure 12**. While wear and tear is visible on the surface of the coating, the performance was still good and hydrophobicity while fluctuating along the surface depending where it was measured was found HC2 to HC5.

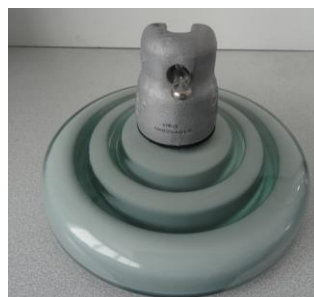
Figure 14: Under-coated toughened glass insulator

In more recent work Sediver has initiated the development of silicone coated toughened glass insulators where only the bottom side of the insulator was coated (**figure 14**). This was suggested to produce favorable conditions of handling and installation, preventing damages which can occur on the surface of the coating during transportation or by the crews at the time of installation. Several applications are already operating with this solution.

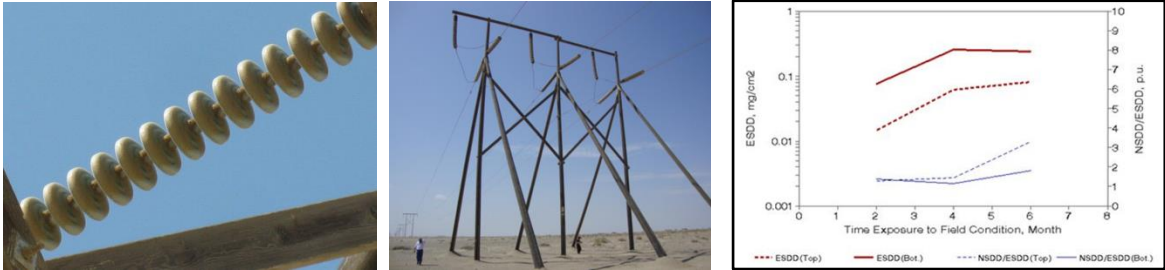
Figure 15: Under-coating toughened glass insulators in Peru (Chiclayo area)

The first trial started in Peru with ISA in 2010 with very good results (**figure 15**). Today other utilities are starting using this technology offered by Sediver, including in the USA.

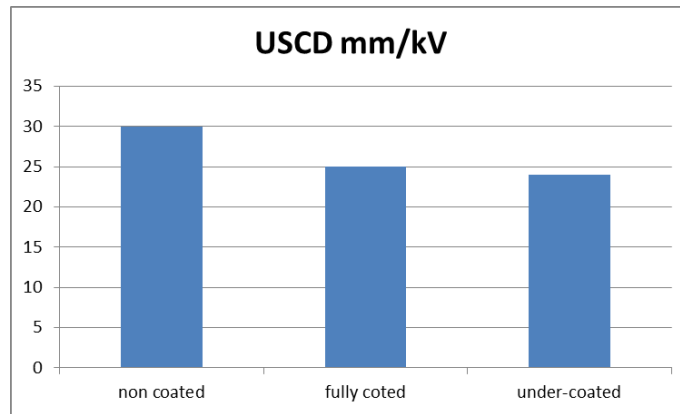
Figure 17: Salt fog test results showing an improvement of 20% of USCD (mm/kV phase/ground) with coated or under-coated (Sediver Research Center).

Salt fog withstand test were also performed on both options and the results show an equivalent (if not better) performance of under-coated toughened glass insulators. The test results in **figure 17** show an improvement of about 20% for an under-coated silicone glass insulator compared to a non-coated unit (salt fog test according to IEC 61507 at 40g/l).
