*World Congress & Exhibition
on Insulators, Arresters & Bushings
Rio de Janeiro, Brazil
May 13-16,2007*

HVDC TOUGHENED GLASS INSULATORS

Abstract

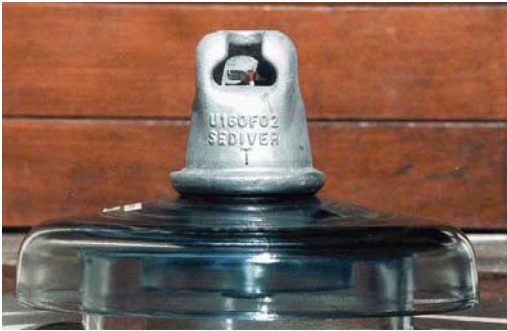
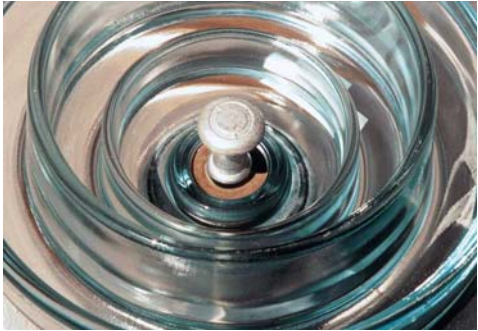
Figure 2 : Current DC toughened glass insulator with corrosion protection features on cap and pin end fittings

The second generation of DC glass, HRTG special glass composition has been designed (6) around a better protection against corrosion (figure 2) and above all, a much higher resistivity as shown in figure 3. This special chemistry of glass is locking the ions through a much lower ionic conductivity in order to stop the migration under DC voltage. Given this “immunity” against ionic stress, the adverse effects described above and seen in the earlier applications have been eliminated. Additionally, special process treatments in the glass moulding have led to a much higher purity of glass, and therefore a lower impact to DC ionic accumulation.

The risk of corrosion of the cap (even minor) has been completely eliminated in the new HRTG generation thanks to the addition of a pure zinc collar around the base of the cap as explained earlier in [figures 1 and 2](#). Such additional protection to the cap has been used since on several major projects like in India or China.

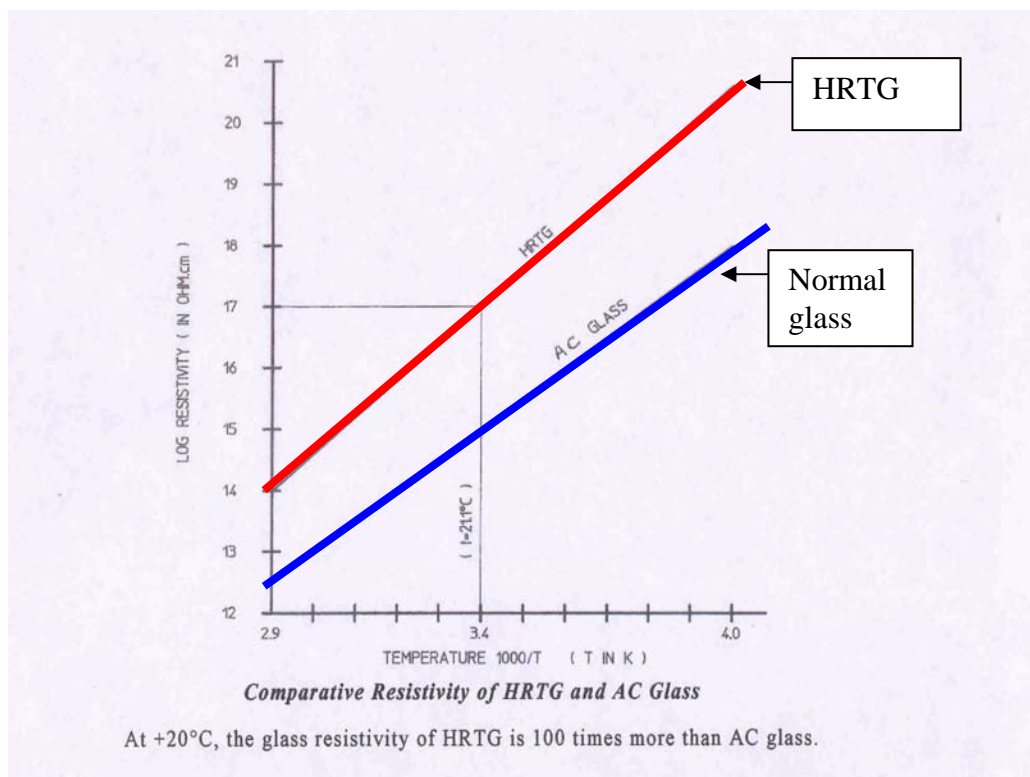
Figure 3: difference of resistivity of HRTG versus normal glass

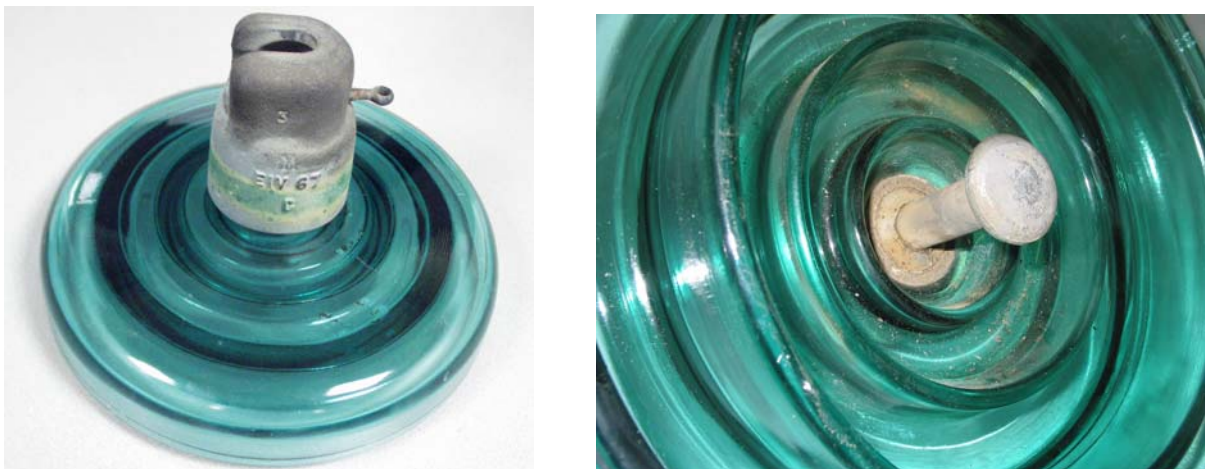
These tests were performed in CEB Laboratory, France and Saint Yorre laboratory France. The overall condition of these insulators, as can be seen in figure 4 is excellent. There was a zinc sleeve on the pin, and the fittings do not show any significant damage.

Figure 4: BPA 500kV DC insulators after more than 35 years in service.
Mechanical rating is 180kN

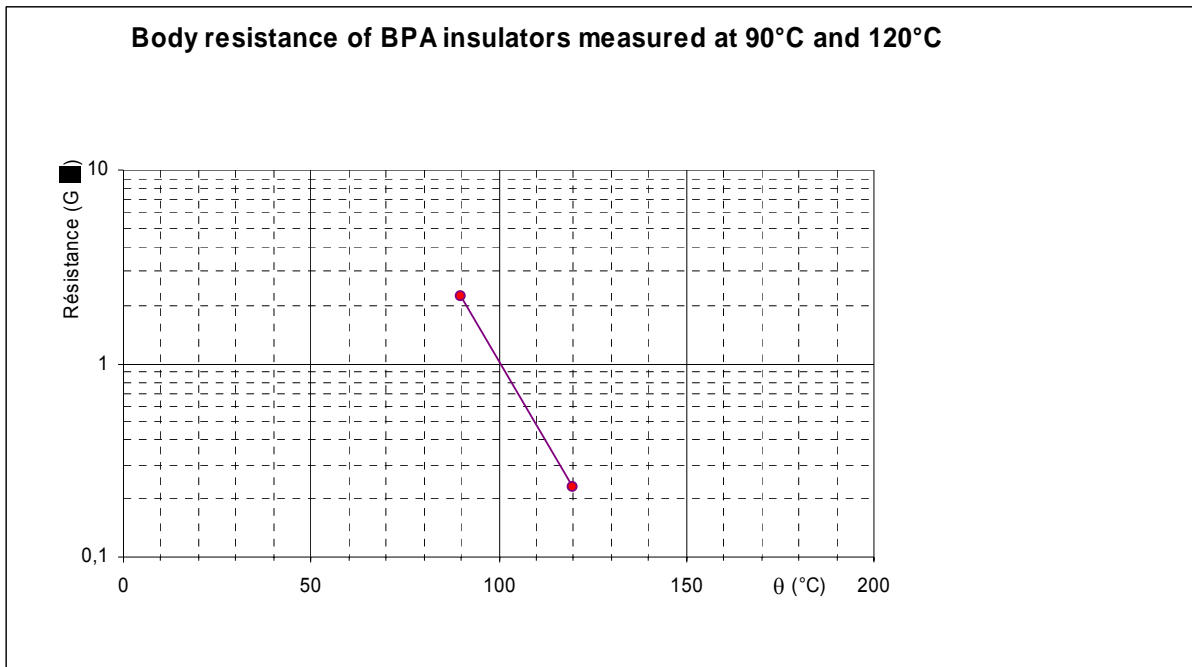
Figure 5: Body resistance of the tested insulators

To verify the integrity of the dielectric under ionic migration conditions, 50 insulators were tested as per IEC 61325 section 18. The Q50 conditions were evaluated as per this method, after determination of the body resistance (figure 5 and 6). The test was performed as shown in figure 7.

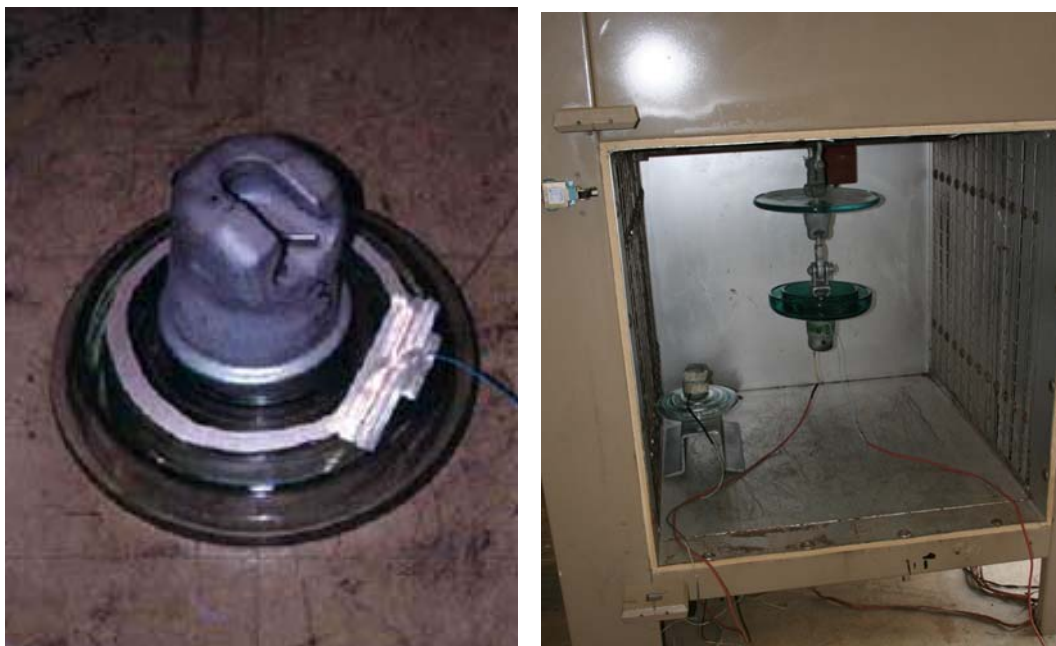
Figure 6: body resistance tests (CEB laboratory, France)

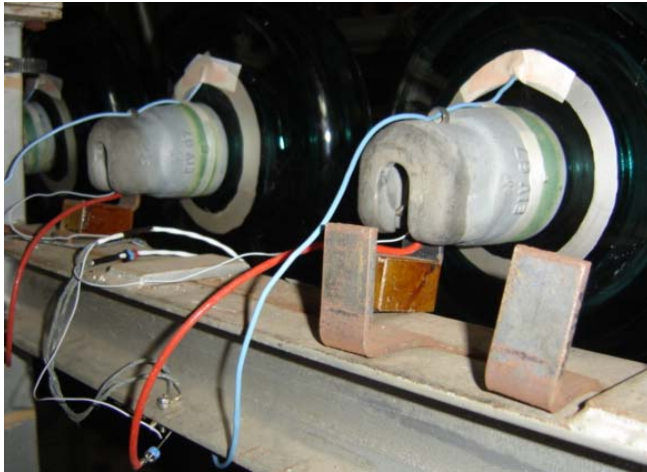
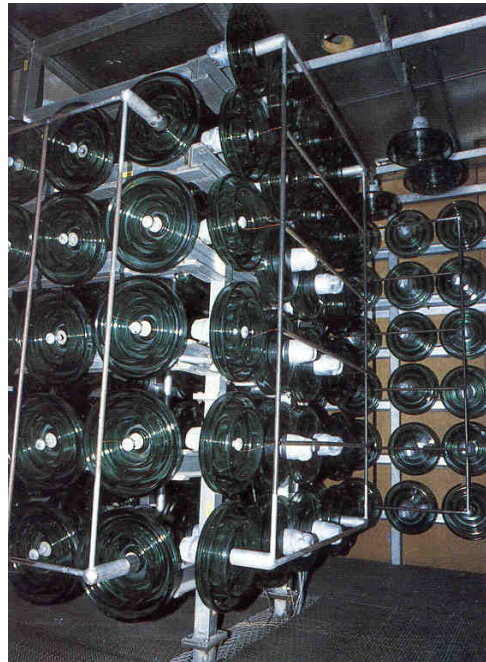
Figure 7: Ionic migration test. (CEB laboratory, France)

Test conditions were 70kV, and 90° C. The charge quantity calculated for the test to achieve under these conditions the Q50 was 153C. A shattering occurred after 258C, equivalent to a service time of **86 years**. The test was stopped after 525C with no further evolution, which is above **100 years** of equivalent service time.

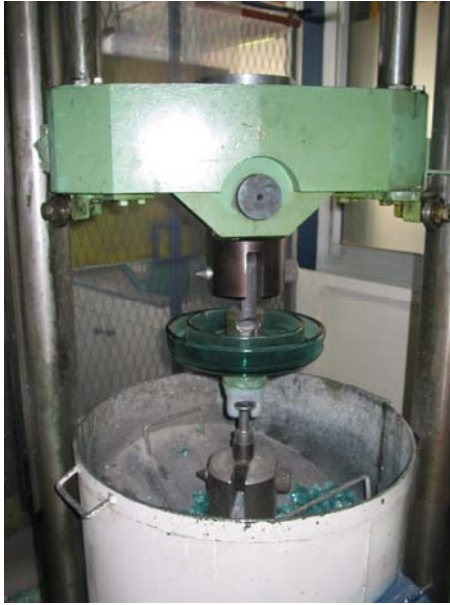
Figure 8 : set up of the tensile test

Ten insulators taken after they passed the ionic migration test were tested. The test was performed as per IEC 60383 in Saint Yorre laboratory, France. The rating of the insulators is 180kN. The set up is shown in figure 8.

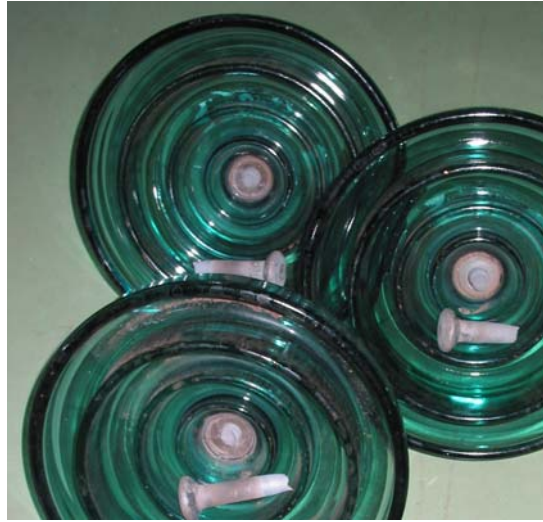
Figure 9: Pin breakage typical of mechanical failure

All the insulators broke at the pin (figure9). The values are:

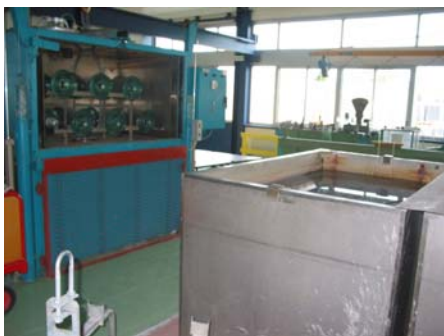
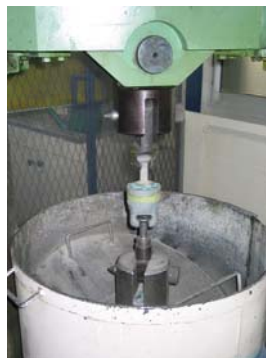
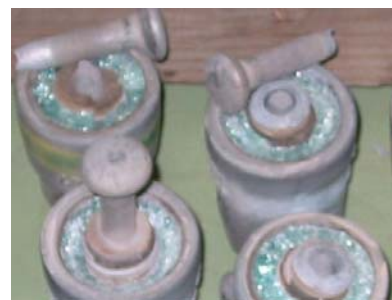
Figure 10: residual strength test with preliminary thermal cycles (IEC 60797)

This test was performed as per IEC 60797 on 15 insulators, using a preconditioning thermal cycle (figure 10). All these insulators had previously passed the ionic migration test.

Out of the 15 units tested, 9 insulators broke at the pin. The lowest value of the pin breakage is 200 kN. For the others, 6 pins were pulled out, the lowest value being 176.1 kN. For these one, the calculation of the acceptance criteria is:

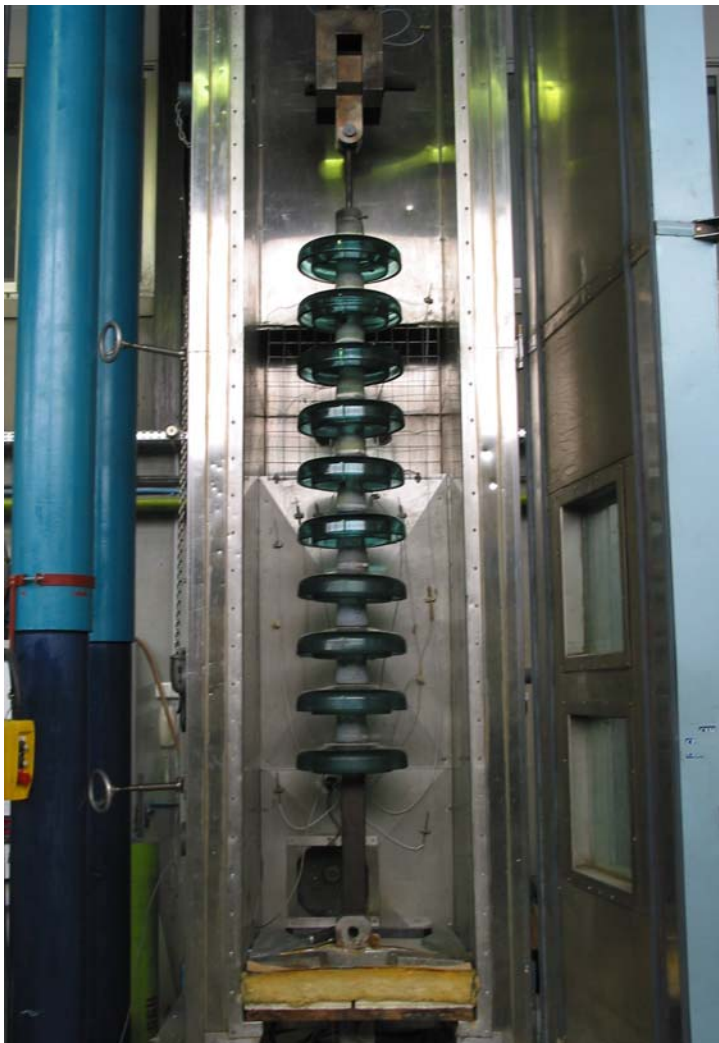
Figure 11: Thermo mechanical test
-50/+50°C
(Saint Yorre laboratory, France)

This test was performed as per IEC 60575 with temperature variations from **-50°C to +50°C.** The set up is shown in figure 11. All 10 insulators were taken from the samples which had passed previously the ionic migration test.

After the 96h cycle test, the insulators were pulled to mechanical destruction. All the values were above rating. (7 broken pins, 3 broken caps)

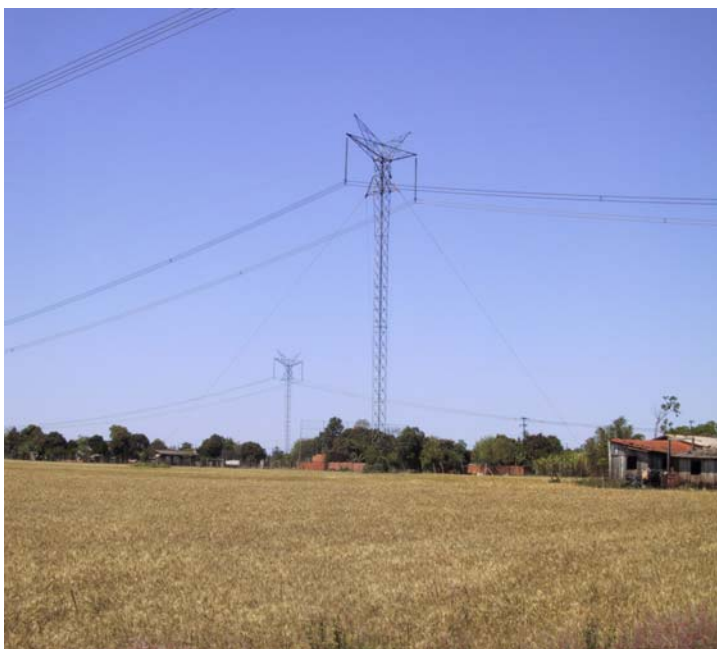
Figure12: Itaipu I and Itaipu II +/-600 KV DC equipped with SEDIVER toughened glass insulators

Some insulators have been removed by FURNAS from the +/-600KV DC lines in Itaipu (figure 12). The main difference with the previous case is the climatic conditions, tropical, warm and highly humid with natural pollution conditions (fungus...).

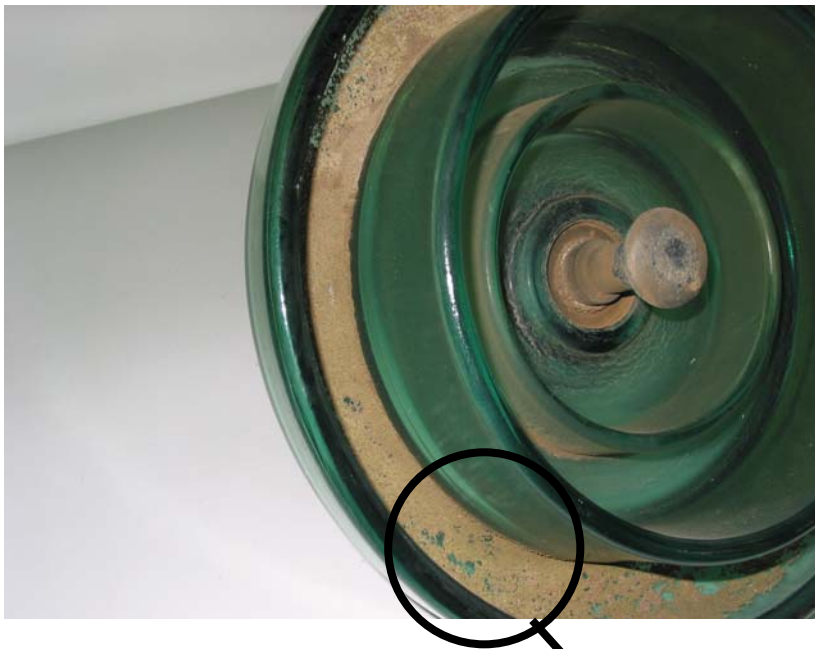
Figure 13: pollution concentration in external section of the bottom of the insulator outside the large rib while the rest of the insulator remains clean

These insulators were produced in 1981 and 1986 respectively from Bipôle I and II. The visual observations show insulators in very good conditions. Some insulators have rust spots at the base of the cap, but overall their aspect is excellent. It appears also that the pollution (when present) is not evenly distributed. Some units are very clean others have a biological type of pollution located mainly between the outer edge of the under skirt and the large rib under the skirt as shown in figure 13. A close up (figure 14) of the pollution deposit shows fungus in this region.

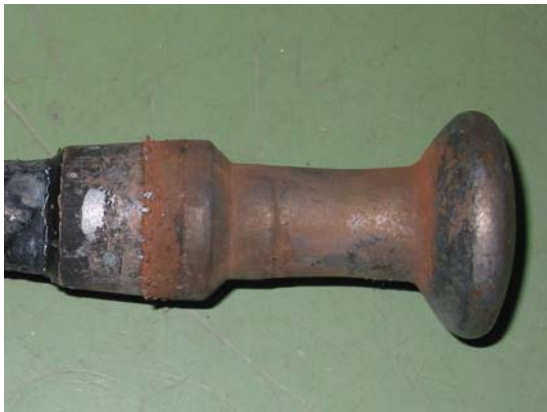
Figure 15 : condition of the pin removed after mechanical test. No corrosion

The insulators removed from these lines do not show any major sign of corrosion on the pin. The pins are in excellent condition (figure 15), In a few cases the base of the cap of some units was rusted as shown in [figure 16](#). Furnas Engineers had spotted these cases, and did not report any particular damaging behaviour.

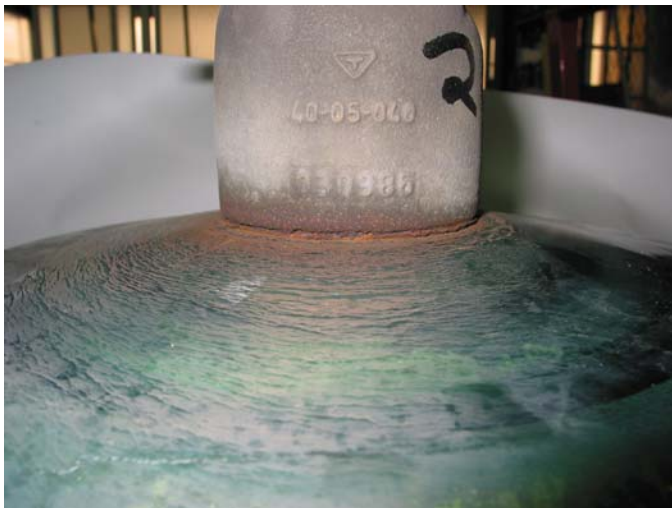
Figure16 : corrosion at the base of the cap on a few units

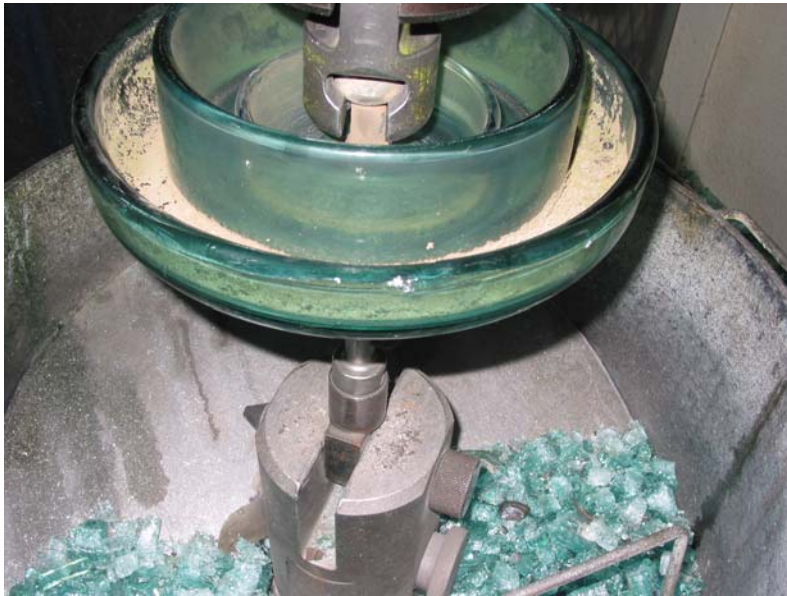
Figure 19: Itaipu insulator during the mechanical test (polarity (-))

These insulators were rated at 160kN. A mechanical test (figure19) was performed on 10 insulators taken from both polarities:

Average failing load: $\bar{X} = 216.2 \text{ kN}$

Standard deviation: $\sigma = 12.1 \text{ kN}$
