World Congress & Exhibition on Insulators, Arresters & Bushings

Rio de Janeiro, Brazil • May 13-16, 2007

# First experience with factory-coated glass insulators on the Italian transmission network

Romeo RENDINA , Maria Rosaria GUARNIERE, Alfonso POSATI (TERNA SpA - Italy) Jean-Marie GEORGE, Sandrine PRAT (SEVES-SEDIVER - France) Generoso DE SIMONE (SEVES – Italy)

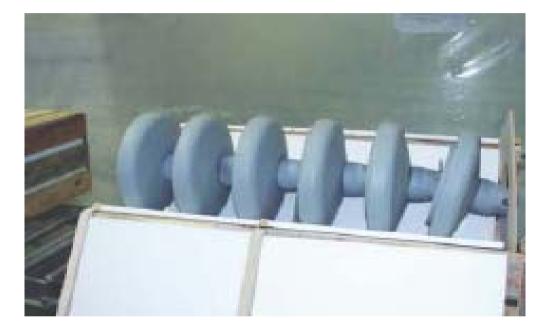
Use of styrofoam boxes and vertical storage of strings

inside protection of a coated insulator box

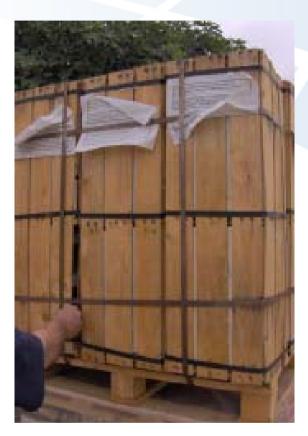
shipping arrangement of crates with coated insulators

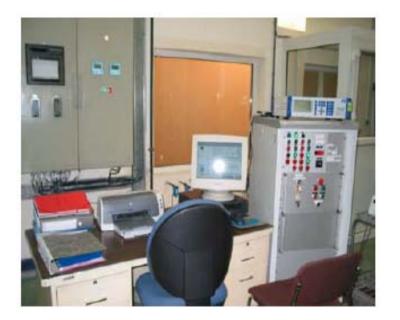
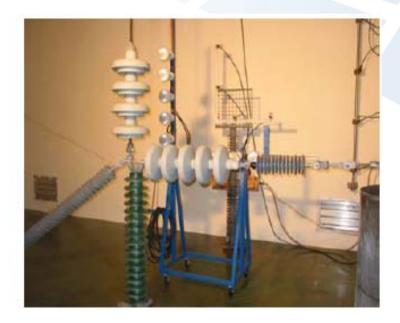
Controls and test chamber for TERNA 2000h ageing test performed at Saint Yorre Laboratories

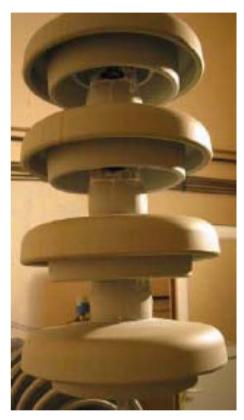
Vertical string after the test

(e.g.: the vertical string had little evolution of the current, fluctuating from 0.75mA peak at the beginning to 0.9mA peak at the end of the test. The horizontal string went from 0.34mA peak to a maximum of 1mA peak at the end of the salt fog sequence, sign of a reduction or temporary loss of hydrophobicity. In the other parts of the cycle, the current was fluctuating between 0.4mA and 0.9mA depending upon the step in the cycle).

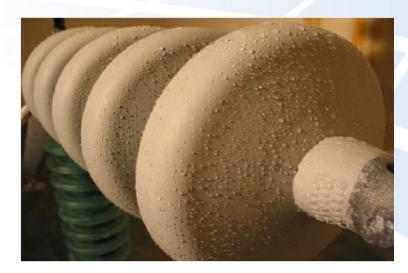
good hydrophobic behaviour after completion of the 2000h ageing test

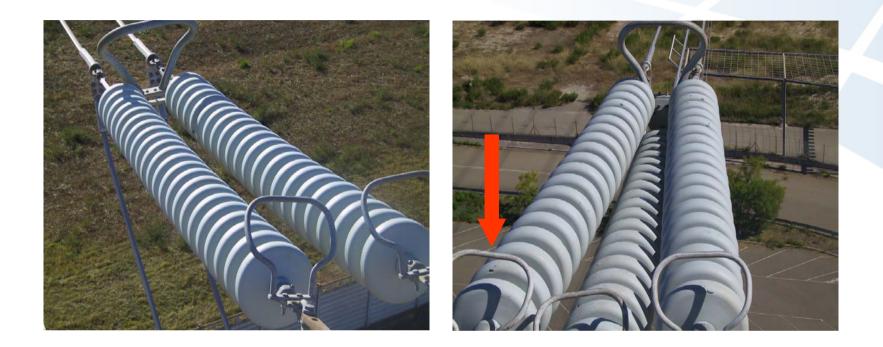
Coated anchor strings installed on a 380 kV line in the proximity of the Mediterranean coast, North of Rome. Minor scratches produced during the installation may be noticed.

- In the case of conventional methods of installation (line out of service), some additional care proved to be necessary when handling the strings, in order to reduce the risk of damages of the coating due to contacts with tower members and line materials. However, in the majority of cases, such damages are purely aesthetic, without any real effect on the pollution efficiency.
- Such risks do not exist in the case of live line working, owing to the specific procedures and tools (cradles, insulating rods and ropes, .....) that are used to prevent any infringement of the electric clearances and that also prevent, as a consequence, any contact between components parts during lifting or positioning.

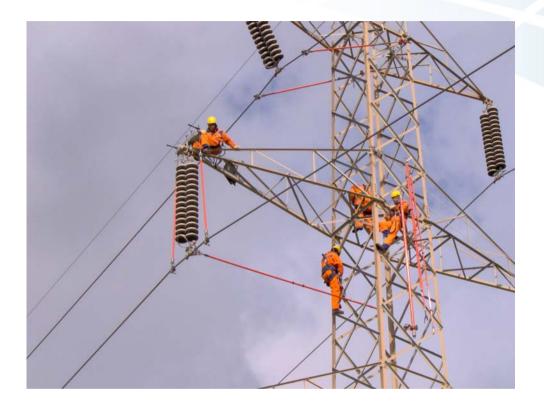
Installation of coated insulators on a 220 kV live line in Sicily, South of Italy
