# MECHANICAL AND ELECTRICAL BEHAVIOUR OF A DAMAGED TOUGHENED GLASS INSULATOR

## IMPACT ON MAINTENANCE STRATEGY FOR OVERHEAD LINE CREWS

SEDIVER S.A. R&D St Yorre, France

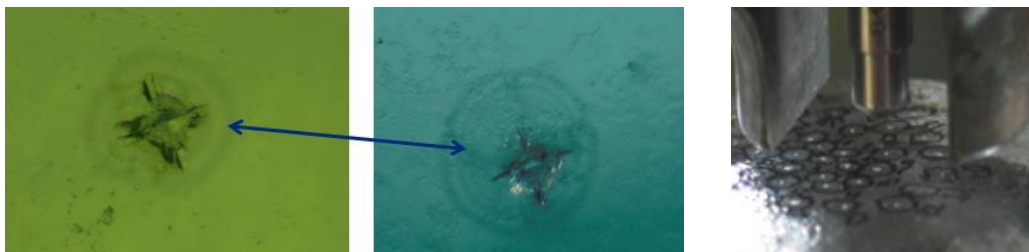
**Figure 2:** compressive strength measured on a new glass insulator (left) compared with the strength of a 50 year old unit (center) removed from service. Indentation measures (right) show a compressive stress in surface in the range of 200MPa to 210 MPa (approx. 30kpsi)

- Toughened glass does not age (figure2). (4).

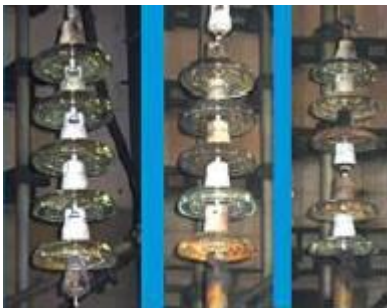
Figure 10 shows the tested strings. Figure 11 shows the string made of 6 stubs during the power arc. The presence of 6 separate arcs crossing the external distance outside the stubs indicates clearly that the stubs do not behave like punctured discs, and as such illustrates clearly the difference with porcelain discs which, once punctured, could lead to a string separation resulting from possible internal arcing along the puncture path leading to excessive energy accumulation inside the cap.

**Figure 10:** strings with stubs

Stubs were subjected to a power arc following the set up and test conditions of IEC 61467 (9). The tests were performed simulating various configurations. The stub was placed once at the bottom, once in the middle and once at the top of the strings. Each string was submitted to two consecutive shots of 6kA/0.2s. The same test was performed with strings which stubs had previously been immersed for 48h in a 10g/l salt solution. An additional test of 6 consecutive shots was made on a string constituted only of 6 stubs.

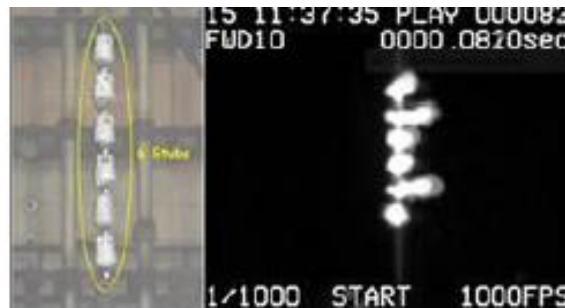
**Figure 11:** power arc on stubs

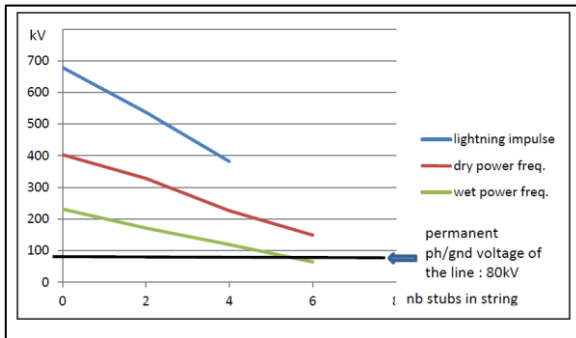
Typical 138 kV strings of 8 units (ANSI class 52-5) were tested under lightning impulses as well as dry and wet power frequency. Intact units were replaced with stubs in various locations along the string. The results in figure 13 show that the most critical case is the wet power frequency performance. When 6 out of 8 units are in a stub condition (75 % of the string being broken), the remaining leakage distance of the two last complete insulators falls below what is required to withstand the operating voltage. However, with half of the string broken the operation of the line (80kV phase-ground) is still maintained (except for cases where pollution is present, for which leakage distance is the prevailing factor). These tests were performed with line end units 1 and 2 always broken.

**Figure 13:** dielectric tests on a 138 kV string with various cases of stub locations and number of stubs in the string

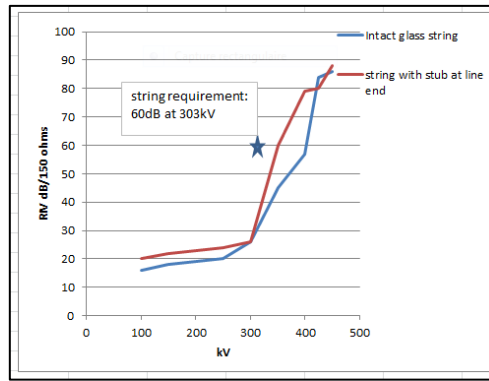
The following RIV test was performed according to ANSI C29-1 (1) on a 500kV string made of 25 ANSI 52-5 glass units, equipped with normal hardware configuration, having a stub at the live end. At nominal voltage the RIV levels are similar both with and without a stub (figure 15).

**Figure 15:** RIV results of a 500kV string containing a stub in the glass string at the live end.
