## **Assessment of toughened glass insulators removed from HVDC lines after more than 40 years in service**

### **SUMMARY**

The purpose of this paper is to outline a general methodology for the effective assessment of toughened glass insulators in operation for many years, and to present the results of Manitoba Hydro's testing of toughened glass insulators removed from HVDC lines after more than 40 years in service. The assessment of these insulators was intended to gauge their remaining life.

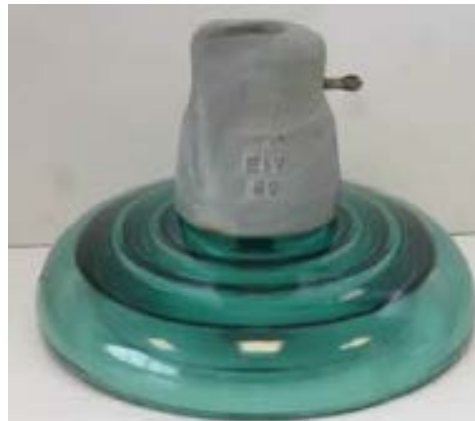
Fig 4 – Removal locations, Manitoba, Canada Fig 5 – Model N21/171DC (1969 production)

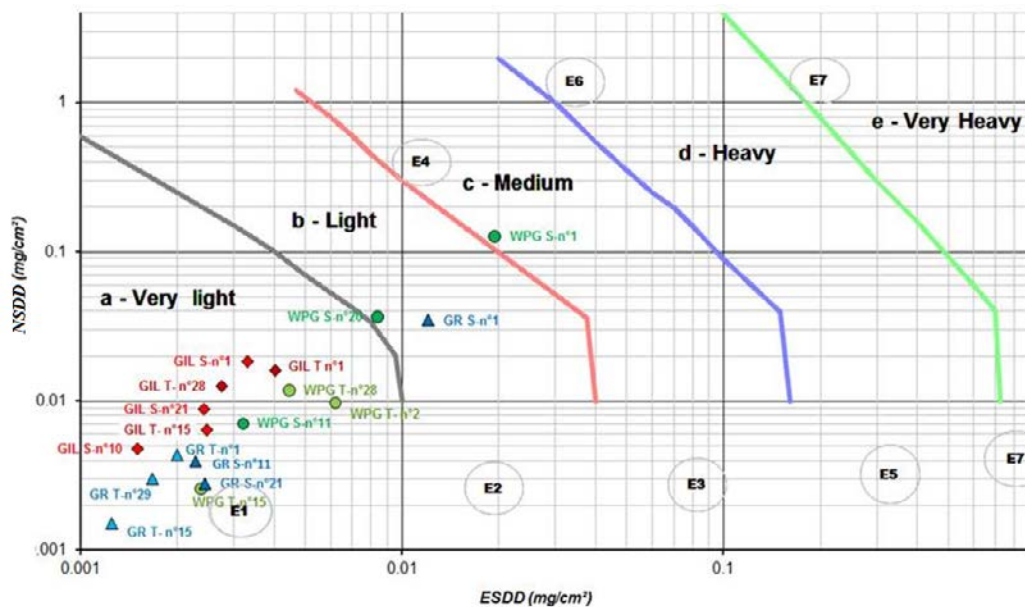
Immediately after the removal of each set of insulators, three insulators were selected from the string and washed with demineralized water for ESDD (equivalent salt deposit density) and NSDD (non-soluble deposit density) measurements, according to IEC 60815 [2]. Washing and measurement was performed separately for the top and bottom sides of the insulator. Samples for pollution measurement were taken at the locations near Winnipeg and Grand Rapids by the Sediver staff. No on site samples were obtained from the Gillam insulators. In order to obtain a pollution sample from Gillam, instructions were left to enclose the insulators in a sealable plastic wrap. They were then shipped to St-Yorre, where pollutions measurements were made. From these measurements, we can observe the pollution level pattern of the bipoles, which is summarized in the below figure. Most of the lines run through very light pollution levels, where the Winnipeg area may on occasion have seen pollution levels as high as medium.

Fig 6 – Pollution level in terms of ESDD and NSDD (Winnipeg, Grand Rapids and Gillam regions)

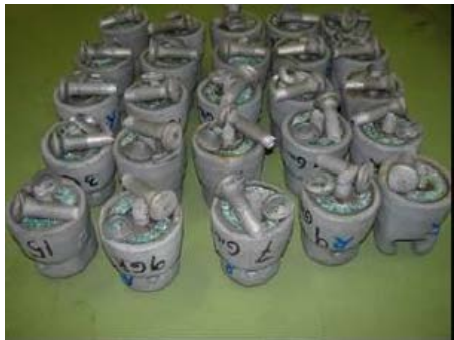
The test results are fully satisfactory, with an acceptance constant higher than 0.65. In fact, all failing loads were higher than the M&E rating of an unbroken (intact) insulator. Similarly to the electromechanical failing load test, the N21/171DC samples all failed by a broken pin, which results in a lower standard deviation.

Fig 9 – Failed stubs

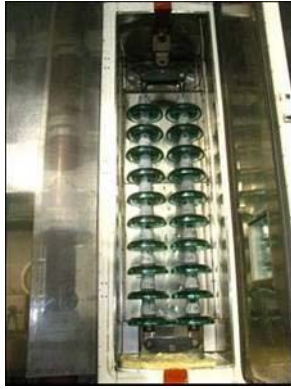
The purpose of this test is to verify the ability of the insulator to withstand combined thermal and mechanical stresses. Twenty (20) units of each insulator type were tested according to CSA C411.1-10 (clause 6.10). The first stage of the test subjects the insulators to four 24 hour cycles of cooling and heating while under a tensile load equal to 70% of the specified electromechanical failing load. The insulators are then subjected to an electromechanical failing load test per CSA C411.1-10 (clause 6.13). The results of the test are summarized in the following table:

*Fig 10 – Thermal mechanical machine*

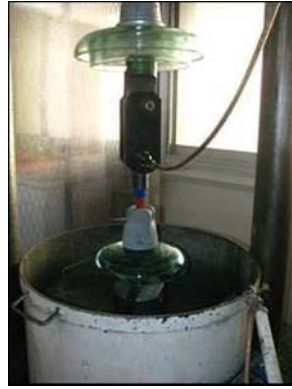
*Fig11 - Insulator in traction machine*

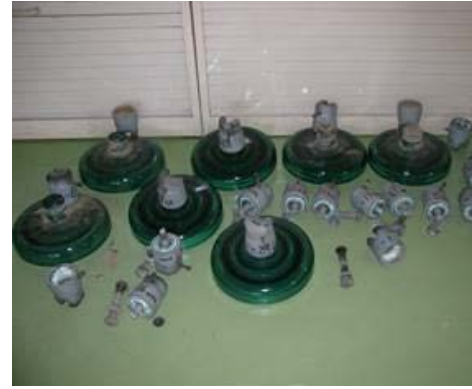
The test results are fully satisfactory for the N21/171DC model, with a quality index higher than 4 and no failing load below the M&E rating. As with the previous tests, all N21/171DC samples failed exclusively by a broken pin while N18P/171DC samples failed by a mix of glass shell shattering, pin pull out, broken pin and broken cap. For the N18P/171DC model, one sample’s glass shell shattered at 172.4 kN (97% of the M&E strength) and as such does not comply with the current standard’s requirements, while all the other units failed above the rating. The unit with the shattered shell at 172.4 kN reached a mechanical load of 228.5 kN before mechanical separation, which demonstrates the strength and reliability of a stub (insulator with broken glass shell).

*Fig 12 - Failed insulators*
