Review of 20 Years of Sediver Silicone Coated Insulators in the Field

J-M. GEORGE – Dr S. PRAT – F. VIRLOGEUX
SEDIVER RESEARCH CENTER
FRANCE

2. Experience in Peru, in highly polluted environment

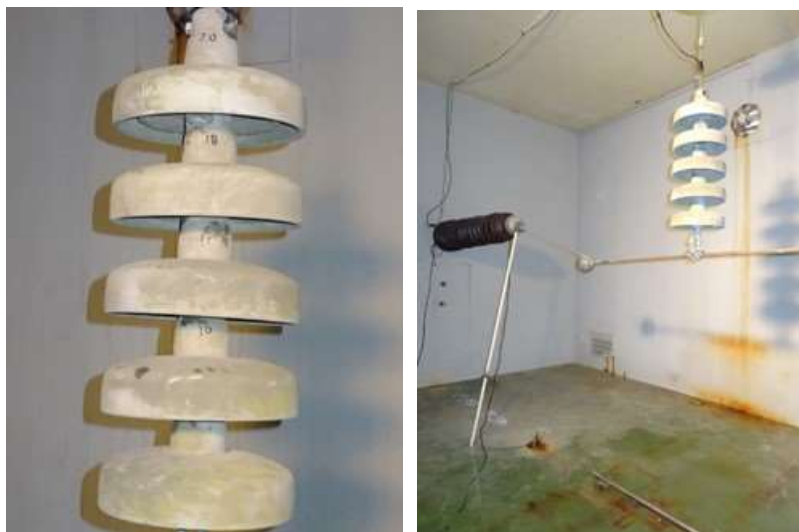
Short strings of 5 units (naturally polluted in service) have been tested in a clean fog environment according to IEC 60507 § 6.7 in order to assess the electrical performance of the naturally polluted string of insulator and the efficiency of the coated glass insulators (Figure 7).

Figure 7: test set up for the clean fog test

A short string of 5 units naturally polluted in service can withstand a voltage of 115 kV.

In addition, during the test, leakage currents were recorded and the test at 115 kV only displays leakage current with a peak intensity of about 20 mA during the 100 minutes of test. Those low values of leakage current are a proof of the effectiveness of the silicone coated string design for the actual level of pollution after 5 years in service.

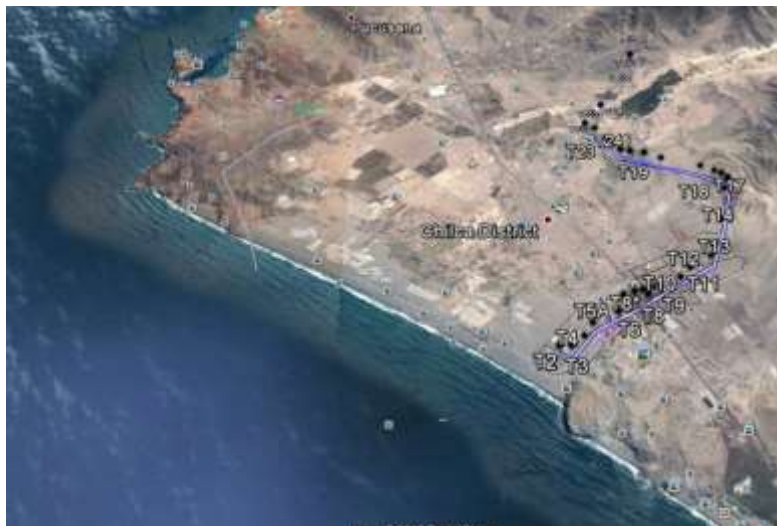
The section of the 500 kV transmission line is in the south district of Lima, named Chilca District, where a power plant is built on the pacific coast. Maintenance team of the local utility reported evidence of electrical activity (dry band arcing activity but no flashover) on the first towers exiting the power plant, few meters away from the ocean. (Figure 8)

Figure 8: site description for the Chilca Fenix overhead line

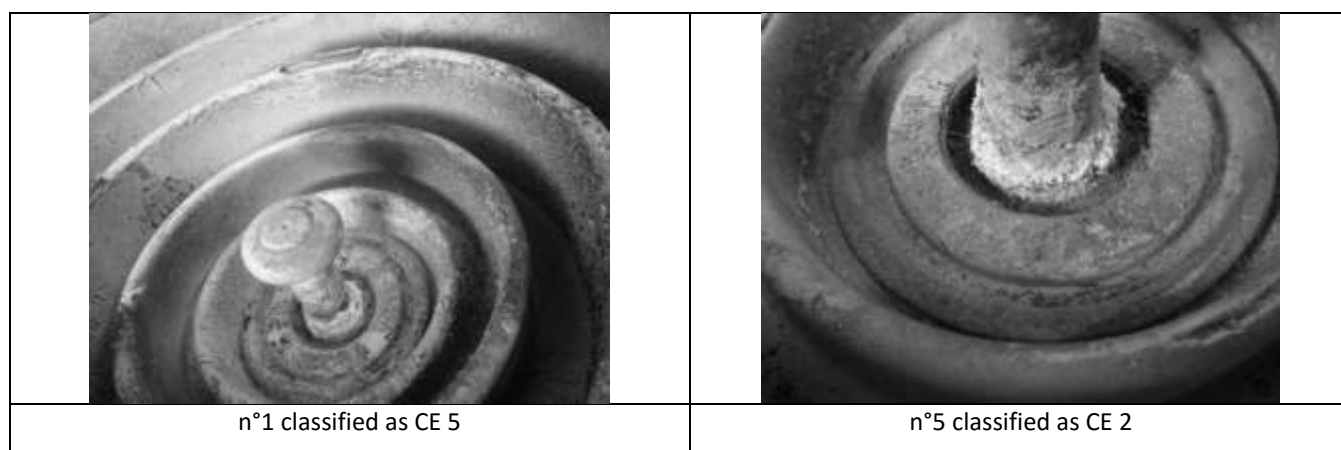
Electrical activities leading to coating degradations can be observed all around the pin on the bottom side of the insulator. Those degradations can be classified according to the Sediver coating erosion chart (see Annex 1). Figure 9 shows the coating degradation all along the string of tower 2 and Figure 10 shows units from tower 3.

Figure 10: Close views on the insulators pins for Tower 3

It should be noted that in the very close vicinity of the insulator pin (few cm), in the area where some surface degradations could be observed, the coating offers hydrophilic surface properties. Moving away from the pin, the silicone coating gradually exhibits better hydrophobic properties, showing the influence that the electrical field density may have on the hydrophobicity property of the silicone material. In the table above, the hydrophobicity class given for the insulator is to be considered as the average hydrophobicity of the section, even if a difference of performances can be observed from one location to another. The overall conclusion is that despite a high level of pollution, evidence of electrical activity leading to a reduction of the hydrophobicity properties, the string of Sedicoat® insulators can still maintain its insulation fonction. In addition it can be mentioned that such surface degradations are not compromising the insulator integrity as the underneath toughened glass is immune and mechanically safe. A similar situation on a composite insulator would require a deep inspection of the units and units with eroded housing should be changed immediately to prevent catastrophic failures of the line.

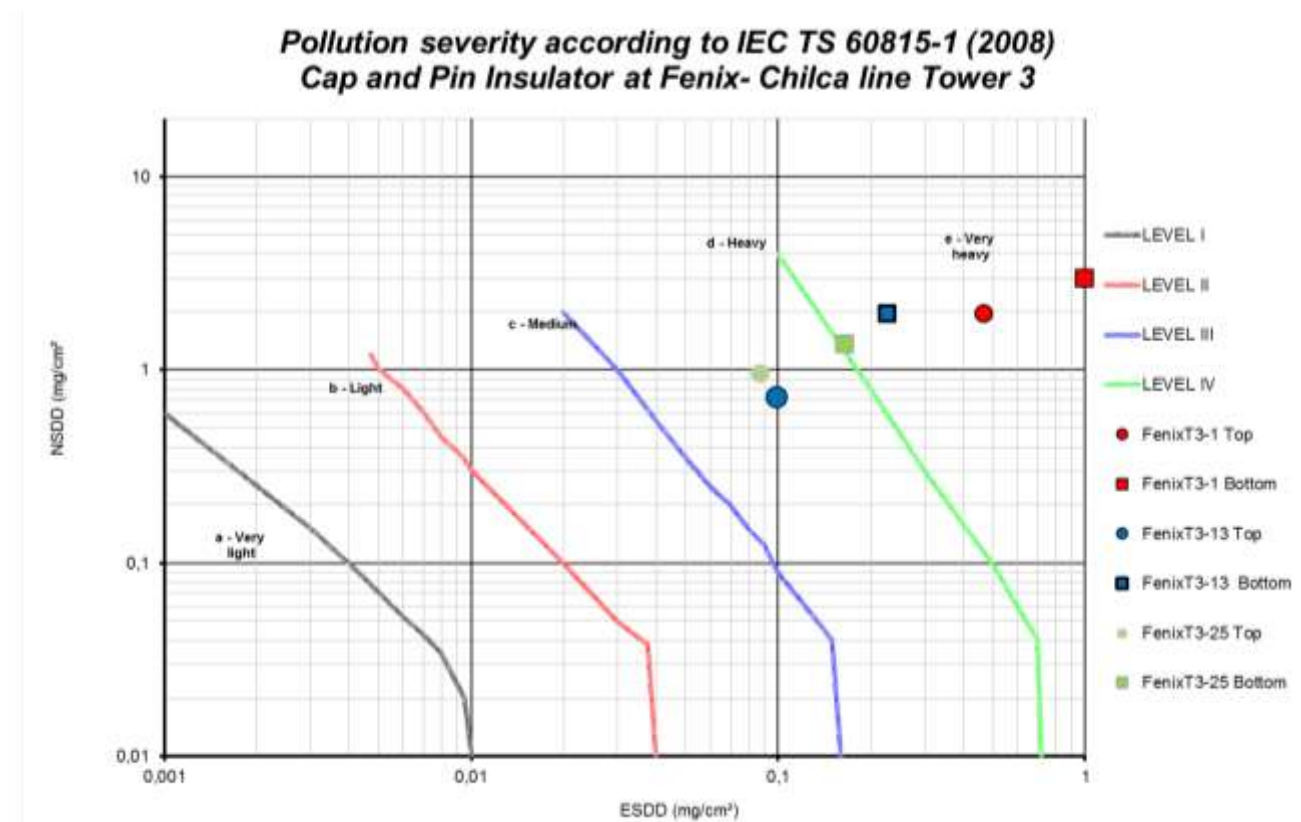
It clearly appears on this chart (Figure 11) that the pollution is characterized by strong ESDD components (obviously related to the vicinity of the Pacific coast).

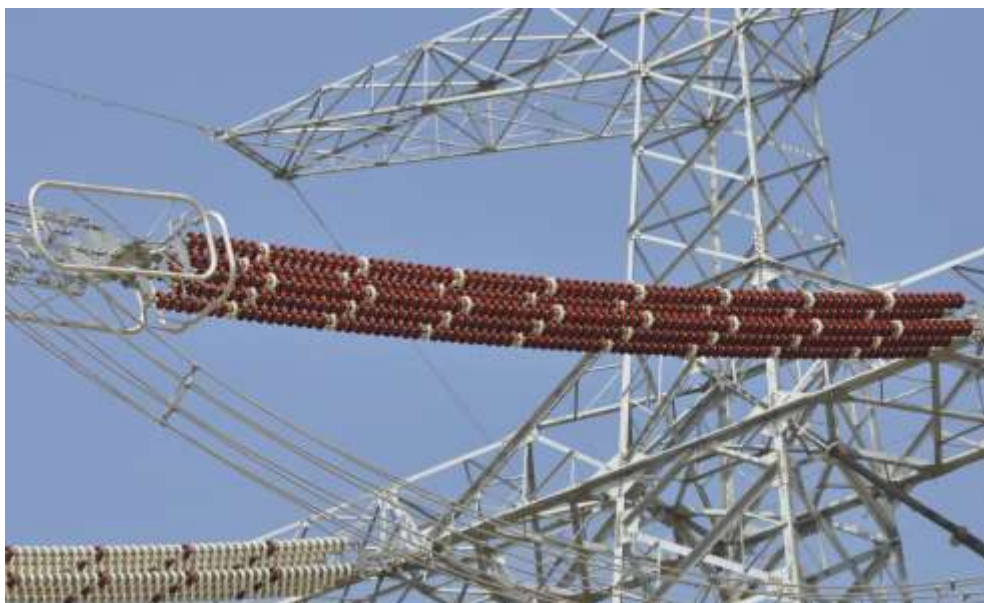
For this project the customer requested to have 2 colours of coating (Red and White). As shown in the Figure 12, every 10 pieces a red coloured unit is placed in the string of white coated units in order to ease the inspection of localization of any defects for the maintenance crew.

Figure 12: Tension strings of the Inner Mongolia 800kV HVDC line with red and white coloured coatings over toughened glass insulators

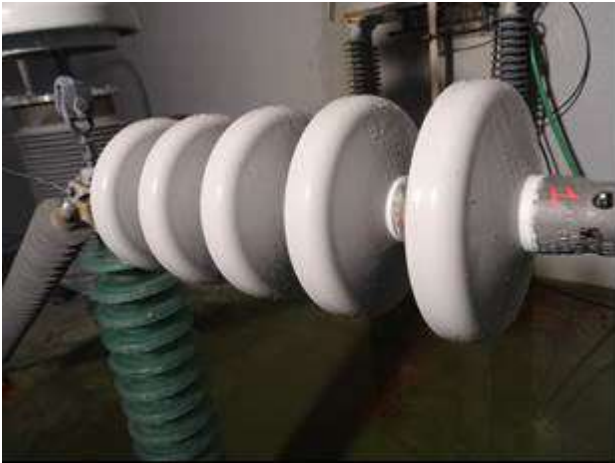
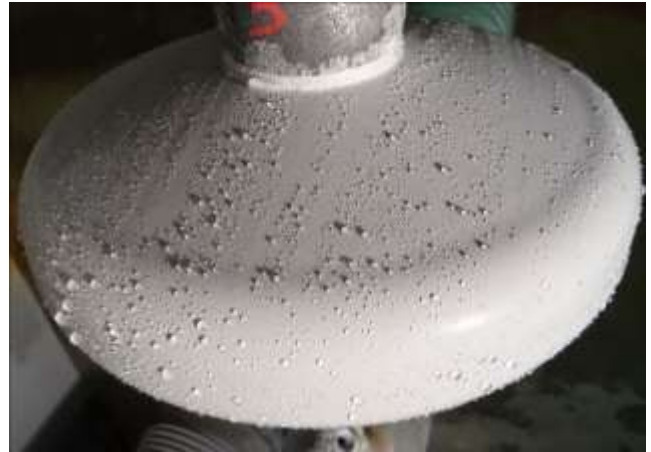
Figure 14: Insulator coated with newly developed SEDCO® coating at the end of the 2000 h multiple stresses ageing test according to TERN specification LIN-00J116 Rev. 1 dated 08/05/2013.

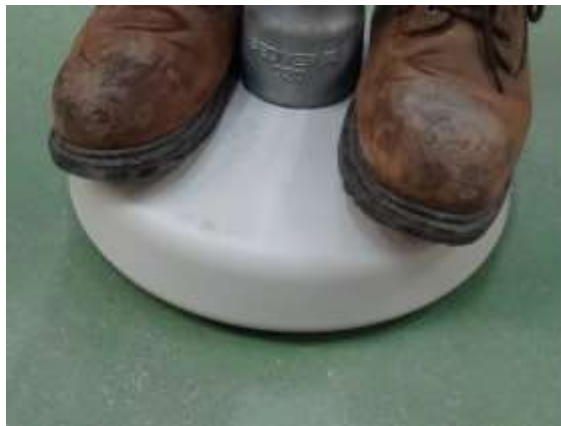
Newly developed Sedco® silicone coating can now match the above mentioned criteria and allow a more user friendly handling, similar to what is more common for regular cap and pin unit handling (Figure 15).

Figure 15: Scratch resistance of the new coating

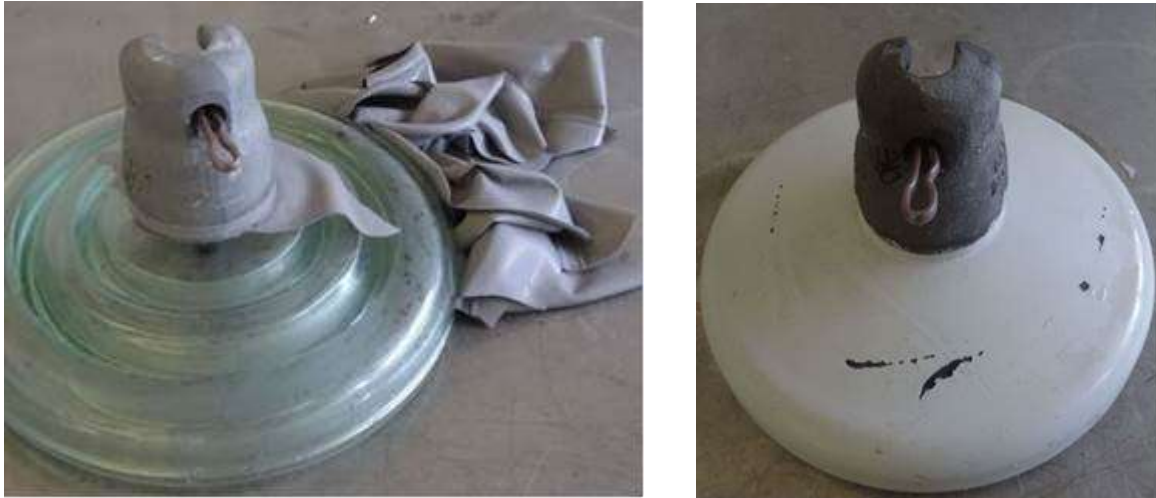
In addition, this Sedco® coating offers outstanding adhesion to the glass surface as shown through by the boiling water test described in IEEE 1523 [5]. In this test silicone coated insulators are immersed in boiling water for 100h and then the adhesion of the coating should be controlled. (Figure 16) This boiling water immersion test can be used to check the adhesion of the coating to the glass shell.

Figure 16: Results of 100 h boiling water test for a commercially available and for the newly developed Sedco® coating

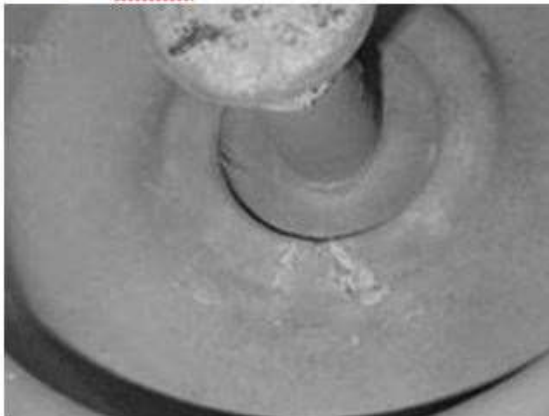
CE 2 : Signs of superficial erosion of the coating

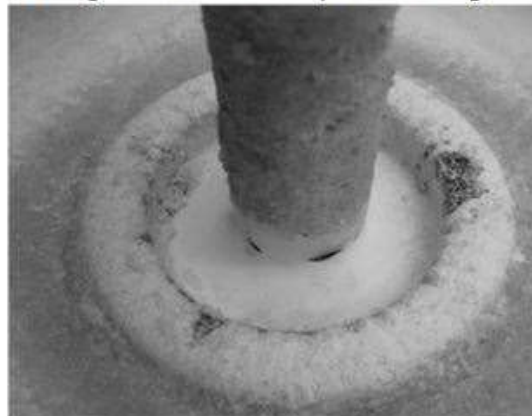
CE 3 : Localized erosion of the coating with spots where insulator surface is apparent

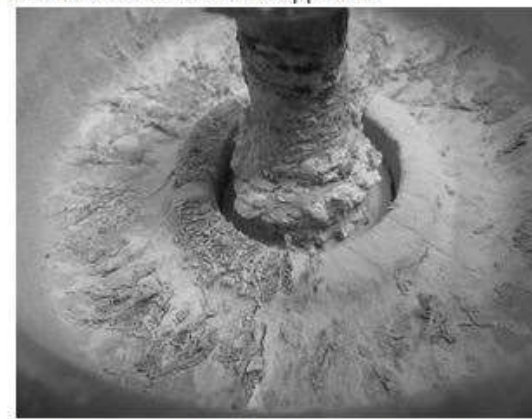
CE 5 : Delamination and erosion of the coating on large areas with large insulator surface visible
