# HVDC overhead line insulators selection and design update features

Jean-Marie George and Luis F. Ferreira, *SEDIVER*

**Abstract—** The increasing number of HVDC projects has raised new interest in the design of components used in various materials dedicated to DC applications. For example, the unidirectional electric field in a dielectric subjected to a DC voltage generates specific stress conditions resulting in unique features making up the design of insulators. Likewise, the impact of polarization in the environment near a DC line requires special attention for airborne contamination which modifies the ability of a string of insulators to withstand the operating voltage under any circumstances.

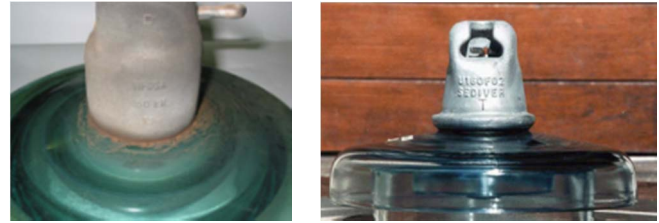
Figure 4. Left: Corrosion at the base of a cap without large zinc ring protection (Itaipu 1) - Right: Optimum design using a large zinc collar at the base of the cap

As stated earlier, DC stresses accelerate the possible corrosion of the metal end fittings. IEC 61325 [2] explains the design of the zinc sleeve for the protection of the pin, and experience shows the benefits of this design. [6]. The cap on the other side needs also special care. Some older insulators (like in the 600KVDC bipole Itaipu 1, Brazil shown in Fig. 4) have some corrosion at the base of the cap [7]. The corrective action for Itaipu 2 was immediately implemented by adding a

large zinc collar at the base of the cap. Fig. 4 shows an insulator with this feature which is not correctly described in the current version of IEC 61325 [2].

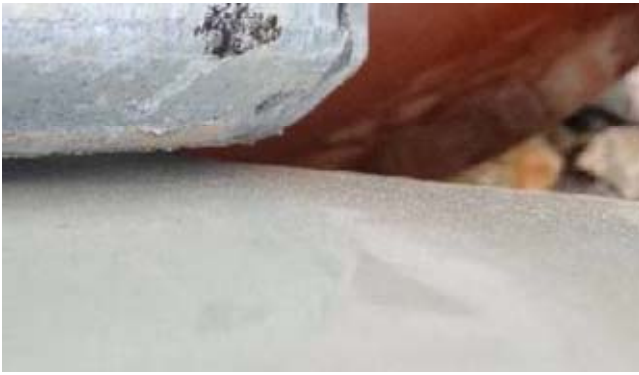
Figure 7. Typical gap between the cap and the dielectric in porcelain designs

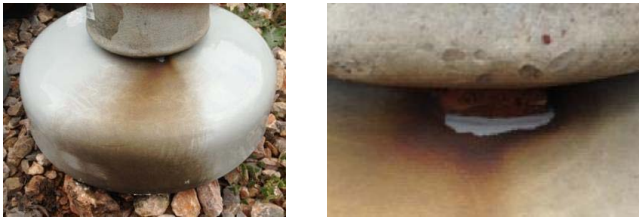
Figure 8. Damaged porcelain insulator resulting from the lack of zinc collar and excessive gap.

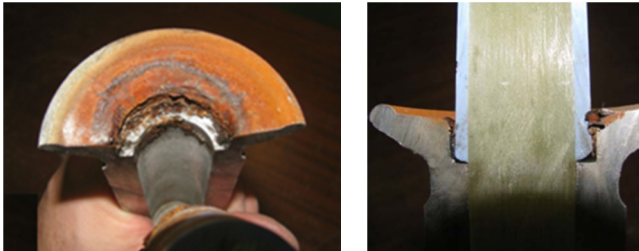
Figure 9. Corrosion and degradation of the seal of a polymer insulator at the triple point resulting in moisture ingress and major risk of failure. (removed from service after a decade)

Polymer insulators are at risk as well. The idea of promoting composite insulators because there are only 2 fittings is not correct. In fact, the risk of corrosion at the fittings is the same with the additional risk of degrading the triple point and destroying the seal (if any) as seen in Fig. 9.

As mentioned earlier long-term performance of polymers in DC remains questionable and field results such as ESKOM [10] demonstrate that after approximately 15 years of service ageing signs start appearing on the housing. Likewise, Fig. 9 describes the risks associated to seal erosion and degradation after a decade in service. This is consistent with the AC experience by many aspects and Terna (the Italian TSO) after an extensive experience with coated glass insulators in AC along their coasts and extreme pollution sites has successfully decided to use silicone coated glass insulators on their 200KVDC line.
