HVDC overhead line insulators selection and design update features

Jean-Marie George and Luis F. Ferreira, *SEDIVER*

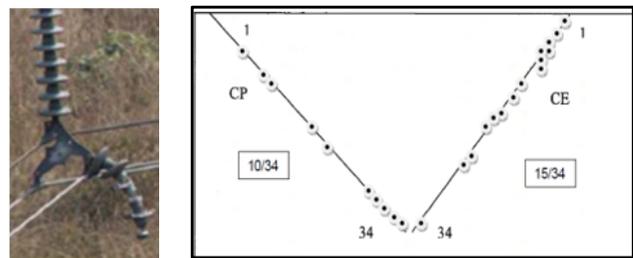
Figure 1. Left: String separation resulting from punctured porcelain. Right: Distribution of punctured discs in a porcelain Vee string in Congo on the 500kV DC Inga-Kolwesi line. Insulators did not have the body resistance required for a DC application. (30% failed units. Round circles show location of punctured discs found during the investigation).

Under DC electric field the ions are migrating through the dielectric itself resulting in the electrical breakdown of the material. First generation insulators were made with a dielectric strength and body resistivity compatible with AC stress levels. Higher shattering rates on glass were found as well as large quantities of punctured porcelain discs. An illustration of this problem is shown in Fig. 1 where porcelain discs were used on a 500kV line in Congo with extensive service interruptions, string separations, with in the end a major difficulty to operate at nominal voltage. While some engineers were looking at a variety of possible root causes (including pollution...) the demonstration was made through a large sampling that many insulators were punctured. This goes unseen, which is typical for porcelain (some manufacturers claim that the failure rate of porcelain is around 1/100000 or less, but it is physically impossible to prove unless several hundred thousand of units are tested one by one to produce such statistics, which of course is not practical and at very high costs).

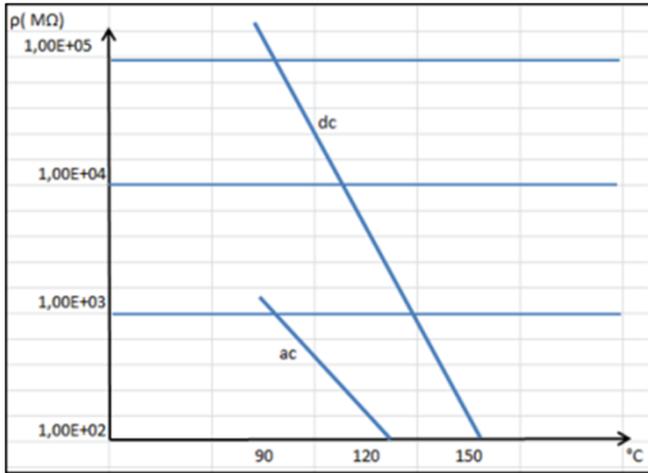
Figure 2. Comparative AC and DC body resistance of toughened glass insulators (ref. Sediver)

Today specific DC materials are defined by their body resistance as per IEC 61325 [2] which describes an ionic migration test and a body resistance test. These procedures offer a methodology for testing under DC conditions the ability of a material to sustain an ionic environment. The body resistance is measured at 3 different temperatures (90°C, 120°C and 150°C). Experience is showing that high resistivity discs will solve the question of thermal runaway. An example

of such values on glass insulators is shown in Fig. 2. A resistance value around 3 GΩ measured as per IEC 61325 at 120°C is a good reference.

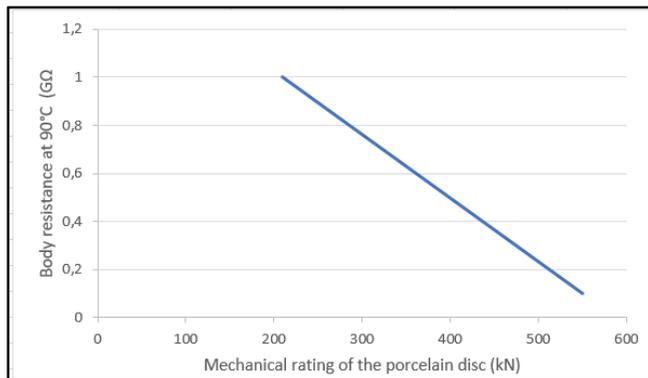
Figure 3: influence of the thickness of the porcelain head (mechanical rating of the insulator) on the body resistance of porcelain insulators measured at 90°C

It is also interesting to note that the heterogeneous nature of porcelain (compared to the amorphous nature of glass) has an influence on the stability of the body resistance as a function of mechanical rating. In fact, the higher the mechanical rating, the bigger the head of the insulator and higher is the probability to have micro structural defects though the thickness of the porcelain material. Fig. 3 shows the evolution of DC porcelain body resistance as a function of mechanical rating.

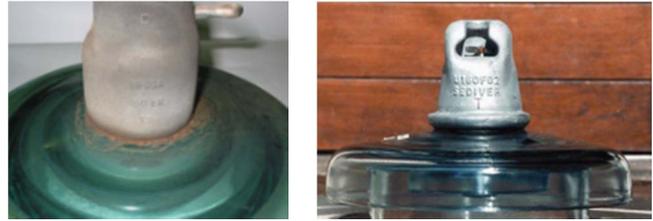
Figure 4. Left: Corrosion at the base of a cap without large zinc ring protection (Itaipu 1) - Right: Optimum design using a large zinc collar at the base of the cap

As stated earlier, DC stresses accelerate the possible corrosion of the metal end fittings. IEC 61325 [2] explains the design of the zinc sleeve for the protection of the pin, and experience shows the benefits of this design. [6]. The cap on the other side needs also special care. Some older insulators (like in the 600KVDC bipole Itaipu 1, Brazil shown in Fig. 4) have some corrosion at the base of the cap [7]. The corrective action for Itaipu 2 was immediately implemented by adding a

large zinc collar at the base of the cap. Fig. 4 shows an insulator with this feature which is not correctly described in the current version of IEC 61325 [2].

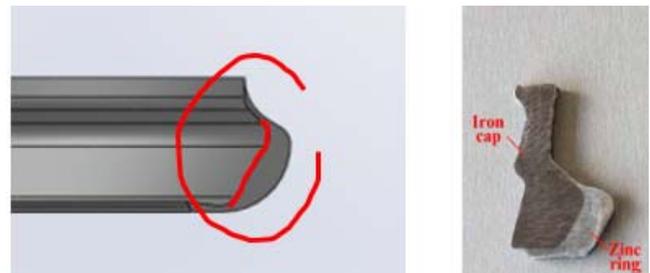
Figure 5. Detail of the zinc collar at the base of the cap

The standard only calls for 5g of zinc which in fact correspond barely to a galvanization thickness of 110μm...this simply does not work and more stringent criteria are required for an effective protection. Field experience is showing clearly that an optimum protection is achieved with at least 100g of zinc distributed at the base of the cap as shown in Fig. 5. Another approach can be based on the contact surface between the casting of the cap and the zinc ring. In this approach a cross section of at least 40mm² is a good reference.

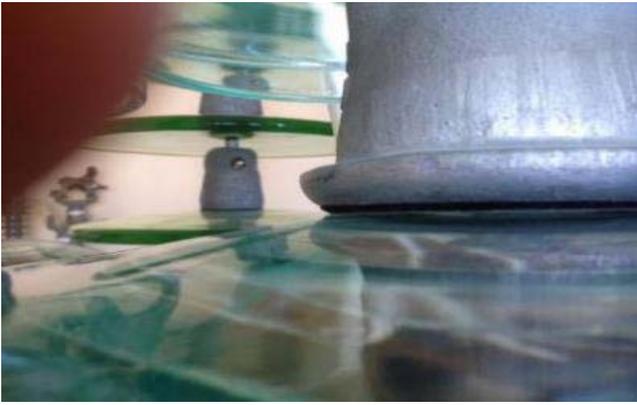
Figure 6. Ideal junction between dielectric and cap

Directly connected to this topic is the quality of the assembly. The gap between the dielectric and the base of the cap can generate discharges and severe risks of corrosion. Ideally the contact should be direct as shown in Fig. 6. Some manufacturers are using plastic seals which don't last (thermal stability). The presence of a gap at the base of the cap as shown in Fig. 7 is known to be critical up to a point where the dielectric can be damaged (Fig. 8 with damaged glaze and crack underneath of the porcelain itself). This has been a reason for taking down more than 20000 porcelain insulators after about 3 years in China [8]. Such degradations are expected to occur faster in high temperature, humidity and elevation.

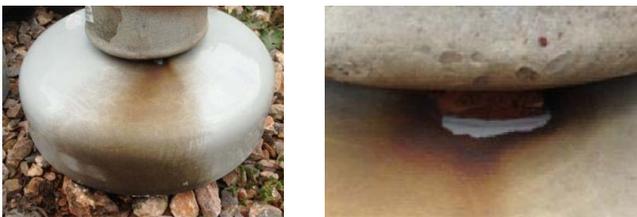
Figure 8. Damaged porcelain insulator resulting from the lack of zinc collar and excessive gap.

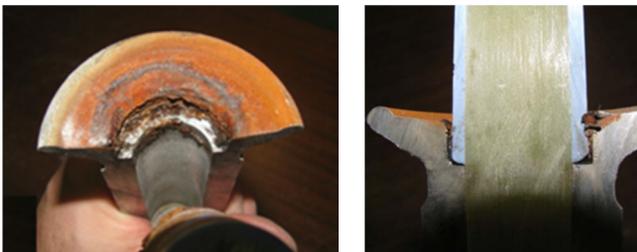
Figure 9. Corrosion and degradation of the seal of a polymer insulator at the triple point resulting in moisture ingress and major risk of failure. (removed from service after a decade)

Polymer insulators are at risk as well. The idea of promoting composite insulators because there are only 2 fittings is not correct. In fact, the risk of corrosion at the fittings is the same with the additional risk of degrading the triple point and destroying the seal (if any) as seen in Fig. 9.

As mentioned earlier long-term performance of polymers in DC remains questionable and field results such as ESKOM [10] demonstrate that after approximately 15 years of service ageing signs start appearing on the housing. Likewise, Fig. 9 describes the risks associated to seal erosion and degradation after a decade in service. This is consistent with the AC experience by many aspects and TERNA (the Italian TSO) after an extensive experience with coated glass insulators in AC along their coasts and extreme pollution sites has successfully decided to use silicone coated glass insulators on their 200KVDC line.

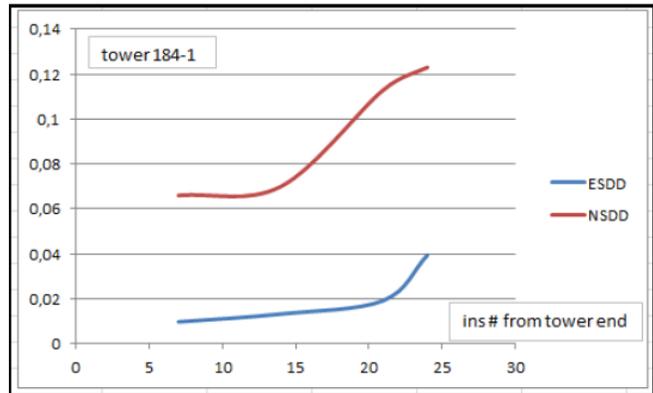
Figure 10. ESDD and NSDD measured along a string of insulators on the Pacific Intertie 500KV, USA.

- In DC the arc does not necessarily follow the surface of the insulator and can bridge some leakage distance
- With the same level of pollution, the flashover of a string of insulators occurs at lower values in DC than AC.
- The non-uniformity of the pollution deposit can impact severely the performance of a string of insulators (either distribution along the string as shown in Fig. 10 or between bottom and top surface of an insulator (this parameter is called “CUR”))

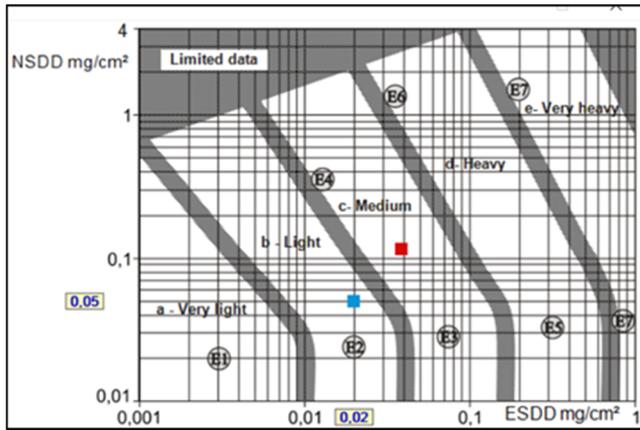
Figure 11. Pollution graph as per IEC 61815-4 [1] describing the contamination level as a relative function of ESDD/NSDD. For an environment where an AC line (blue dot) would capture a pollution of ESDD = 0.02mg/cm² and NSDD = 0.05mg/cm² a DC line would be estimated at ESDD = 0.04mg/cm² and NSDD = 0.011 mg/cm² (red dot). (based on [1] and Sediver DC estimator software).

Fig. 11 shows the IEC graph of ESDD and NSDD combined with an example of pollution measured on an AC line (blue dot) and the estimated level of pollution if this line was built as a DC line (red dot). This estimation is based on a theoretical model utilizing a set of equations described in IEC 60815-4 [1]; Among these equations, the following is interesting since it describes how to estimate the expected ESDD under DC when starting from an AC estimation (ESDD_{ave}):

$$ESDD_{dc} = ESDD_{ave} \times K_p \times K_{NSDD} \times K_{CUR} \times K_d \times K_s$$

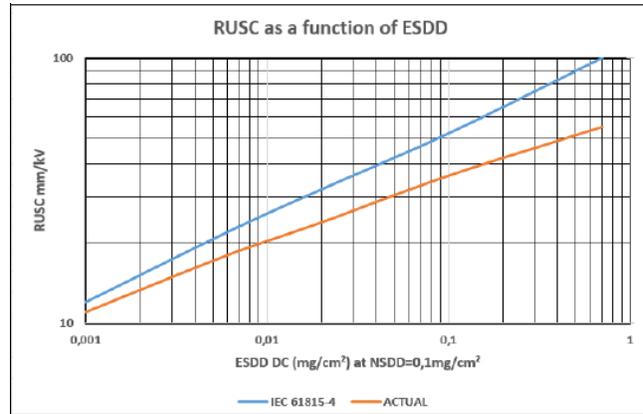
Figure 13. USCD as a function of ESDDdc as per [1] in blue and as per actual laboratory tests and field experience in orange as per [3]

According to [1] the graph for this operation is as per Fig. 13. Several indicators [3] such as laboratory tests and field experience seem to indicate that for non-hydrophobic materials (glass and porcelain) this curve is too severe. The reality seems to be closer to the line represented in orange in Fig. 13. The difference between theory and actual results can induce an overdesign of the string length of about 20% (and subsequently of the towers height and costs).

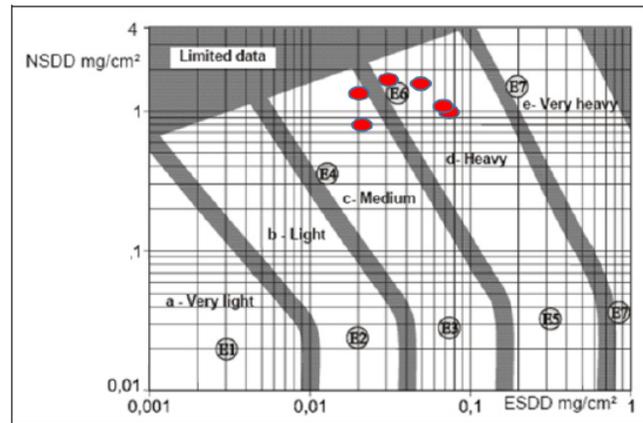
Location	Insulator nb. from tower	ESDD (mg/cm ²)	NSDD (mg/cm ²)	CUR
IBUNA	1	0,07	1,01	27,5
	14	0,02	0,89	9,67
	25	0,07	1,06	8,58
ITABERA	1	0,02	1,52	12
	14	0,03	1,77	22
	25	0,05	1,74	19,25

Figure 14. Itaipu pollution levels measured on actual insulators removed from the line. It is interesting to see in the table below the graph the CUR values often found beyond 10.

Fig. 14 shows the pollution levels measured on actual insulators from a region where there are no reports of outages linked to contamination.

The strict theoretical model would require a USCD= 47mm/kV while the line is insulated at 28.5mm/kV. This case which describes to the extreme the inconsistency in [1] is most likely the result of CUR values (ratio of ESDD between bottom and top of the insulator) beyond the normal range of application of the equations in [1].

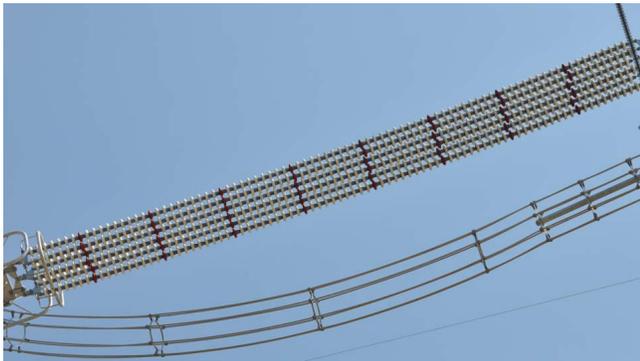
Figure 15: 800KVDC with factory coated glass insulators in China

Polymers are marginally used in DC except for China. More recently and for the first time a Chinese 800KVDC was built using factory coated silicone glass insulators instead of polymers (Fig. 15). This is a strong trend today especially when facing severe local pollution conditions.
