Insulators under fire

SEDIVER Research Center

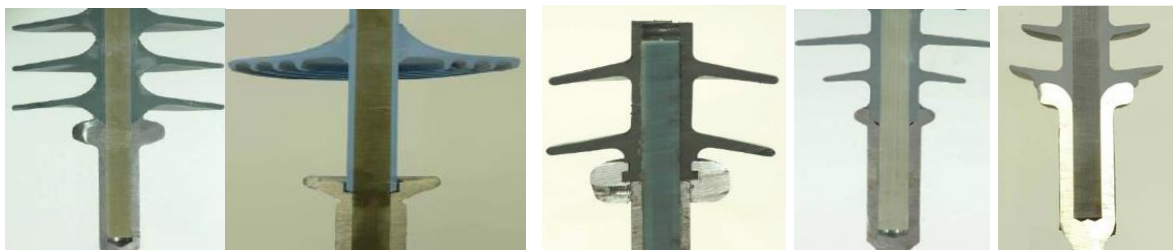
- a. **Composite insulators** exist in a large variety of designs (figure 1) and are made of organic materials which therefore have temperature limitations. The diversity of possible designs and materials used to make these insulators dramatically increases the complexity of their long term evaluation. There are three main design features to look into as described hereafter and checked in detail in section 2.

Figure 1: typical designs of composite insulators

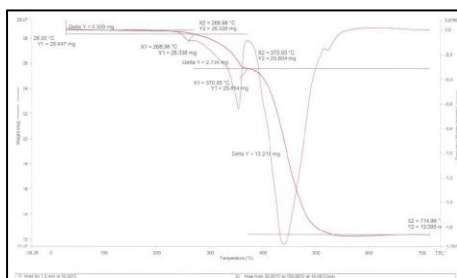
- The housing, typically silicone rubber, is a material designed to chalk and not burn (in most cases). Silicone rubbers exist in numerous chemistries but the most popular silicone compounds contain a fire retardant filler such as ATH (Alumina TriHydrate). For erosion and electric tracking resistance the amount of this additive in the silicone is usually above 45% and can be measured by Thermo Gravimetric Analyses (TGA). Figure 3 shows the graph obtained by TGA of a silicone rubber. The decrease in weight during the test is typical of the loss of water from the ATH molecule during heating. Normally ATH is decomposing around 250C (482 F). Silicone rubber subjected to excessive heat will display a white powderish surface as shown in figure 4.

Figure 3: TGA curve of silicone

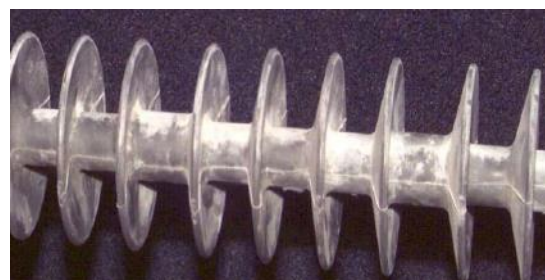
Figure 4: white powderish aspect of heated silicone

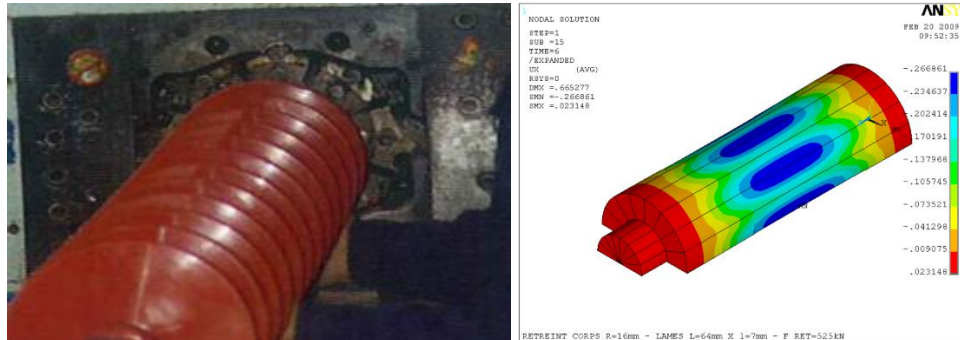
- The end fittings of modern composite insulators are normally crimped by compression (like cable joints). The particularity of this process is to ensure enough pressure through the end fitting (made of steel, cast iron or aluminum) to ensure a sufficient grip on the fiberglass rod which is not a metal. To avoid a thermal relaxation during the molding of the rubber housing onto the core, the end fittings are usually crimped after the housing is in place. Figure 5 shows

this process and the compressive stress distribution into the rod which must be preserved from any damage such as cracks during the crimping (this is still a sensitive operation despite the use of compression sensors intended to control the process)

Figure 5: crimping process and internal stress distribution on a fiberglass rod/fitting connection

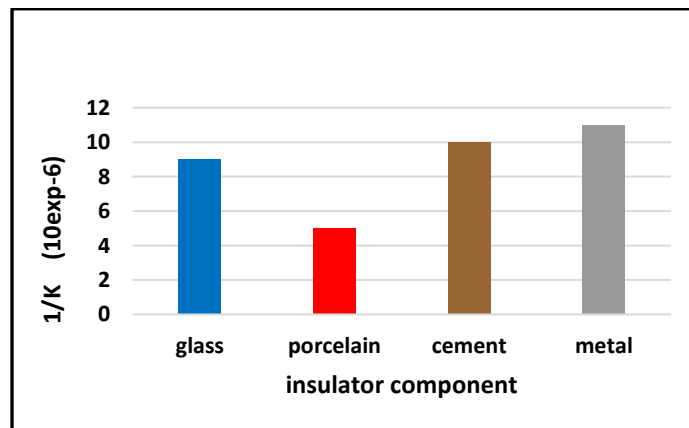
b. Porcelain insulators, besides their end fittings (cap in cast iron and pin made of forged steel) are made of mineral materials. The cement is either alumina cement, or (usually) portland cement. The assembly is usually not made with pure cement but with a mortar containing silica (sand) and other minerals. The stability of the cement with temperature is high and the resilience of such an assembly is mostly driven by the design of the head and the coupling of the thermal expansion coefficients between the end fittings, the cement and the porcelain body. Figure 6 shows the linear expansion coefficients of typical porcelain insulator components. The particularity of the porcelain body is related to its heterogeneous structure of porcelain which contains crystals having themselves different properties. This aspect of porcelain is what leads to the inherent ageing of the dielectric with possible punctures of internal crack propagation (figure 7). This parameter needs to be taken into consideration for resilience performance under heat (see section 2).

Figure 6: linear expansion factor coefficient of glass and porcelain insulators and their components

- c. **Toughened glass insulators** are assembled like porcelain insulators with cement (usually alumina cement but sometimes portland) but do not have any microstructure and the coupling of the thermal expansion factors is more homogeneous as seen in figure 6. The glass is toughened for strength purposes and the prestresses built in the bulk thickness of the dielectric are a balance of compressive and extension forces (figure 8). The mechanical shield represented by this toughening operation makes glass immune to any crack propagation or puncture. A toughened glass insulator will either be intact or shatters if any excessive adverse stress is applied. In this case the glass insulator becomes a so called “stub” (figure 9) which electro mechanical performance remains intact (no internal puncture, and high residual strength). When subjected to heat the glass can suffer of superficial chips or can shatter if exposed to brutal and immediate heat. It is important to understand that the toughening prestress is permanent unless the glass shell is exposed to a permanent temperature of 700°C (1300F) for a duration of 6 hours or more, which will not happen since the insulator will shatter at a temperature of approximately 400F leaving a stub which remains sound. In the next section such properties will be described in detail.

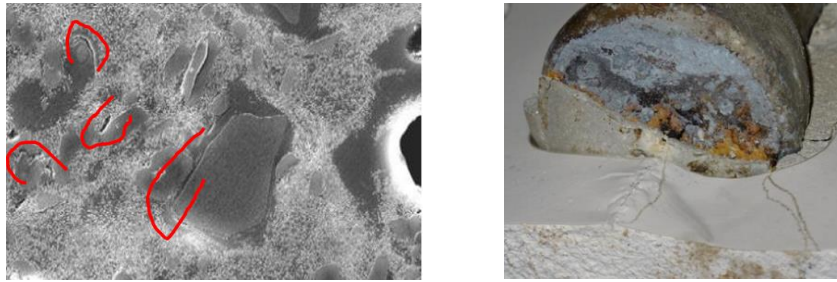
Figure 7: microstructure of porcelain and internal microcracks leading to punctures of the dielectric

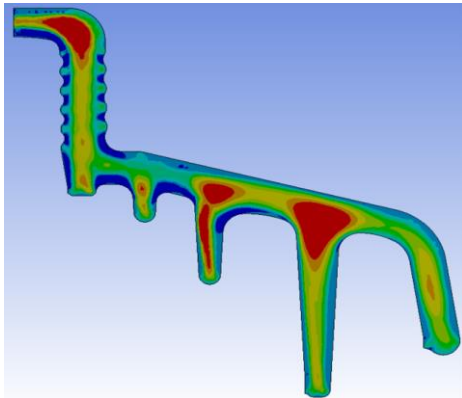
Figure 8: toughening internal prestresses

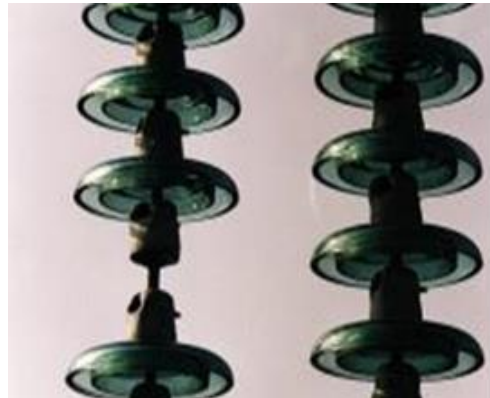
Figure 9: typical aspect of a “stub”

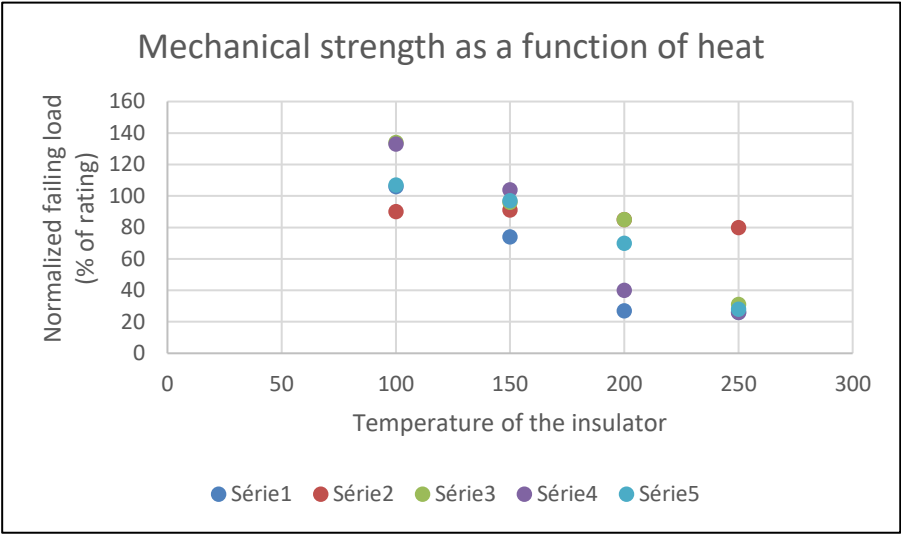
- a. **Polymer insulators**: The combination of the crimping compression of the end fitting over the fiberglass rod itself sensitive to heat (see figure 2) can be feared as a weak point under heat conditions. In order to establish this property tests were performed with various composite insulators (mostly distribution dead ends). Samples were introduced in an oven for 3 hours and pull tested while still hot until failure occurs. Figure 10 shows the normalized results with a reference at 100% corresponding to their ratings. It appears clearly that the strength goes rapidly below the everyday load design of the line.

Figure 10: mechanical resilience of composite insulators at different temperatures (temperature in °C.)

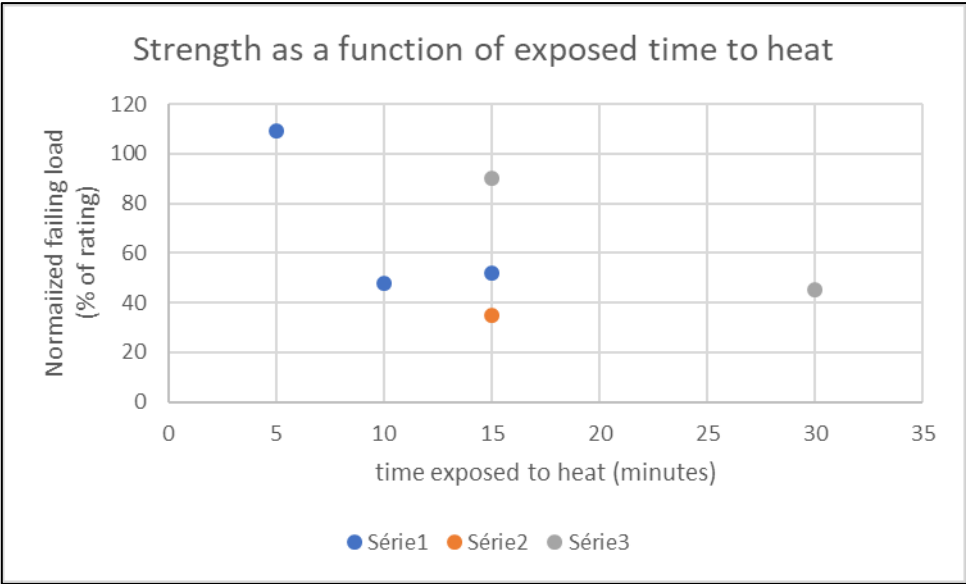
An additional test was performed with insulators exposed at 300°C (572F) for short durations. Figure 11 shows again normalized strength with reference to the rating of the insulators. It appears that very

quickly (less than 30 minutes the strength goes down to 30% to 40% with serious risks of line drop whenever such loads are encountered.

Figure 11: strength of various composite insulators as a function of time after being exposed to 300°C (572F)

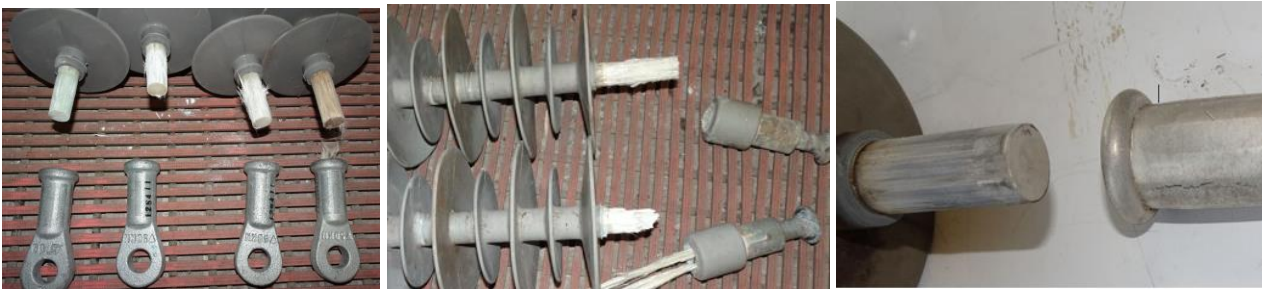
In most cases the rod slips out of the fitting as shown in figure 12. It can be interesting to note that the best values (but still very weak results are obtained with forged steel fittings and fiberglass rods which have a very high Tg. (Tg > 180°C, 360F)

Figure 12: typical aspect of the tested units after the mechanical pull test

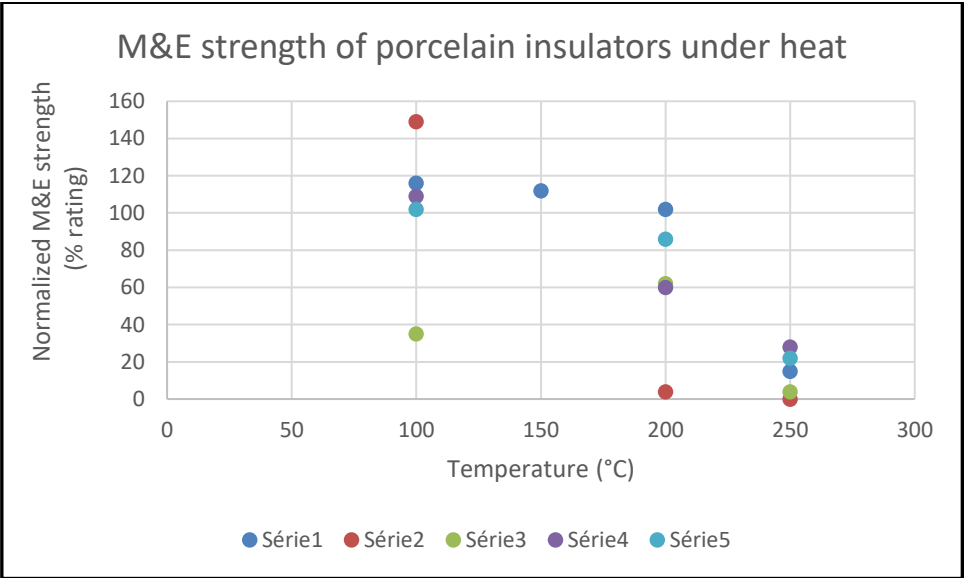
- b. **Porcelain insulators** underwent a similar test with various insulators placed in a furnace for 3h before being pull tested. Given the risk for porcelain to puncture the relevant test in this case is the ANSI M&E test. A number of units failed with cracks either visible or not. As expected, the difference in expansion between components favors this type of failure. However, and while most units survived their mechanical stress with no separation below the rating, most failed electrically from internal punctures not visible from the outside. This demonstrate that once porcelain insulators have been directly or not in contact with high heat there is a major risk for having hidden defective units on a power line. Figure 13 shows the M&E test results and figure 14 the typical physical aspects of the units after test.

Figure 13: M&E test results of porcelain insulators subjected to heat prior to pull testing

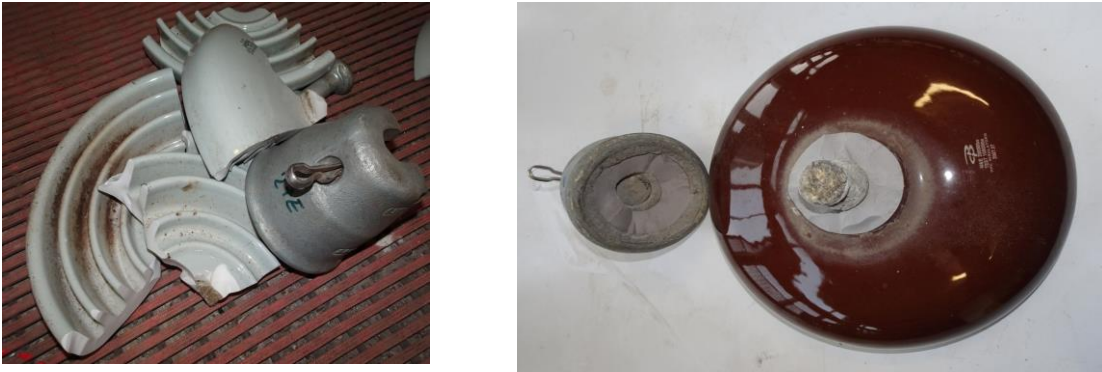
Figure 14: overall aspect of the insulators after the test

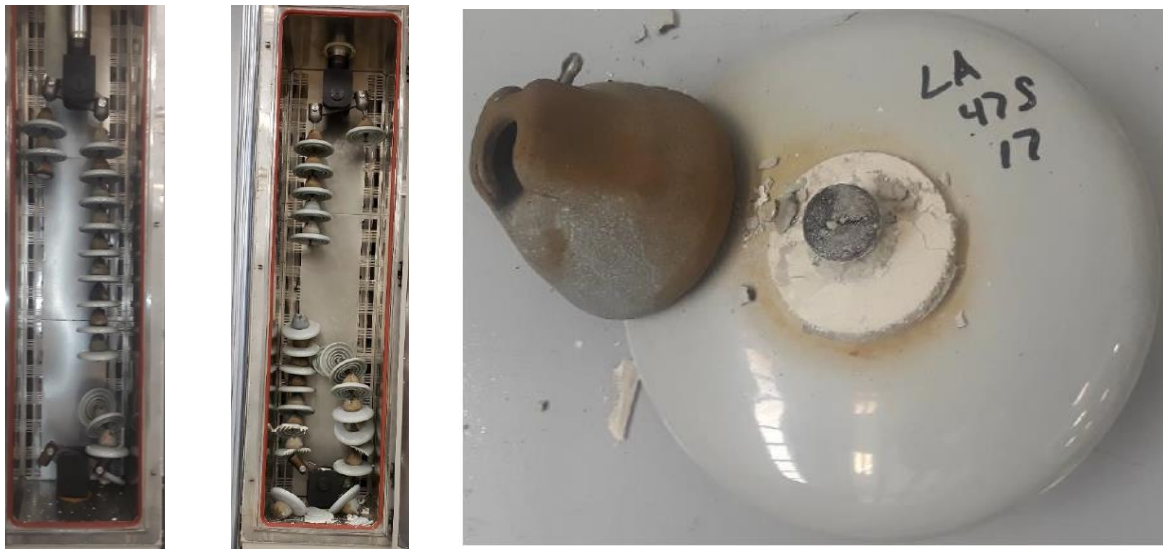
It can be noted that while these results show only an M&E failure, old porcelain insulators carrying already deeper and older cracks internally might lead to a string separation which could adversely under such conditions drop a conductor. (simulation in a thermo mechanical test as shown in figure 15). The cement itself (in fact a mortar) shows no specific heat sensitivity. The dehydration of the cement could generate some slight crumbling but by design the head works under compression leading to a wedge effect. The tested units were all assembled with Portland cement. The separation of the head is strictly the result of the porcelain body cracking in two pieces.

Figure 15: string separation during a thermo mechanical test performed on weak porcelain units containing already cracks from years of ageing.

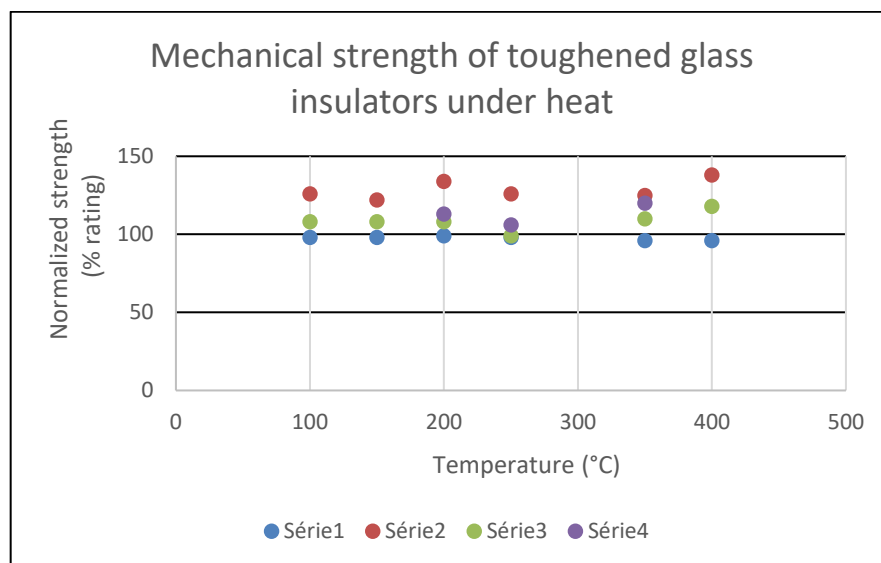
- c. **Toughened glass insulators** were tested with the same procedure. The insulators were pre heated in an oven for a duration of 3h but in this case up to 400°C (752F) since, as shown in figure 16 not much was happening. (Toughened glass does not puncture, and as per ANSI, the test is a mechanical test only, no use for an M&E combined given the fact that toughened glass does not generate cracks but shatters). The test was carried out to the maximum temperature of the oven.

Figure 16: Mechanical test results on toughened glass insulators (normalized to the rating)

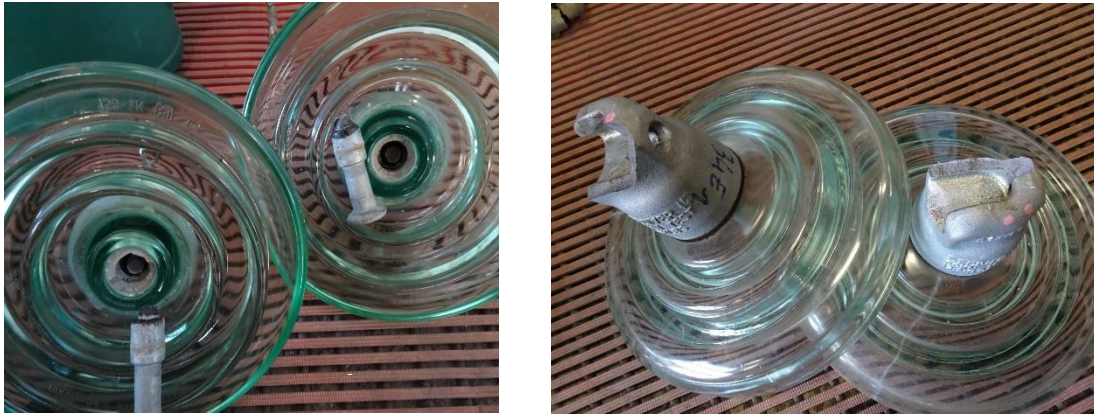
In a few cases the glass shattered before the mechanical separation, but in all the other cases the failure mode was a breakage of one of the fitting, usually the pin as shown in figure 17. It is also interesting to note that, while all the results seem very stable the lowest performer was assembled with Portland cement. Without enough elements to come to any conclusion on the influence of cement, it can be interesting to remember that Alumina cement is a better thermal refractory than Portland.

Figure 17: Typical aspect of the glass units after the test

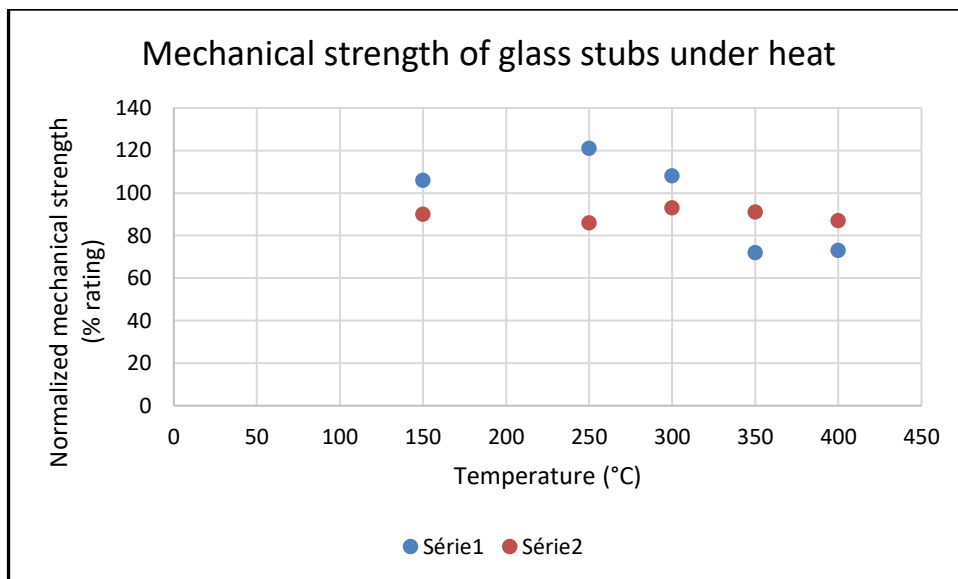
Since toughened glass can shatter, an additional test was carried out on stubs which were preheated as well and pull tested. Figure 18 shows the normalized test results. All the failure modes were identical with a pin pull out taking out the cement with the pin from the inside of the head of the insulator as shown in figure 19. All the values remain above 65% of their initial rating, which is the requirement in ANSI for new insulators tested for their residual strength.

Figure 18: Normalized mechanical strength of stubs preheated and pull tested at different temperatures

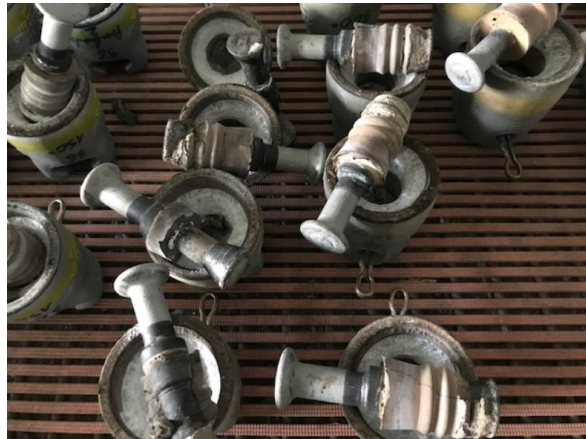
Figure 19: Overall aspect of the stubs after the mechanical test under heat conditions

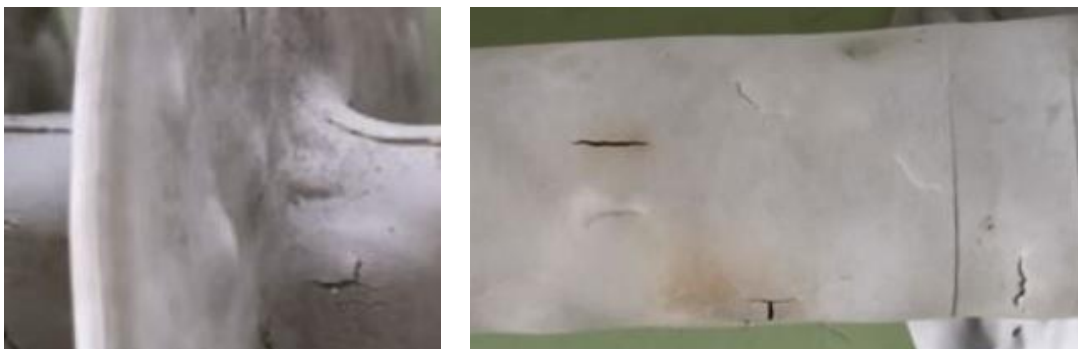
In section 1 we described the chemical mechanism of protection offered by ATH in silicone compounds. The main target is not to be a fire retardant, even if the chemical used is classified as such. The main attribute of the addition of this filler is to slow down the erosion of the silicone during dry band arcing or pollution related activity. At some point in time the rubber will fail leading to cracks on the core (figure 21). Of course the rubber does not burn, and many compounds used in the overhead line industry are classified HB and V0 in IEC60695, but once cracks appear the insulator is doomed to fail either electrically (internal tracking) or mechanically (brittle fracture, decay fracture...). It is important also to consider the existence of sulfuric acid and other fire related acids which will destroy progressively the core of the insulator. In most cases these degradations are not easy to spot visually as shown in several cases presented in figure 21.

Figure 21: Cracks in silicone housing left after being subjected to heat for a few hours

- The degradation of the housing of composite insulators under heat and fire can breach the integrity of the housing leading to moisture and acid ingress. Future failures and line drops after the fire is out could occur if these small cracks are not spotted and the insulators replaced.

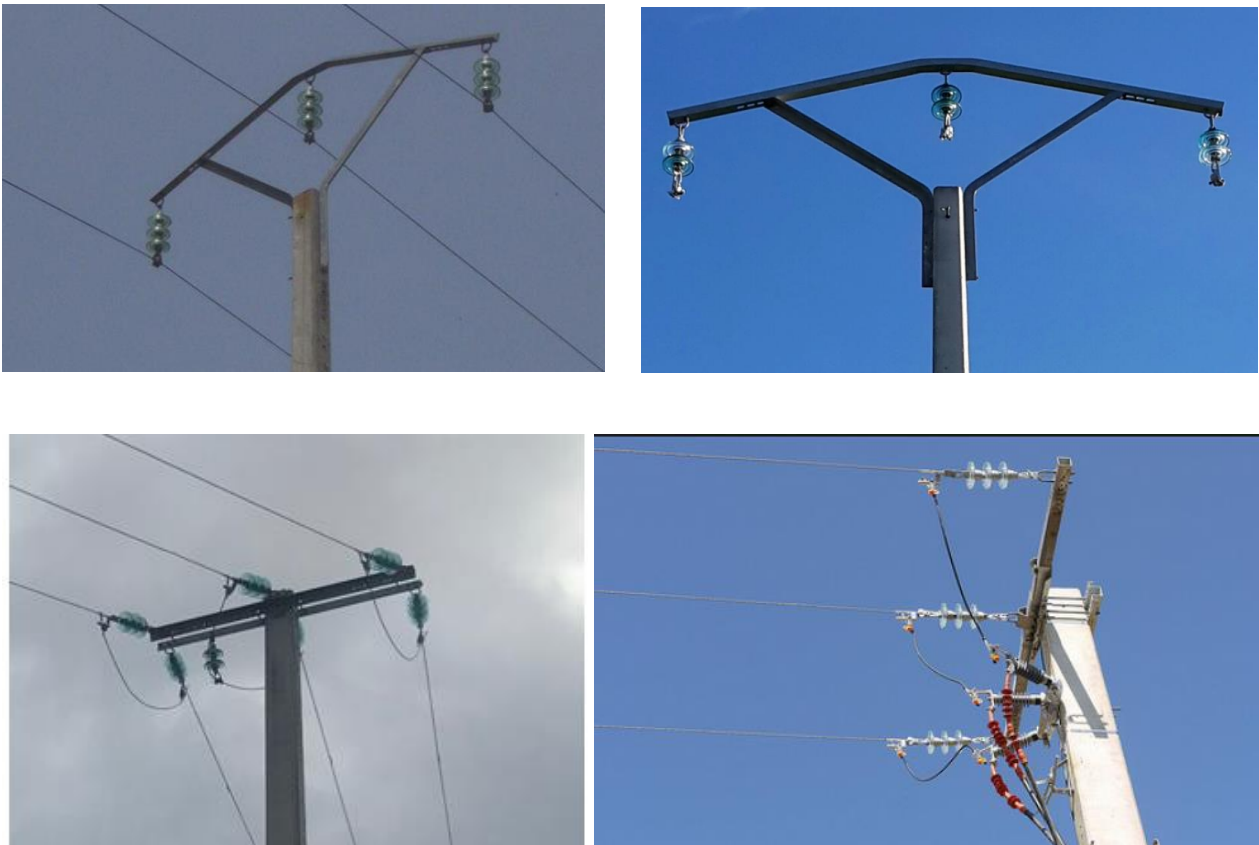
Strengthening the pole brings the weak link on the insulators especially if they are pin or post types working under cantilever which limits are driven by stubs, bolts and the intrinsic strength of the pin or post itself. It appears also that a tensile load is easier to secure consistently than bending loads. Therefore a line design where deadends are strictly made of glass with tangent structures made of concrete with suspension glass cap and pins would offer the best resilience. The grid hardening would result from insulators immune to heat and a mechanical structure where heavy duty strings working systematically in tension with ratings which could go up to 20kips or 30 kips or more are being used. Figure 22 gives examples of such systems using glass insulators for their strong resilience to adverse environments such as those encountered in fire driven environments or areas where conductors are not allowed to touch ground under any circumstances.

Figure 22: examples of resilient distribution lines using concrete poles and toughened glass insulators in suspension and tension.

- Use glass especially for deadends but also for tangent structures
- Modify the design of the distribution lines design replacing pin and post types by suspension strings working only in tension and installed on concrete poles.
- Transmission lines should use glass only.
