Evaluation of Field Returned Insulators from US Grid Through Laboratory Testing

Ron Duckstein
Tech Support & Sales Director
Sediver USA

Context

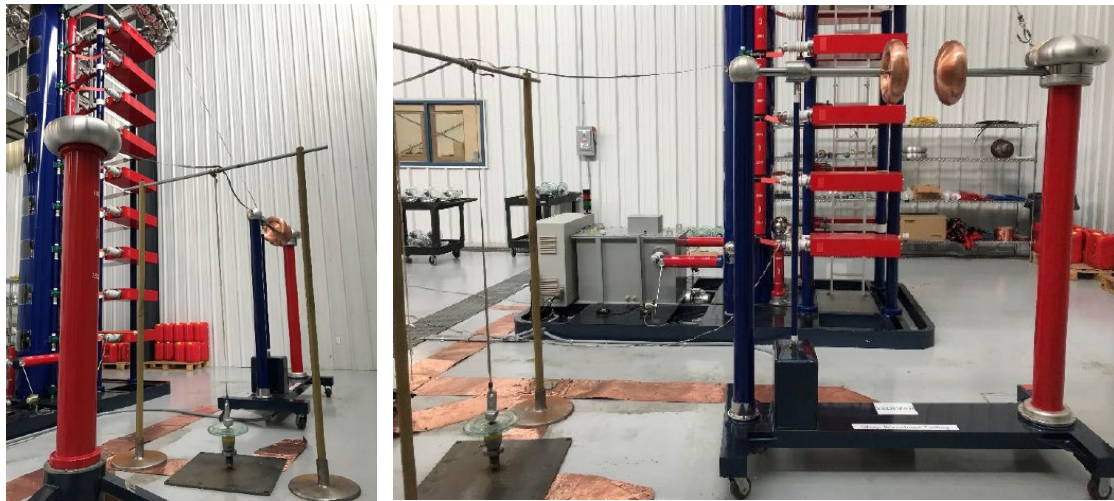
Figure 1: typical arrangement of steep front wave test with impulse generator and air gap. (Sediver West Memphis laboratory)

Dealing mostly with old porcelain, one may be wondering if it is more beneficial to test the insulators as per the standard which was in place when they were manufactured or if it is wiser to test as per the current version of the standards. A perfect example is the dielectric strength test, which under ANSI is the classical oil puncture test. Today modern versions of standards in IEC and CSA are calling for a steep front wave test which simulates with more consistency a transient overvoltage in air, rather than testing an insulator in oil knowing that the oil characteristics can strongly influence reliable results. Table 1 and Figure 1 show the difference of performance between both tests performed on either glass or porcelain insulators.

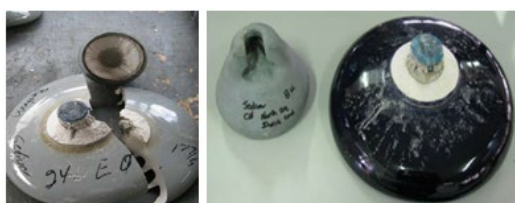
Insulator type/rating (kips)	30	50
Average M&E (kips)	27	44
Standard deviation (kips)	6	8
Average - 3s	9	20

Figure and table 2: Mechanical results and standard deviations of 40 year old porcelain discs removed for testing from a 500KV line. The results do not show very low average values but huge variations and large standard deviations. The dispersion of the results was enough to consider that these units should be replaced rapidly.

The same question stands for the mechanical tests either M&E or thermo mechanical procedures. The most recent versions of the standards are calling for 3 or 4 standard deviations. Should old insulators be measured against standards for which they were not designed? While we have to agree with some who would argue that what was done in the past survived quite well, operating conditions and reliability expectations have changed. Today most service interruptions which were acceptable in the past are no longer tolerated and subsequently when evaluating an old line, the question is less about knowing how they compared to their initial performances but much more to evaluate risks and potential threats. Under this approach, the current test practices should be considered as the only acceptable method, with a detailed examination of the results and their meaning. As an illustration, Figure 2 and Table 2 show M&E test results from insulators which had been in service for approximately 40 years on a 500KV line in the West of the USA.

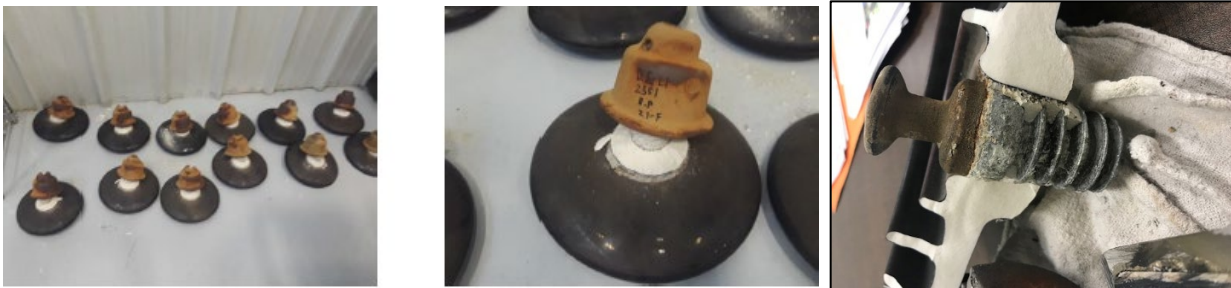
Figure 3: M&E test results on old porcelain from 1920 still passing the rated value; Average strength is at 13.4 kips with a standard deviation of 800 lbs. With 3 standard deviations the insulators are still good. The reason is mostly because of stable climatic conditions and an early 20th century over-designed product compared to the actual application.

These tests are the most commonly used, either in the type test sequence of new insulators or in the investigation performed on old units. Between these two tests, the thermo mechanical goes beyond establishing the condition of insulators since it uses a 96 hour pre-stress sequence of hot and cold variations to stimulate potential flaws and weaknesses. The example below from a US utility which sent units to our laboratory are quite interesting in this regard. The units are old (1920), rated 11kips and still in operation. The M&E testing shows still good results as described in Figure 3 but the thermo mechanical shows clear evidence of the ageing as shown in figure 4.

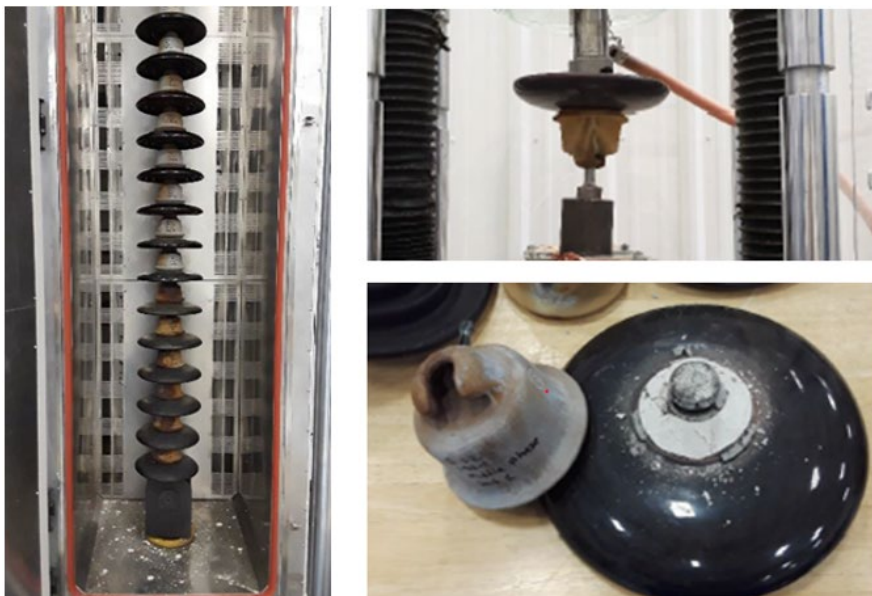
Figure 4: the M&E (right) of the same batch of insulators fails after a thermo mechanical test (left) as per ANSI 29 2B. Average failing load is at 10 kips (for a 11kips rating) with a standard deviation of 1500 lbs.

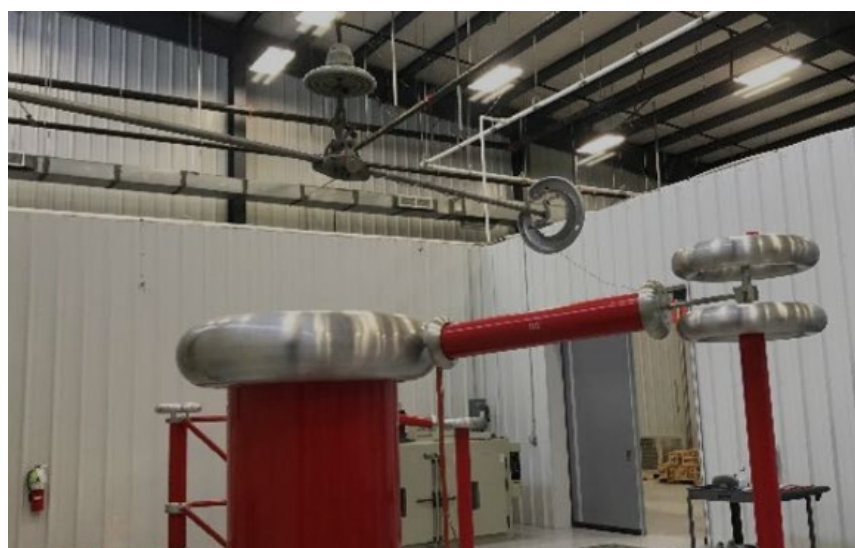
It should be mentioned that prior to any test on porcelain insulators, the integrity of the dielectric is checked through a power frequency flashover test (figure 6). The following case describes a situation where more than 200 units rated 20 kips were received from a utility on the East Coast and tested. None of these units were found to be punctured when they arrived at the Sediver laboratory in West Memphis.

Figure 6: Power frequency verification prior to implementation of an investigation program

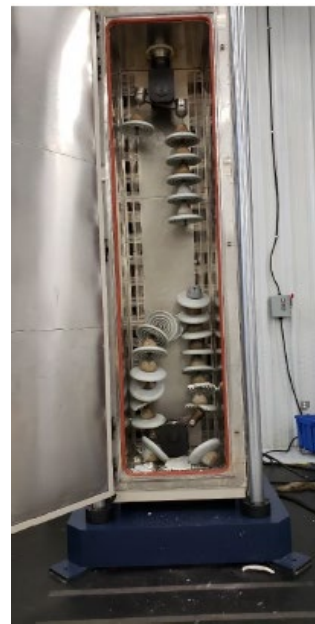
While the M&E test was already showing values below rating, the decision was made to also go through a thermo mechanical 96 hour test as per ANSI C29 2B. The M&E results (table 7) show that values were relatively in line with expectations from old porcelain insulators with a standard deviation close to 4000 lbs. However during the second test, a string separation occurred after 12 hours at 60% of the rating (figure 7) with a collateral damage on the parallel string tested simultaneously.

Breakage value (lbs)		Type of breakage
Electrical	Mechanical	
--	25,471	Porcelain Head Breakage
17,535	22,414	Porcelain Head Breakage
24,302	26,550	Porcelain Head Breakage
20,458	21,694	Porcelain Head Breakage
--	31,811	Pin Break
24,302	24,931	Porcelain Head Breakage
--	29,180	Porcelain Head Breakage
22,256	29,765	Porcelain Head Breakage
20,907	21,312	Porcelain Head Breakage
22,706	23,178	Porcelain Head Breakage
19,446	20,323	Porcelain Head Breakage
19,221	19,873	Porcelain Head Breakage
11,937	15,422	Porcelain Head Breakage
17,063	17,063	Porcelain Head Breakage
14,388	15,917	Porcelain Head Breakage
21,357	22,661	Porcelain Head Breakage
--	18,210	Porcelain Head Breakage
16,411	17,580	Porcelain Head Breakage
15,062	18,097	Porcelain Head Breakage
15,962	24,707	Porcelain Head Breakage
--	18,592	Porcelain Head Breakage
--	24,392	Porcelain Head Breakage
--	27,539	Pin Break
16,636	20,008	Porcelain Head Breakage

Table and Figure 7: M&E test on a batch showing values below rating and catastrophic failure in TM (right) after 12 hours at 60% of the rating.

This combination of results urged the utility to plan for a refurbishment of the line. It can be noted also that the M&E test shows first an electrical puncture while the mechanical failure occurs at higher loads. The fact that the thermo mechanical test shows a separation at an early stage of the test indicates that these units, while not yet punctured, are nevertheless close to their end of life.
