Overhead Lines Under Extreme Heat Resulting from Wildfires

Jean Marie GEORGE
Scientific Director

Sandrine PRAT
PhD Research Manager

**Overhead Lines Under Extreme Heat
Resulting from Wildfires
SEDIVER Research Center**

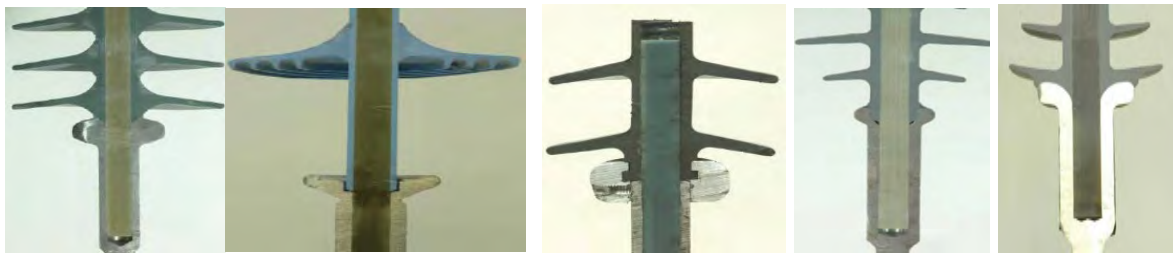
- a. **Composite insulators** exist in a large variety of designs (figure 1) and are made of organic materials which therefore have temperature limitations. The diversity of possible designs and materials used to make these insulators dramatically increases the complexity of their long-term evaluation. There are three main design features to look into as described hereafter and checked in detail in section 2.

Figure 1: typical designs of composite insulators

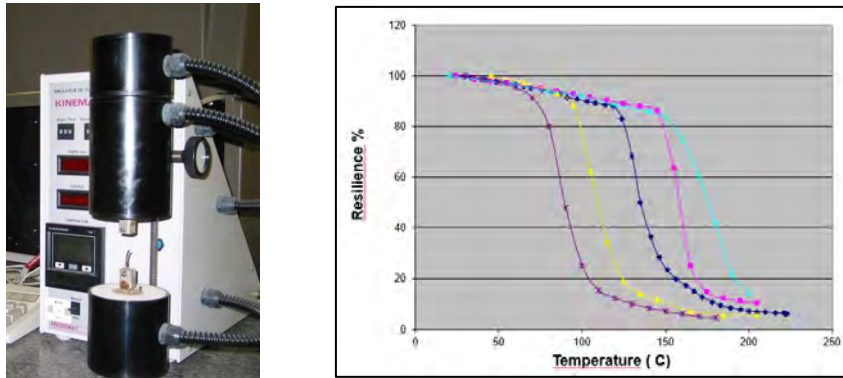
- The fiberglass rod is made of resin reinforced by glass fibers. Resins used for insulators can be polyester, vinyl ester or epoxy. The strongest and best performers are made with epoxy resins. Resins are defined by a thermal set point called Tg (softening point) above which the resin is progressively losing its mechanical strength. This characteristic can be established by DSC (Differential Scanning Calorimetry). The mechanical weakening of the interface between the glass fibers and the resin in the rod (key for mechanical strength) can also be measured through a torsional strength test on a small slice cut from a rod. Figure 2 shows the test equipment and the results obtained from commercially available fiberglass rods used in the manufacturing of composite insulators. The mechanical resilience of the samples is decreasing with temperature. The sensitivity to heat is directly the result of the chemistry of the resin itself.

Figure 2: Torsional strength test showing the loss of resilience at the Tg set point

- a. **Polymer insulators:** The combination of the crimping compression of the end fitting over the fiberglass rod itself sensitive to heat (see figure 2) can be feared as a weak point under heat conditions. In order to establish this property tests were performed with various composite insulators (mostly distribution dead ends). Samples were introduced in an oven for 3 hours and pull tested while still hot until failure occurs. Figure 10 shows the normalized results with a reference at 100% corresponding to their ratings. It appears clearly that the strength goes rapidly below the everyday load design of the line.

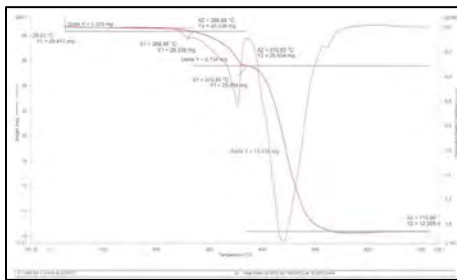
- The housing, typically silicone rubber, is a material designed to chalk and not burn (in most cases). Silicone rubbers exist in numerous chemistries, but the most popular silicone compounds contain a fire retardant filler such as ATH (Alumina TriHydrate). For erosion and electric tracking resistance the amount of this additive in the silicone is usually above 45% and can be measured by Thermo Gravimetric Analyses (TGA). Figure 3 shows the graph obtained by TGA of a silicone rubber. The decrease in weight during the test is typical of the loss of water from the ATH molecule during heating. Normally ATH is decomposing around 250C (482 F). Silicone rubber subjected to excessive heat will display a white powderish surface as shown in figure 4.

Figure 3: TGA curve of silicone

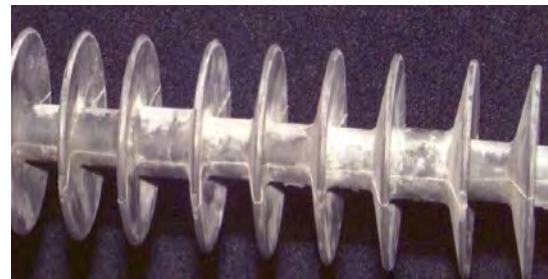
Figure 4: white powderish aspect of heated silicone

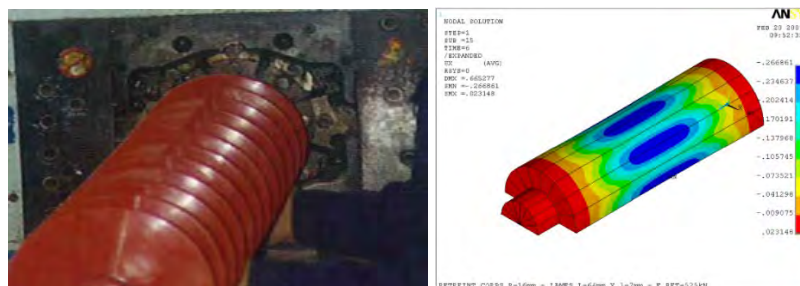
- The end fittings of modern composite insulators are normally crimped by compression (like cable joints). The particularity of this process is to ensure enough pressure through the end fitting (made of steel, cast iron or aluminum) to ensure a sufficient grip on the fiberglass rod which is not a metal. To avoid a thermal relaxation during the molding of the rubber housing onto the core, the end fittings are usually crimped after the housing is in place. Figure 5 shows this process and the compressive stress distribution into the rod which must be preserved from any damage such as cracks during the crimping (this is still a sensitive operation despite the use of compression sensors intended to control the process)

Figure 5: crimping process and internal stress distribution on a fiberglass rod/fitting connection

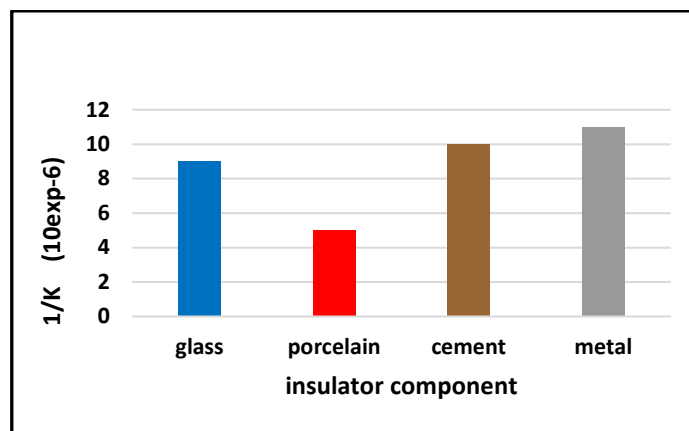
- b. **Porcelain insulators**, besides their end fittings (cap in cast iron and pin made of forged steel) are made of mineral materials. The cement is either alumina cement, or (usually) portland cement. The assembly is usually not made with pure cement but with a mortar containing silica (sand) and other minerals. The stability of the cement with temperature is high and the resilience of such an assembly is mostly driven by the design of the head and the coupling of the thermal expansion coefficients between the end fittings, the cement and the porcelain body. Figure 6 shows the linear expansion coefficients of typical porcelain insulator components. The particularity of the porcelain body is related to its heterogeneous structure of porcelain which contains crystals having themselves different properties. This aspect of porcelain is what leads to the inherent ageing of the dielectric with possible punctures of internal crack propagation (figure 7). This parameter needs to be taken into consideration for resilience performance under heat (see section 2).

Figure 6: linear expansion factor coefficient of glass and porcelain insulators and their components

- c. **Toughened glass insulators** are assembled like porcelain insulators with cement (usually alumina cement but sometimes portland) but do not have any microstructure and the coupling of the thermal expansion factors is more homogeneous as seen in figure 6. The glass is toughened for strength purposes and the prestresses built in the bulk thickness of the dielectric are a balance of compressive and extension forces (figure 8). The mechanical shield represented by this toughening operation makes glass immune to any crack propagation or puncture. A toughened glass insulator will either be intact or shatters if any excessive adverse stress is applied. In this case the glass insulator becomes a so called “stub” (figure 9) which electro mechanical performance remains intact (no internal puncture, and high residual strength). When subjected to heat the glass can suffer of superficial chips or can shatter if exposed to brutal and immediate heat. It is important to understand that the toughening prestress is permanent unless the glass shell is exposed to a permanent temperature of 700°C (1300F) for a

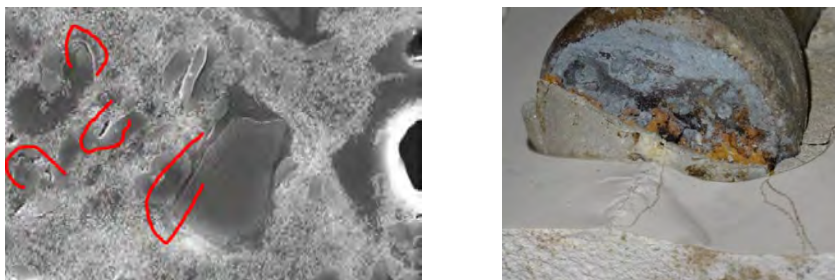
Figure 7: microstructure of porcelain and internal microcracks leading to punctures of the dielectric

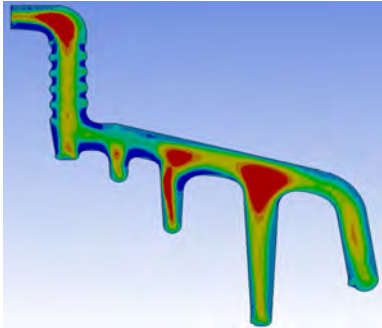
Figure 8: toughening internal prestresses

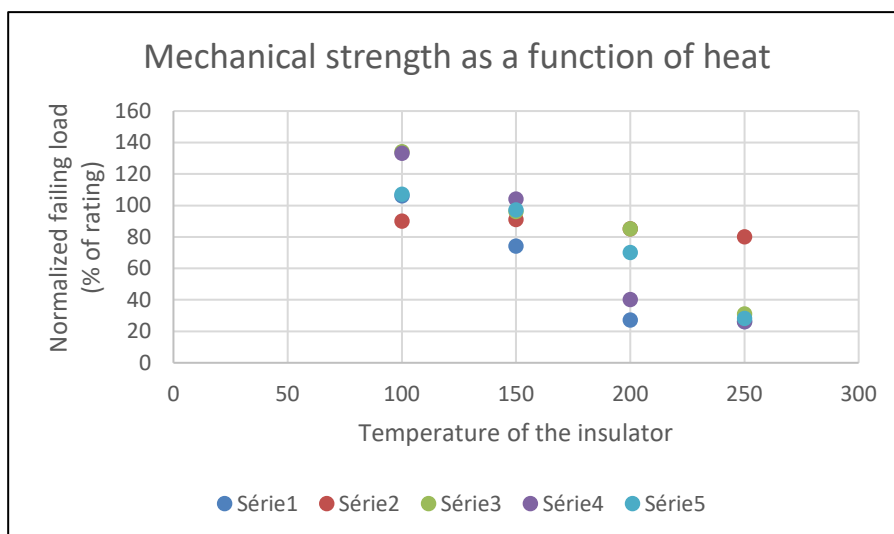
Figure 10: mechanical resilience of composite insulators at different temperatures (temperature in °C.)

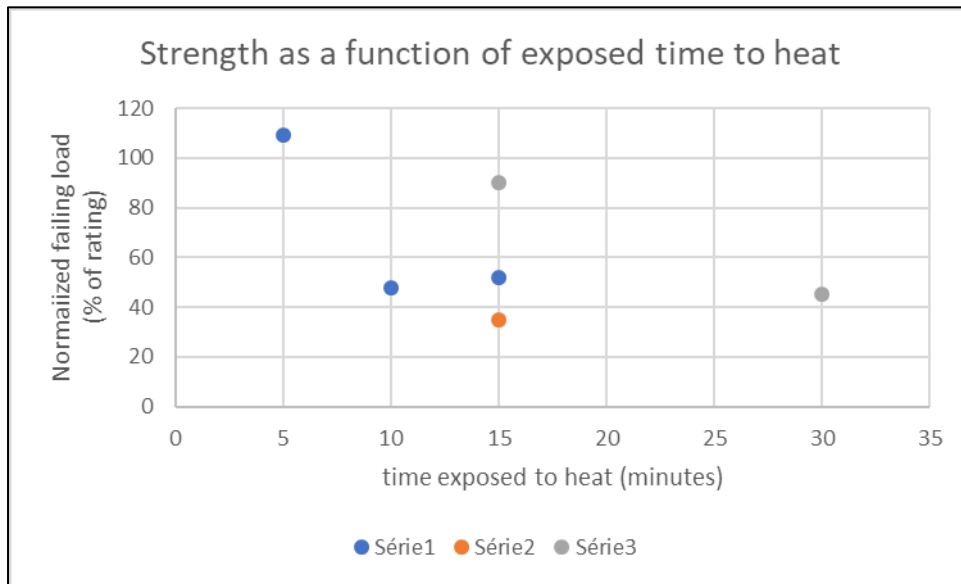
An additional test was performed with insulators exposed at 300°C (572F) for short durations. Figure 11 shows again normalized strength with reference to the rating of the insulators. It appears that very quickly (less than 30 minutes the strength goes down to 30% to 40% with serious risks of line drop whenever such loads are encountered.

Figure 11: strength of various composite insulators as a function of time after being exposed to 300°C (572F)

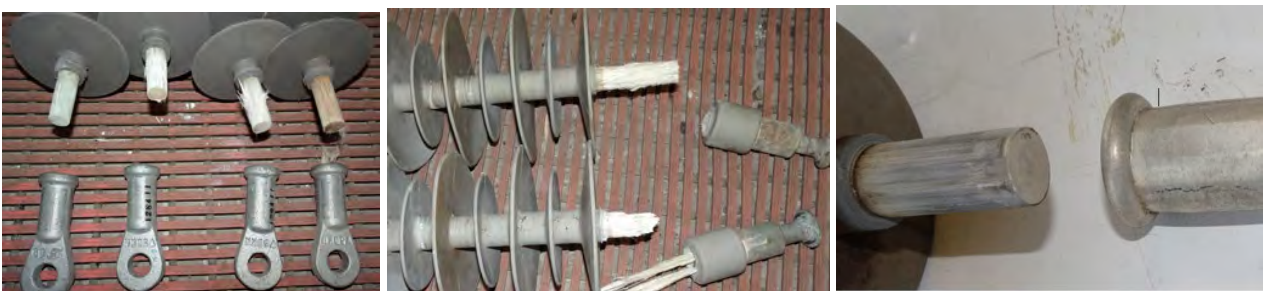
In most cases the rod slips out of the fitting as shown in figure 12. It can be interesting to note that the best values (but still very weak results are obtained with forged steel fittings and fiberglass rods which have a very high Tg. (Tg > 180°C, 360F)

Figure 12: typical aspect of the tested units after the mechanical pull test

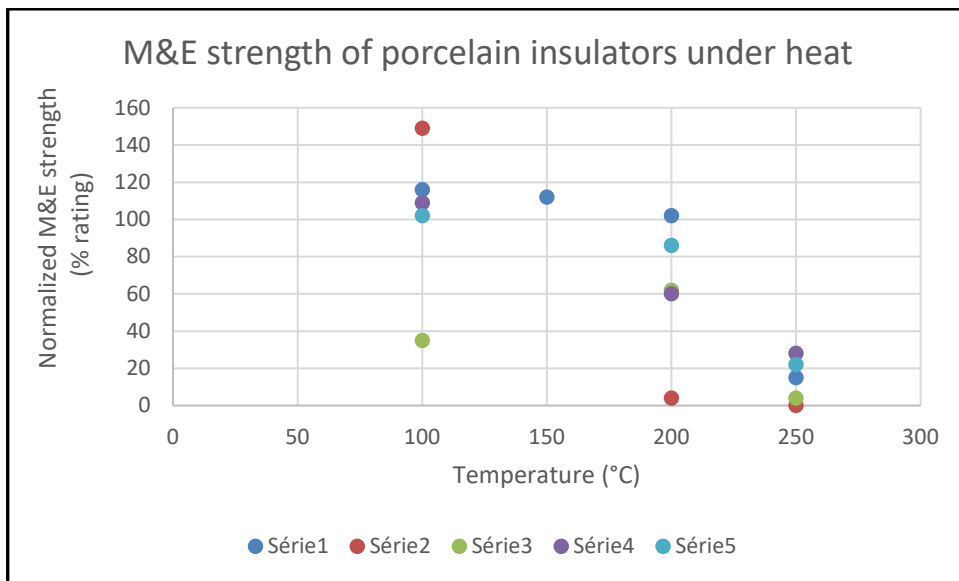
- b. **Porcelain insulators** underwent a similar test with various insulators placed in a furnace for 3h before being pull tested. Given the risk for porcelain to puncture the relevant test in this case is the ANSI M&E test. A number of units failed with cracks either visible or not. As expected, the difference in expansion between components favors this type of failure. However, and while most units survived their mechanical stress with no separation below the rating, most failed electrically from internal punctures not visible from the outside. This demonstrate that once porcelain insulators have been directly or not in contact with high heat there is a major risk for having hidden defective units on a power line. Figure 13 shows the M&E test results and figure 14 the typical physical aspects of the units after test.

Figure 13: M&E test results of porcelain insulators subjected to heat prior to pull testing

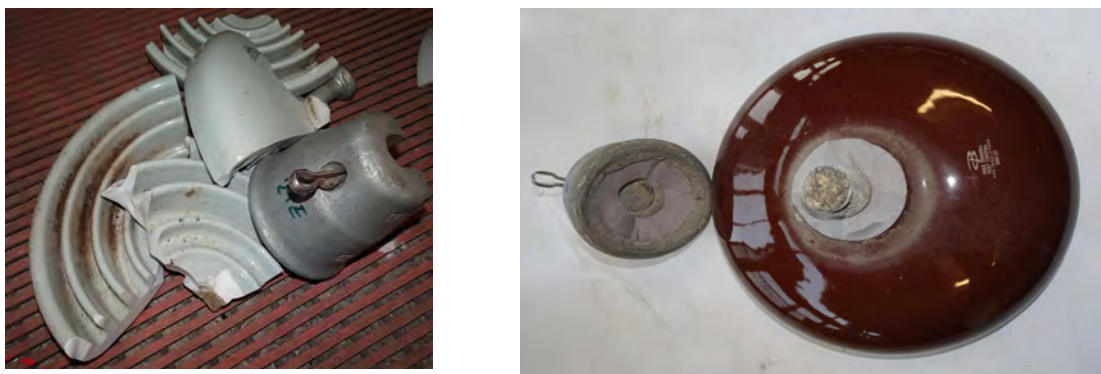
Figure 14: overall aspect of the insulators after the test

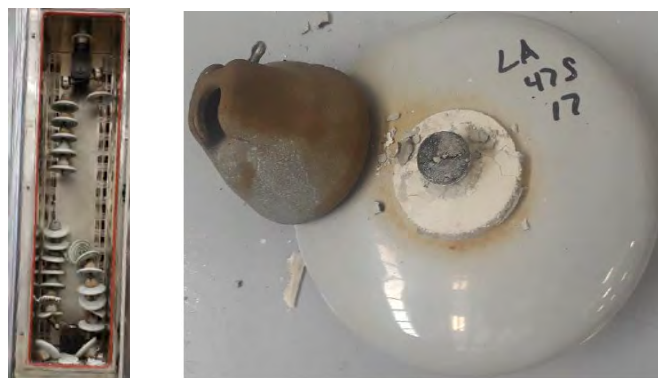
It can be noted that while these results show only an M&E failure, old porcelain insulators carrying already deeper and older cracks internally might lead to a string separation which could adversely under such conditions drop a conductor. (simulation in a thermo mechanical test as shown in figure 15). The cement itself (in fact a mortar) shows no specific heat sensitivity.

Figure 15: string separation during a thermo mechanical test performed on weak porcelain units containing already cracks from years of ageing.

The dehydration of the cement could generate some slight crumbling but by design the head works under compression leading to a wedge effect. The tested units were all assembled with Portland cement. The separation of the head is strictly the result of the porcelain body cracking in two pieces.

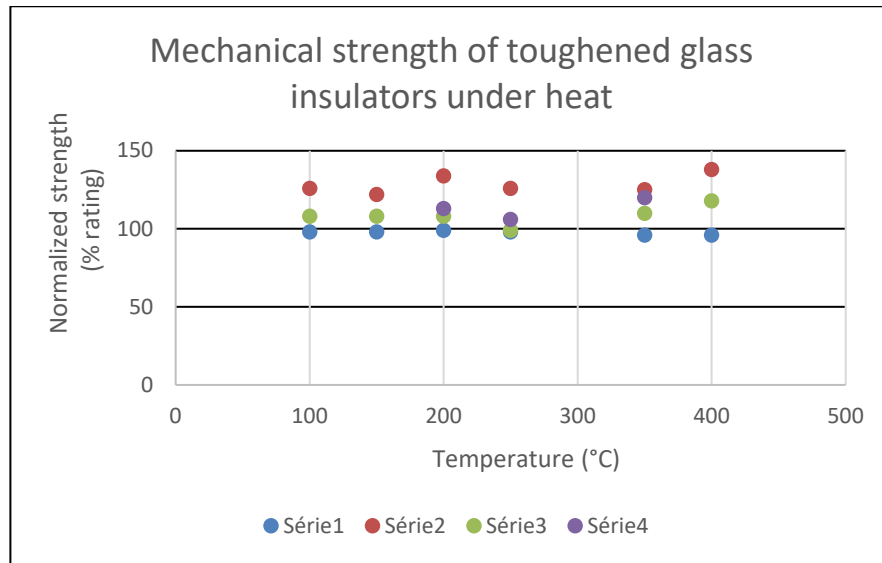
- c. **Toughened glass insulators** were tested with the same procedure. The insulators were pre heated in an oven for a duration of 3h but in this case up to 400°C (752F) since, as shown in figure 16 not much was happening. (Toughened glass does not puncture, and as per ANSI, the test is a mechanical test only, no use for an M&E combined given the fact that toughened glass does not generate cracks but shatters). The test was carried out to the maximum temperature of the oven.

Figure 16: Mechanical test results on toughened glass insulators (normalized to the rating)

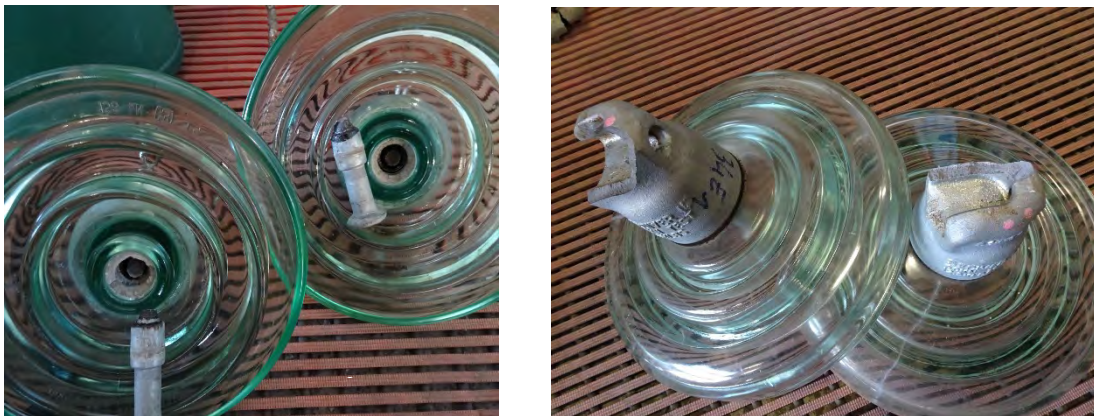
In a few cases the glass shattered before the mechanical separation, but in all the other cases the failure mode was a breakage of one of the fitting, usually the pin as shown in figure 17. It is also interesting to note that, while all the results seem very stable the lowest performer was assembled with Portland cement. Without enough elements to come to any conclusion on the influence of cement, it can be interesting to remember that Alumina cement is a better thermal refractory than Portland.

Figure 17: Typical aspect of the glass units after the test

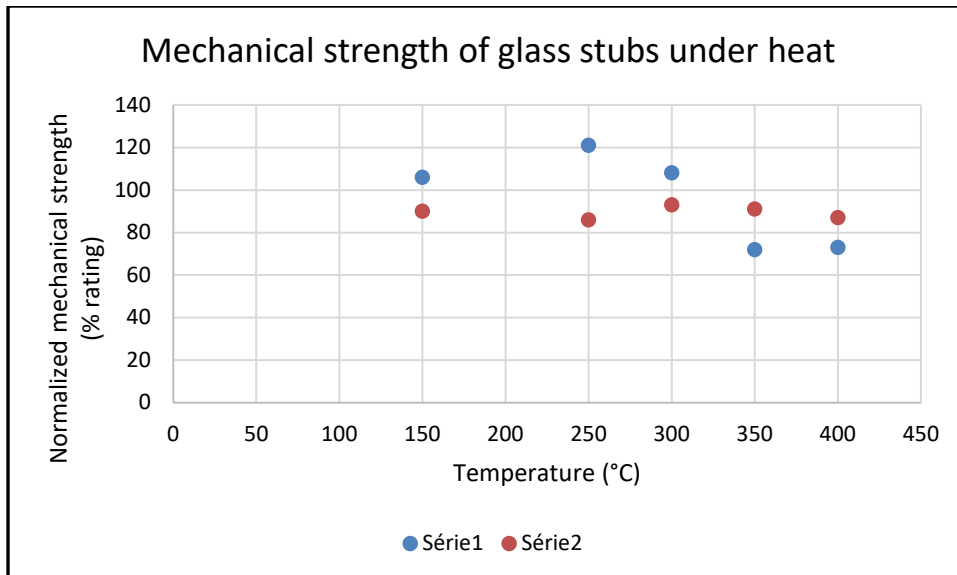
Since toughened glass can shatter, an additional test was carried out on stubs which were preheated as well and pull tested. Figure 18 shows the normalized test results. All the failure modes were identical with a pin pull out taking out the cement with the pin from the inside of the head of the insulator as shown in figure 19. All the values remain above 65% of their initial rating, which is the requirement in ANSI for new insulators tested for their residual strength.

Figure 18: Normalized mechanical strength of stubs preheated and pull tested at different temperatures

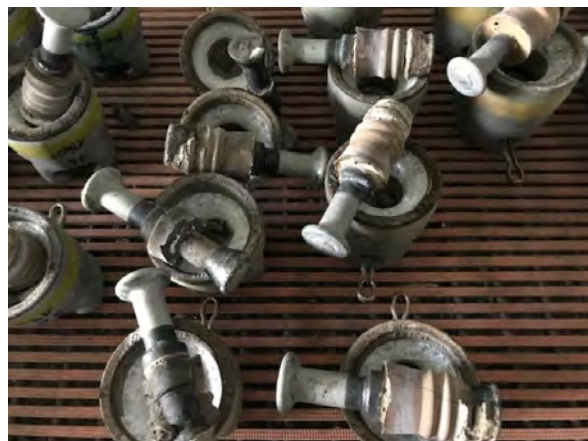
Figure 19: Overall aspect of the stubs after the mechanical test under heat conditions

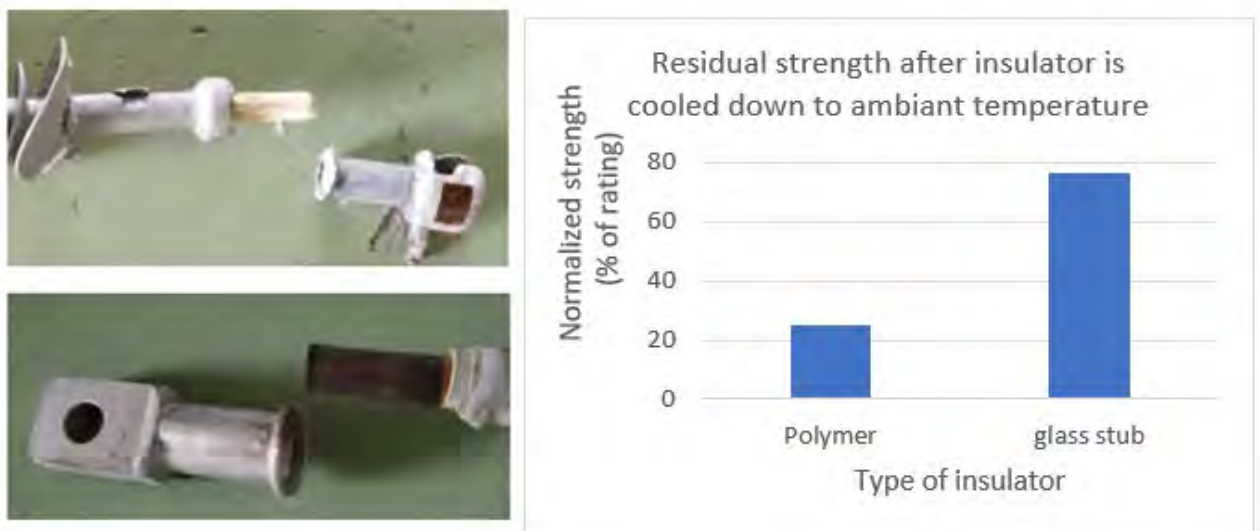
One question left after investigating the behavior of polymers under fire is to know their residual strength once they cooled off. Tests were performed on insulators which had previously been subjected to heat maintained for 2h at 300°C (572F). The results are shown in figure 20 with a strength between 20% and 30% of the rating. This result can be compared with the results on broken glass (stubs) largely above the standard requirement for residual strength.

Figure 20: Fitting pull out after the insulators were cooled down after a heat cycle at 300°C and comparison with results on glass stubs tested in the same conditions

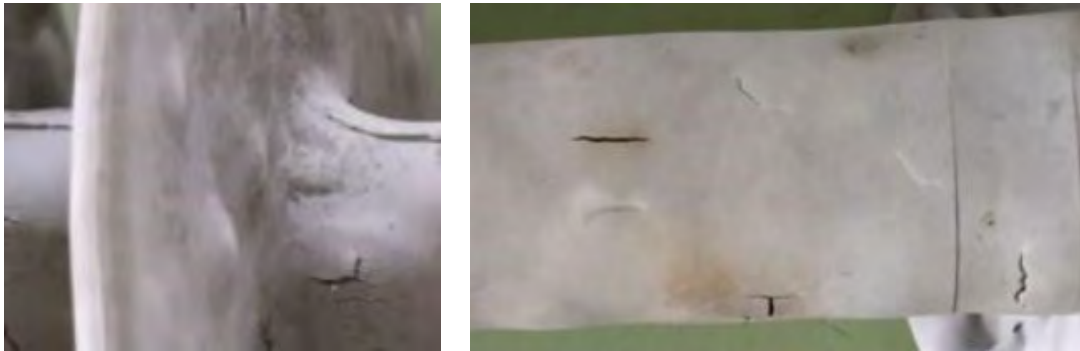
In section 1 we described the chemical mechanism of protection offered by ATH in silicone compounds. The main target is not to be a fire retardant, even if the chemical used is classified as such. The main attribute of the addition of this filler is to slow down the erosion of the silicone during dry band arcing or pollution related activity. At some point in time the rubber will fail leading to cracks on the core (figure 21). Of course the rubber does not burn, and many compounds used in the overhead line industry are classified HB and V0 in IEC60695, but once cracks appear the insulator is doomed to fail either electrically (internal tracking) or mechanically (brittle fracture, decay fracture...). It is important also to consider the existence of sulfuric acid and other fire related acids which will destroy progressively the core of the insulator. In most cases these degradations are not easy to spot visually as shown in several cases presented in figure 21.

Figure21: Cracks in silicone housing left after being subjected to heat for a few hours

- The degradation of the housing of composite insulators under heat and fire can breach the integrity of the housing leading to moisture and acid ingress. Future failures and line drops after the fire is out could occur if these small cracks are not spotted and the insulators replaced.
