Asset Management: Evaluation of Old Insulators

Fábio Frutuoso
Sediver
Brasil

Damien Lepley
Sediver
France

This article presents a technical approach to asset management in transmission lines, focusing on the evaluation of the longevity of toughened glass insulators withdrawn from service after more than 40 years of operation in humid tropical environments in Brazil.

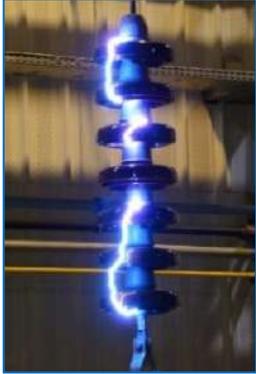
Photo 4 - Atmospheric Impulse Test

To illustrate what's happen when a porcelain insulator is punctured, a lightning impulse test was carried out on a short string consisting of 3 intact units at both ends and a punctured unit positioned in the middle. Photo 4 clearly illustrates that, in the case of a punctured porcelain insulator, the electrical discharge propagates internally.

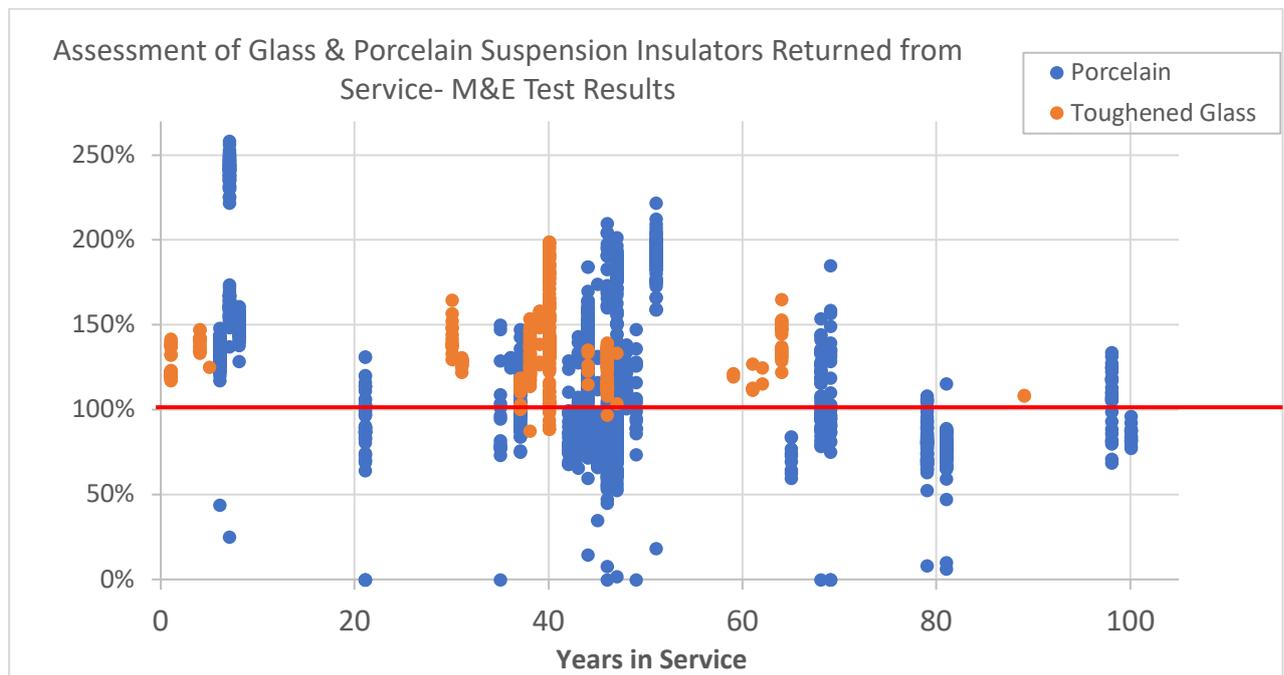
Fig 2 – M&E test results as a function of age for both porcelain and glass insulators. Porcelain units are represented in blue while toughened glass insulators are shown in orange.

Figure 2 shows an analysis of the samples according to the number of years of service. Differences in performance are observed, highlighting that toughened glass insulators present, proportionally, fewer results below the classification compared to porcelain populations.

Porcelain insulators exhibit dielectric aging, with less than 1% failure up to 20 years and about 50% after 45 years, due to the propagation of microcracks caused by thermal stresses.

In conclusion, the article recommends that porcelain insulators older than 20 years be subjected to periodic inspections using laboratory methods or field-specific equipment. For toughened glass insulators, the text considers that visual inspections remain adequate, even for older models.

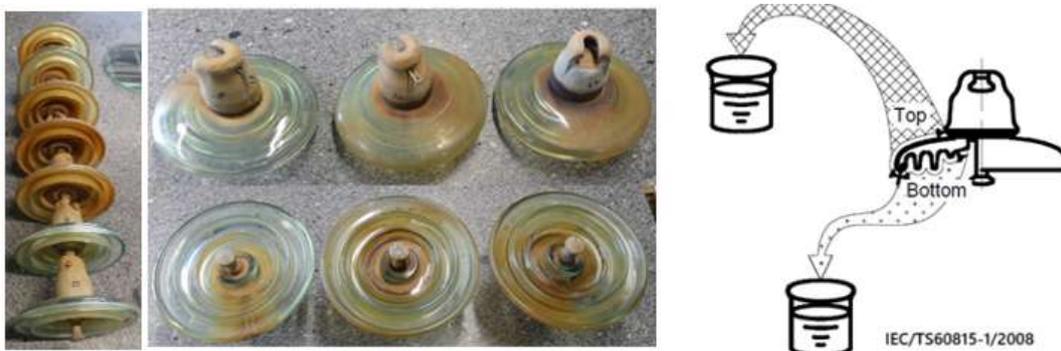
Photo 14 – Samples used for the evaluation of the pollution levels

The severity of the pollution at the site (SPS), also referred to as the pollution level, was determined with the ESDD (Equivalent Salt Deposit Density) and NSDD (Non Soluble Deposit Density) method following the guidelines outlined in Appendix C of IEC/TS 60815/2008. The pollutants from the top and bottom were removed separately from the insulator surfaces to calculate CUR and the ESDD and NSDD values and classify the pollution severity level.

The insulator strings were dimensioned for the b-Light pollution level (USCD 27.8mm/kVphase-ground).

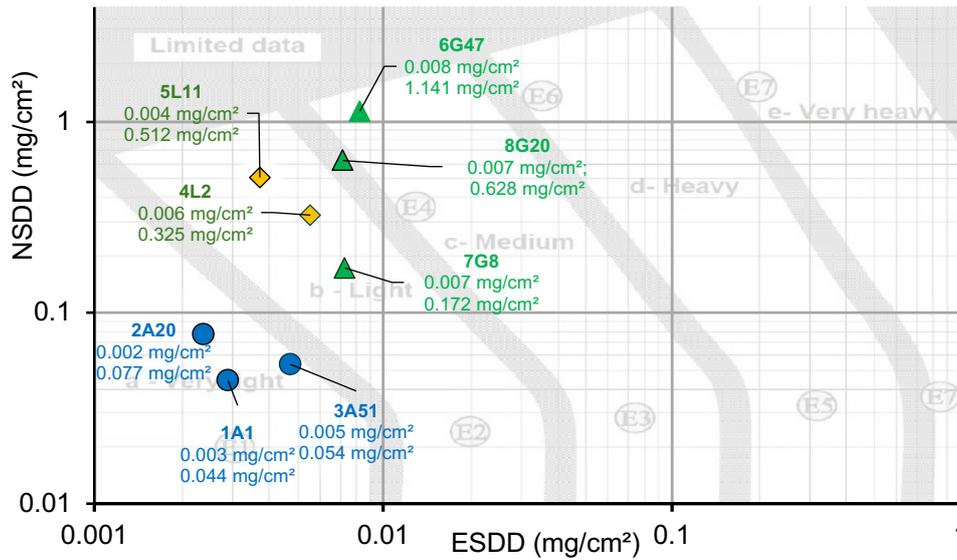
Fig. 5 – Severity chart and table with ESDD/NSDD measurements

Group	N ^o	Surface	ESDD (mg/cm ²)	NSDD (mg/cm ²)	CUR	ESDD (mg/cm ²)	NSDD (mg/cm ²)	Pollution Class
A	1	TOP 1A1	0,003	0,033	0,9	0,003	0,044	Very Light
		BOT 1A1	0,003	0,050				
	20	TOP 2A20	0,003	0,035	0,6	0,002	0,077	Very Light
		BOT 2A20	0,002	0,100				
	51	TOP 3A51	0,008	0,033	0,4	0,005	0,054	Very Light
BOT 3A51		0,003	0,065					
L	2	TOP 4L2	0,007	0,107	0,8	0,006	0,325	Light
		BOT 4L2	0,005	0,445				
	11	TOP 5L11	0,004	0,179	0,9	0,004	0,512	Light
		BOT 5L11	0,004	0,695				
G	47	TOP 6G47	0,005	0,462	2,0	0,008	1,141	Medium
		BOT 6G47	0,010	1,543				
	8	TOP 7G8	0,008	0,104	0,9	0,007	0,172	Light
		BOT 7G8	0,007	0,212				
	20	TOP 8G20	0,006	0,057	1,3	0,007	0,628	Light/Medium
		BOT 8G20	0,008	0,966
