Silicone coating of insulators: latest technical knowledge based on field performance and laboratory testing

JM George	A. Le Du	D. Lepley	S. Prat	F. Virlogeux
		SEDIVER

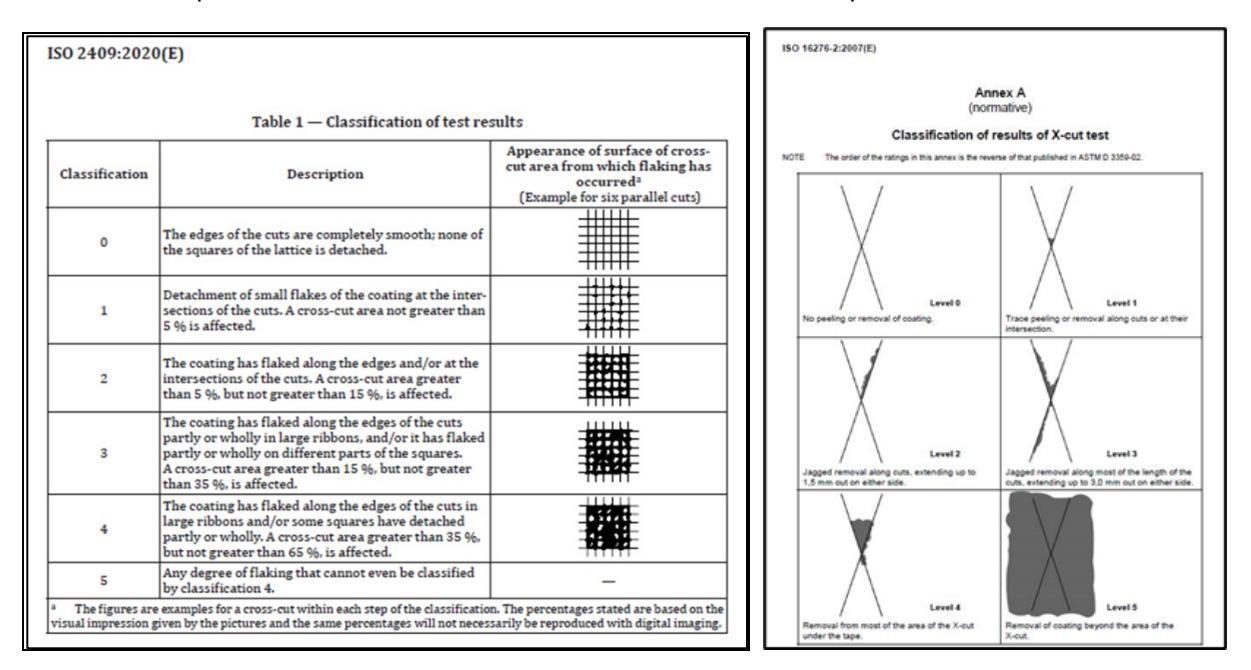
Figure 1: Classification of adherence for the 2 standards

There have been lots of discussions on this test (refer to CIGRE TB 837 brochure [1]) because the standards mentioned above are applicable to varnish (not silicone) and limited to a maximum thickness of 250 μ m for ISO 2409 [4]. The X cross test method in ISO 16276 [5] does not give thickness limitations. The classification of adherence given in these standards are shown in figure 1. Nevertheless, the multiblade cross-cut test described in ISO 2409 [4] has been used and adopted by all manufacturers and users and proved to be effective. Class 0 and 1 are the usual accepted adherence levels.

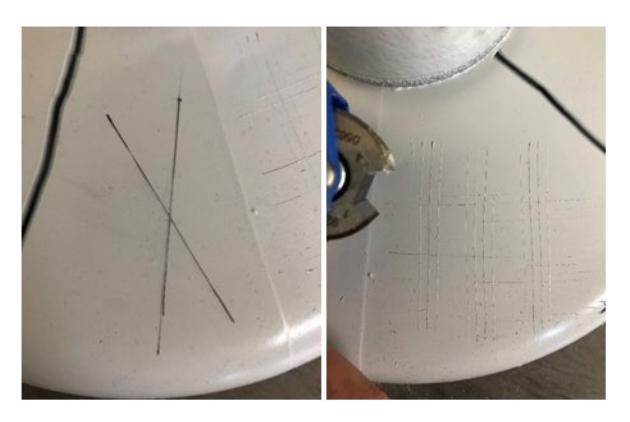
Figure 2: Satisfactory adherence tested with X cut method (left) and Cross cut methods (right)

Sediver is performing this test on a very regular basis and accumulated large data using the multiblade technique with blades distant of 3mm as per ISO 2409 [4] and benchmarked in multiple circumstances this method against the X cut described in ISO 16276-2 [5] including insulators with low adherence. It appeared clearly that the multiblade technique can detect insulators which coatings are questionable

while the X cut does not necessarily point out these weaknesses as shown in figure 2,3 and 4. The multiblade test seems therefore preferable and more accurate.

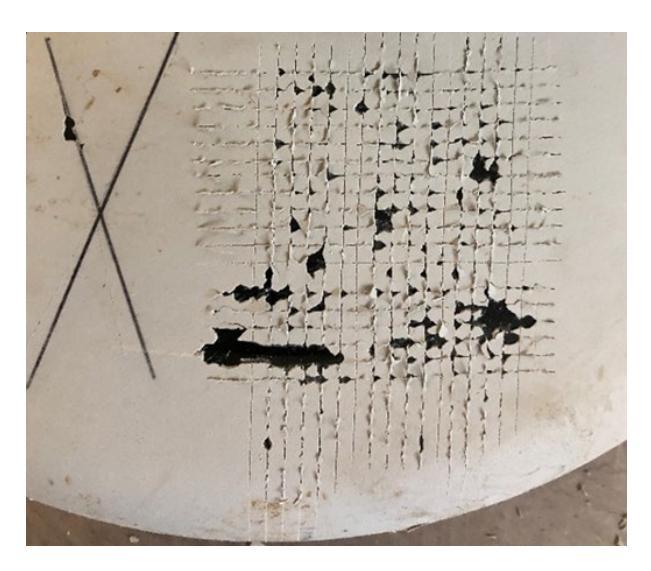
Figure 3: X cut (left) classifies the adherence as Level 1 or 2 whereas Cross cut (right) classifies adherence as class 3 or 4

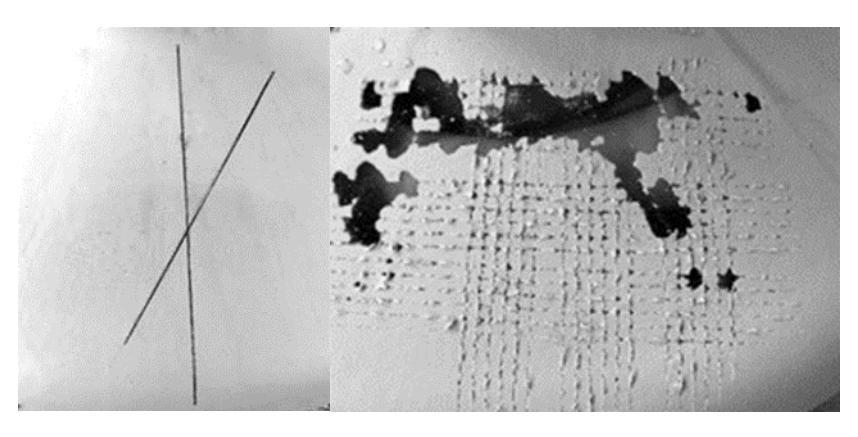
Figure 4: X cut (left) classifies the adherence as level 0 whereas Cross cut (right) classifies adherence as class 5

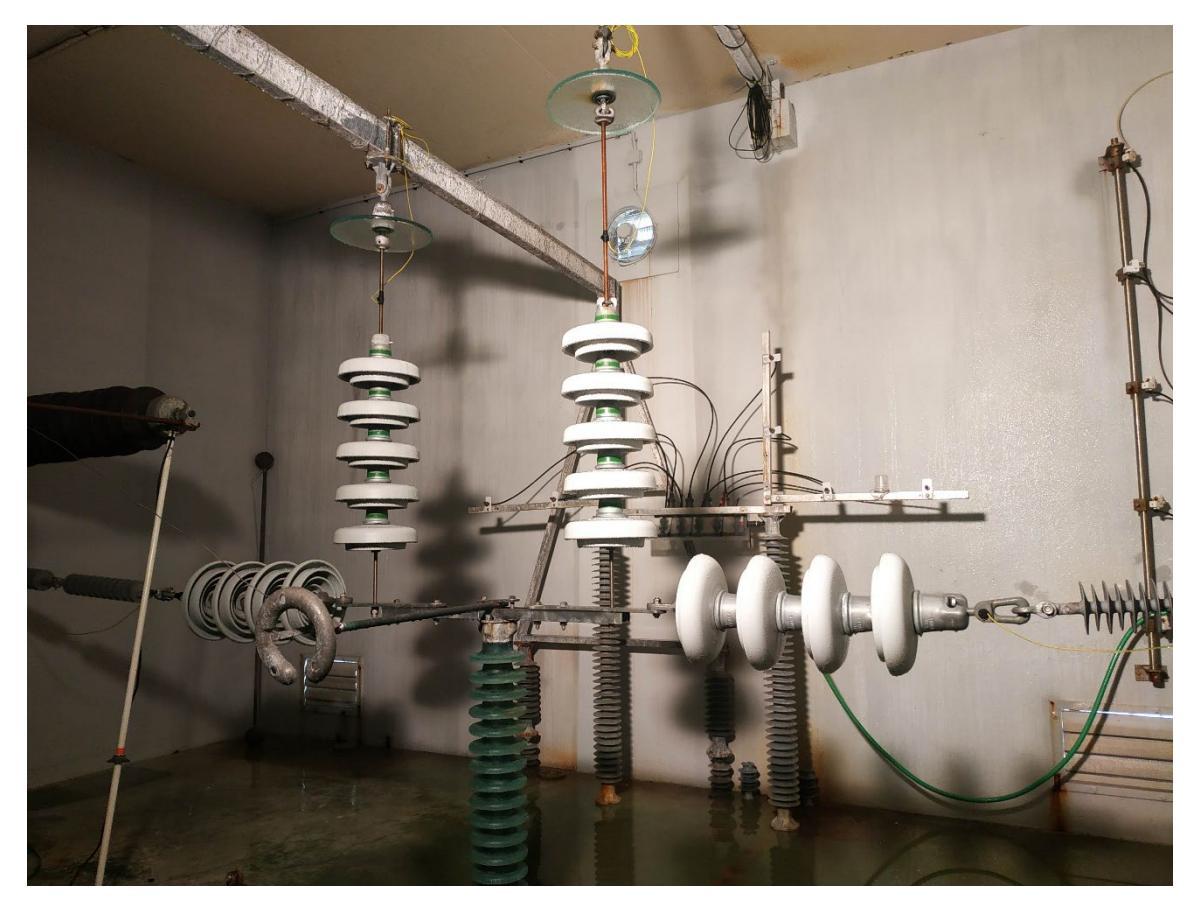
Figure 6: Set up of the double string configuration in the 2000h DC multi-stress test

In this test 4 strings were tested using 2 different coatings and for each case a vertical and a horizontal string as shown in figure 6.

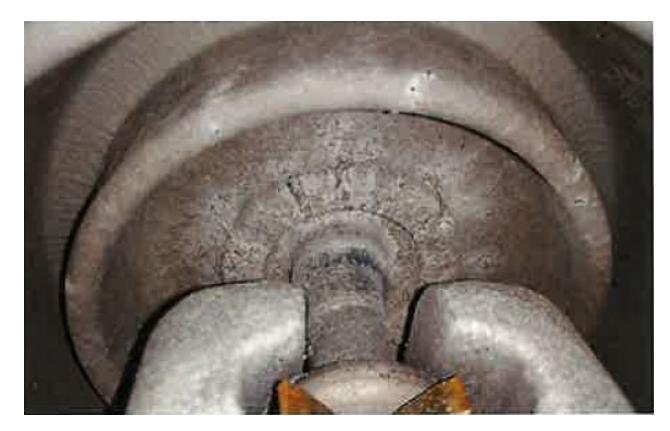
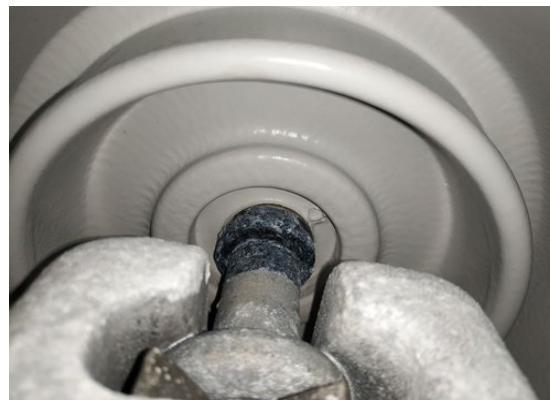
Figure 7: Erosion (class 3 to 4 as per [10]) on coating n°1 after the 2000h DC test

Figure 8: Typical aspect of coating n°2 after the 2000h DC test

a. The 2 different coatings do not perform identically one being more eroded (figure 7) while the second coating formulation remains intact (figure 8).

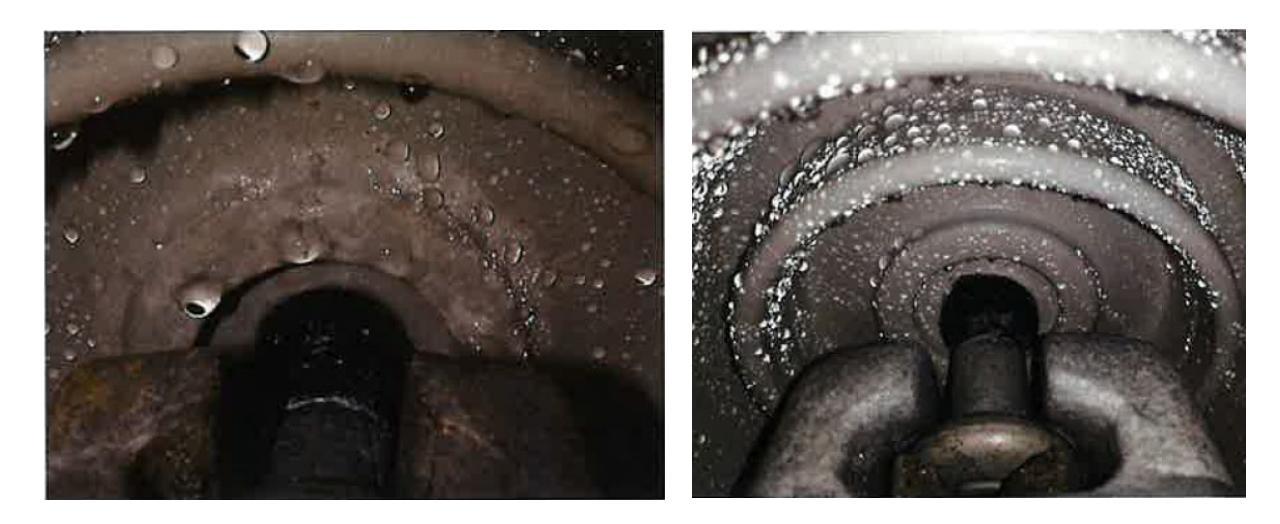
Figure 9: Coating n°1: hydrophobicity HC5-HC6 after the 2000h DC test

Figure 10: Coating n°2 hydrophobicity HC1-HC2 after the 2000h DC test

b. Coating n°1 led to several flashovers after 1500h. It shows (figure 9) a substantial reduction in hydrophobicity (HC5 to HC6) at the end of the test.

c. Coating n°2 did not flashover, no erosion and full hydrophobicity retained over the entire time of the test (figure 10)

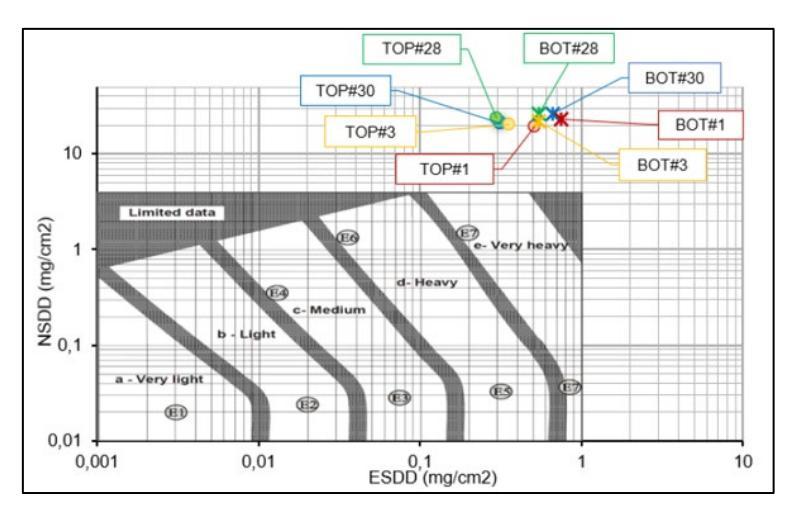
Figure 12 Pollution levels measured on site in Peru

With millions of insulators in service for now more than 20 years there are silicone coated insulators used in the most various environmental conditions. Sometimes the pollution conditions go beyond anything described in IEC TS60815 [3]. For example, in Peru ESDD/NSDD levels are far beyond the very heavy class as shown in figure 12 and figure 13 crossing dry deserts with salt mixed with sand and sometimes very close to the coast.

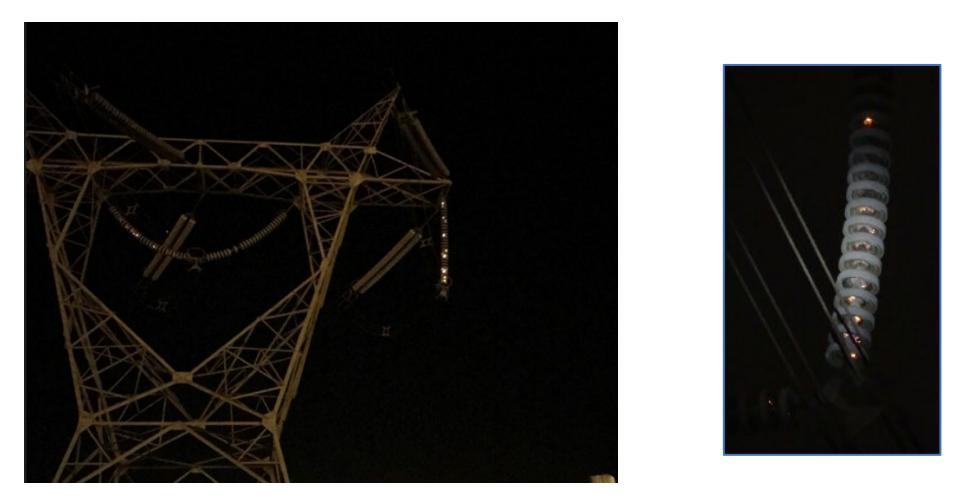
Figure 14: Electric activity on a string of glass silicone coated insulators on the 500kV Chilca Feniz line

Despite the benefits of silicone coatings or silicone housing (for polymers) the amount of pollution and environment conditions has shown that over time dry band arcing can become strong (figure 14) degrading the insulator surface as shown in figure 15 and already described in various occasions in test stations [11].

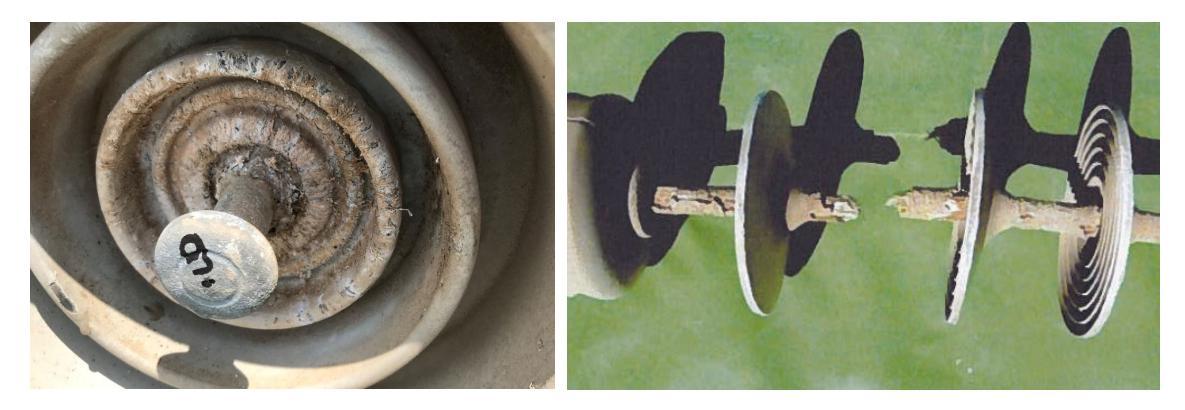
Figure 15: Erosion of the coating of a glass insulator (left). Polymer insulator failure (right) [12]

Even if some units are shattered and unlike for polymer insulators there is no risk of facing a line drop with a stub as it is the case with polymer insulators (figure 15 from Peru). Wisdom would therefore favour silicone coated glass with possible stubs rather than service interruption with catastrophic failures.

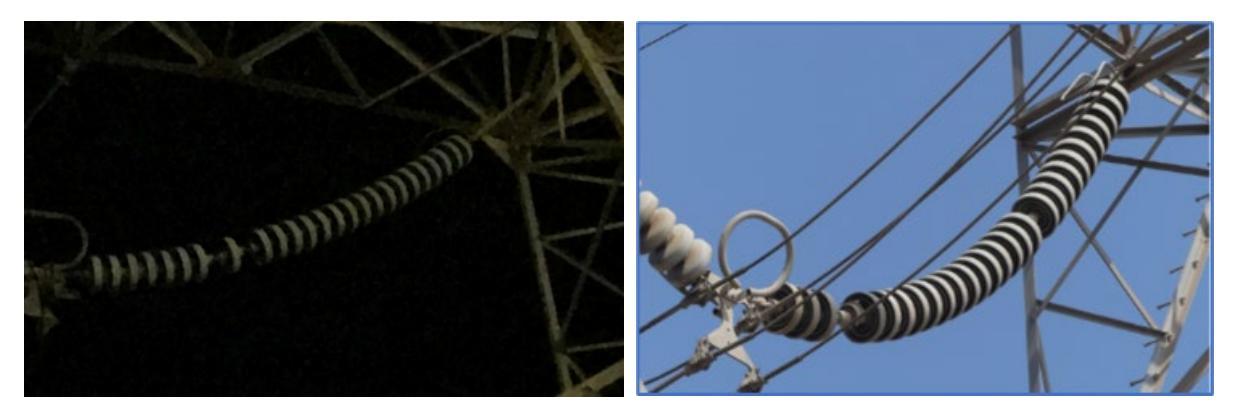
Figure 16: Stubs in a string of coated insulators subjected to extreme conditions (beyond the IEC TS 60815 class "very heavy") and severe under insulation (USCD=55mm/kV)

Under these extreme conditions it is possible to see glass insulators shatter (figure 16) once the coating is severely eroded around the pin.

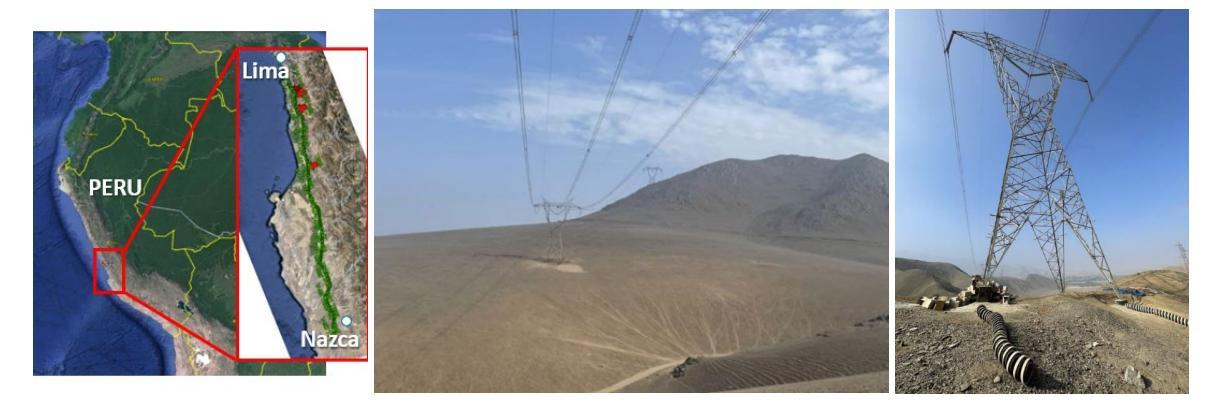
Figure 17 : 500kVAC line Chilca Poroma USCD =54mm/kV

Another interesting field report comes from a recent line inspection in Peru as shown in figure 17.

The insulators have been in service for 8 years in an area with dust, near the coast with no rain, and never washed. Some insulators were taken down for evaluation and pollution levels were established beyond "very heavy" as often in Peru (figure 18).

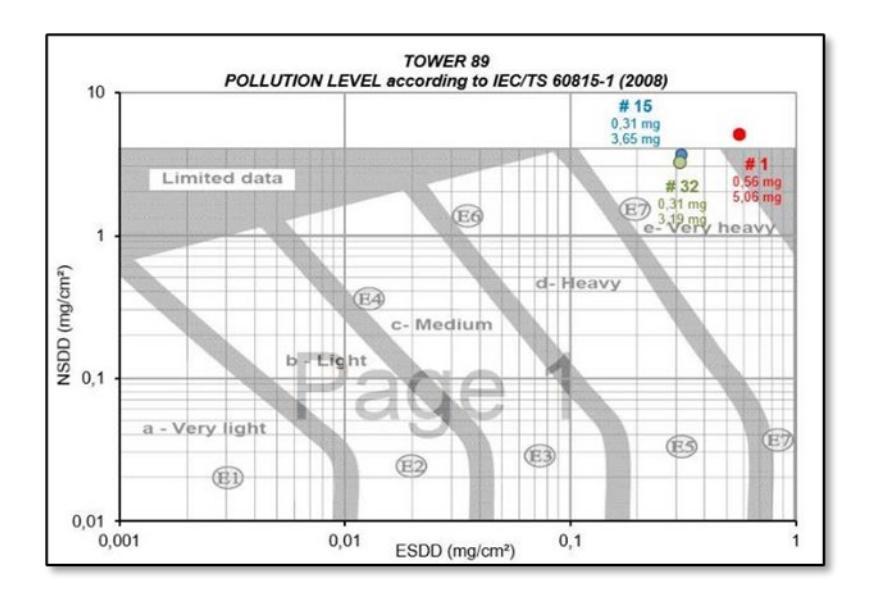
Figure 18: Example of ESDD/NSDD levels found during the inspection

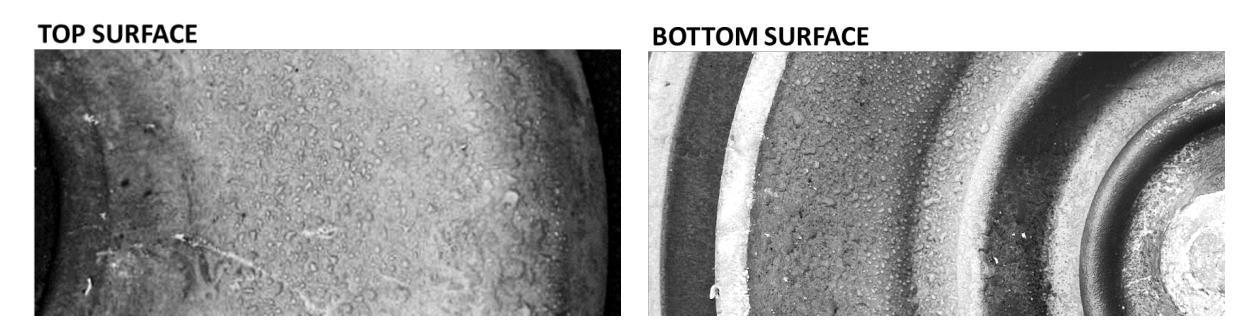
Figure 19: Hydrophobicity checks showing HC1 and HC 2 levels despite the extreme pollution deposits

Hydrophobicity was checked as shown in figure 19 with very good transfer property despite the harsh environment.

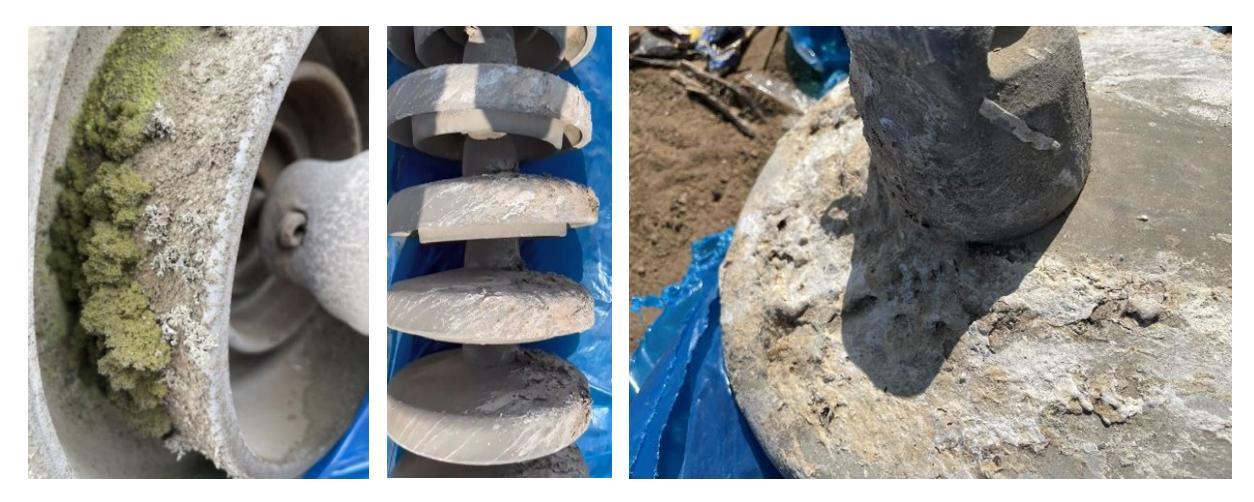
Figure 20: Left: lichens and moss on the coating. Center and Right: heavy bird dropping

Other interesting findings shown in figure 20 demonstrate that despite hydrophilic deposits such as moss, lichens or heavy bird droppings, overall, the performance of the strings remain excellent.
