DC-toughened glass insulators pre-coated with RTV silicone rubber – field returns from aged samples installed on HVDC lines

M. Marzinotto, G. Lavecchia, M.R. Guarniere,
A. Posati, M. Rebolini
Terna Rete Italia – TERNA Group
Viale E. Galbani 70, 00156 Roma, ITALY

Abstract—RTV silicone rubber coating on ceramic insulators has been used for at least two decades in order to solve critical problems related to pollution in harsh environments. In Italy the experience on AC 380 kV transmission lines started ten years ago; today this kind of insulators is considered as an attractive solution to solve problems of flashovers in highly polluted areas. Recently a trial installation started on HVDC Terna's lines. The first tests performed on an insulator string sampled after more than 2 years have shown that RTV pre-coated insulators seem to be a valid alternative to ceramic insulators in highly polluted environment even if further investigations are needed in order to better understand their behavior under DC stress.

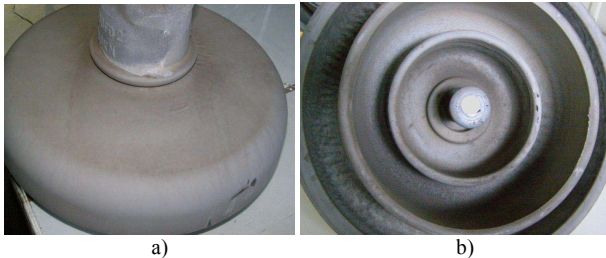
In Fig. 2 a picture from the top and bottom surface of insulators #12 and #1 has been reported in which it can be pointed out that in the former a scrape is evident while in the latter no significant signs of degradation can be revealed. In particular the dark signs under the external rib on Fig. 2 b) represents pollution accumulation. The scrape on the insulator coating reported in Fig. 2 a) can probably be linked to handling operations and in any case not due to any electrical activity.

Fig. 2. Visual inspection: a) insulator #12 top surface with a lateral scrape; b) insulator #1 bottom surface with dirt under ribs and without interesting signs of degradation.

Similar scrapes have been noted also in some other units, but in any case due to their position on the insulator surface and the absence of any electrical activity in the surrounding, those are clearly related to handling at the time of installation, or during sampling or during transportation from the site of installation to laboratories. One very important statement here is to note that there is no degradation related to electrical activity.
