CORRELATION ASSESSMENT BETWEEN ACTUAL POLLUTION PERFORMANCE OF INSULATOR STRINGS IN DC AND THEORETICAL MODELS

J.M. George, E. Brocard, D. Lepley, F. Virlogeux

SEDIVER Research Center, St Yorre, France

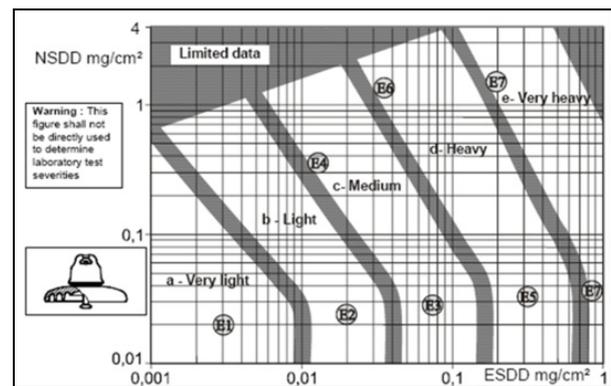
Figure 1 Pollution classification as in [1] and [2]

The severity of the contamination in any given environment is classified in [1] and [2] from very light to very heavy according to Figure 1. The specific creepage distance is determined to avoid flashovers of the string of insulators under the given contamination conditions. One important element in this discussion is RUSC (Reference Unified Specific Creepage distance which is the minimum USCD calculated as per [1] and [2]). Once this is defined, the insulator unit design can be selected from a suppliers catalog as well as the number of insulators in the string.

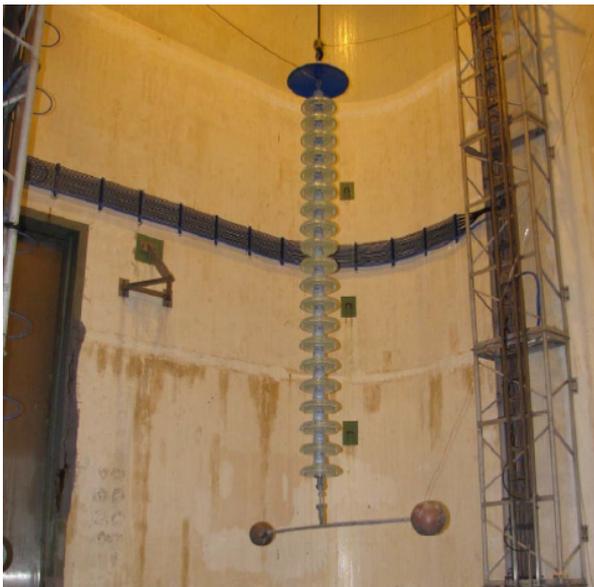
Figure 2 Pollution test on a string of 20 units with a USCD = 36.6 mm/kV

The following example shows the possible discrepancy between the results from the theoretical method and laboratory test results. A typical 300kV dc string of 20 toughened glass DC units having an individual leakage distance of 550mm was tested with artificial pollution conditions established at an ESDD=0,047mg/cm² and NSDD=0,1mg/cm² (Figure 2). This translates into a USCD=36.6mm/kV. According to [1] and [2], the theoretical RUSC for this environment would be 44,8 mm/kV. The performance of the string was excellent with leakage current peaks around 10mA (Figure 3).

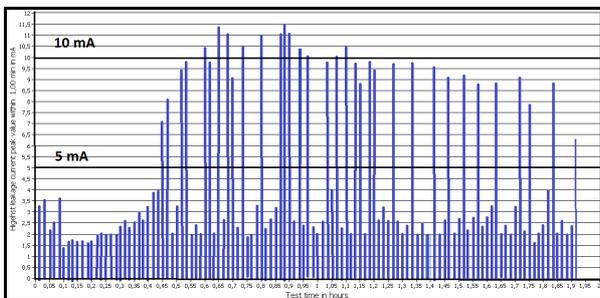
Figure 3 Leakage currents over a 100 mins withstand period measured on a string of 20 units for an ESDD=0,047mg/cm² and NSDD=0,1mg/cm². USCD = 36.6 mm/kV

The difference of 20% is most likely very conservative given the low currents measured during this test. It is therefore permitted to believe that the model is not adequate for describing accurately the performance under pollution of a DC string. If such a line was designed with the results from the calculation method chances are that the string over design would generate unnecessary over costs. Based on this first example it appears obviously that the model needs to be reviewed and challenged against additional testing and field evaluation.

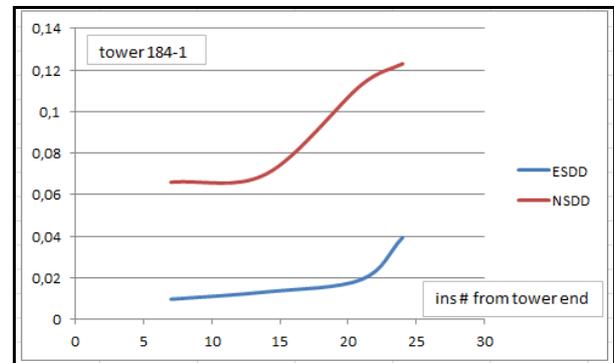
Figure 4 Distribution of the contamination along the 500 kVdc string

Among these cases, the pollution pattern of a 500kVdc line which did not show specific pollution problems over more than 40 years of service in a desertic environment show a non uniform distribution along the strings as described in Figure 4. This line is designed with a USCD= 25mm/kV.

The theoretical model would recommend using at least 42mm/kV considering a uniform contamination along the string with an ESDD=0,04mg/cm² and a NSDD=0,1mg/cm², CUR=1.

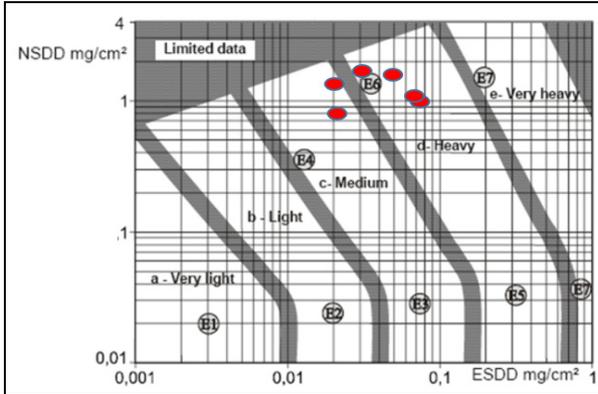
Figure 5 Pollution levels measured at Itaipu 600kVdc, Brazil

Another very interesting example comes from Brazil with the 600kVdc Itaipu bipoles. Several strings were removed from bipole 2 for evaluation. For this line the actual USCD value is 28.5mm/kV. The pollution levels are classified as “heavy” accounting for agricultural and industrial pollution near Sao Paolo. Figure 5 summarizes the pollution levels. It is interesting to see the very important CUR ratios in Table 1. While the maintenance department ensured that there was no line interruption related to pollution problems in this region the theoretical model predicts intense flashovers unless the strings are redesigned with at least a USCD=47mm/kV. One could argue in this particular case that the CUR level is out of the classical range considered in the design of the model (the typical range

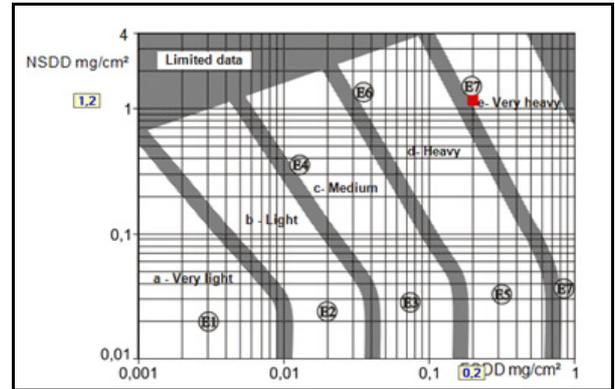
Figure 7 Level of contamination measured on the 200kVdc line from Terna

Terna in Italy for example is now using such products on their 200kVdc line [6] in Tuscany (Figure 7 and 8) and Sardinia eliminating washing for now at least 5 years (so far no washing was needed compared to previous years practice). Some areas are classified as “very heavy” as shown in Figure 7.

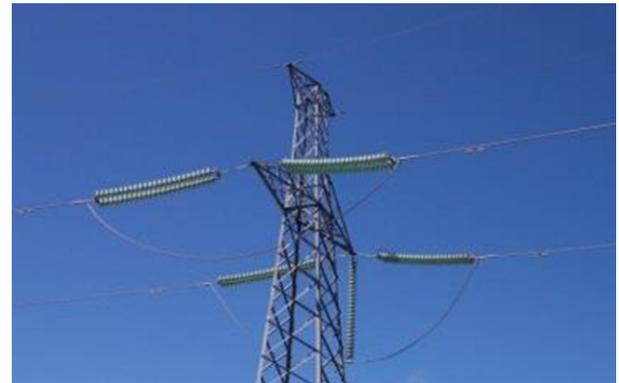
Figure 8 Silicone coated toughened glass insulators installed in Italy on the Terna 200kV dc line

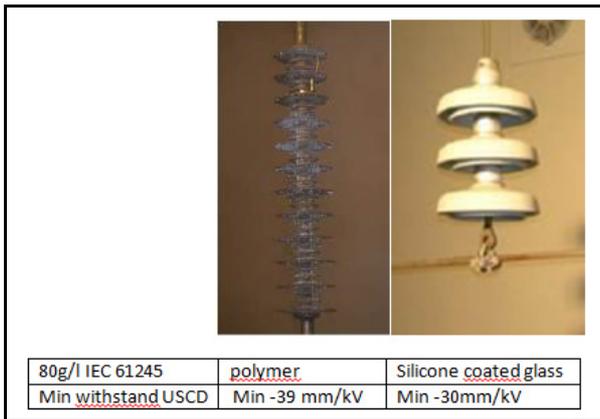
Figure 9 Salt fog test comparison

A comparative pollution test between toughened glass pre-coated insulators and polymer insulators was performed in salt fog conditions for a coastal application. The results are summarized in Figure 9 showing the benefits of a classical glass string coated with silicone compared to a composite silicone housing insulator.

These results show the difficulty to come up with a general performance statement without doing actual testing. In this particular case both test objects are considered as hydrophobic materials. In both cases their respective leakage distances were equivalent during the tests but material and shape matters.

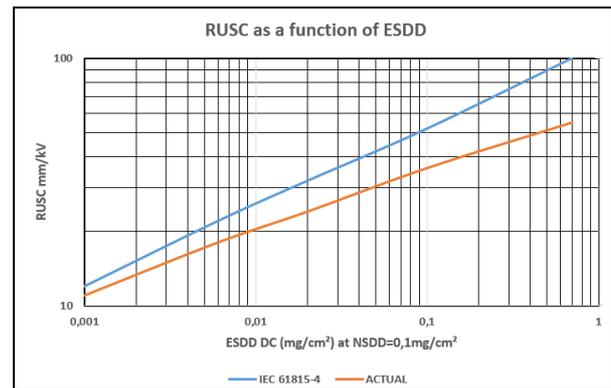
Figure 10 specific creepage distance as per [1] and [2] versus test data and field experience gathered over the last years (in blue the current curve versus red the estimated true performance)

Figure 10 gives an idea of the magnitude of the margin of error in the theoretical evaluation of the RUSCD versus laboratory or field performance. This graph needs to be further adjusted by more test results to fine tune the reference to a RUSC.

The type of errors possible with a mathematical model can lead to a possible overdesign of 20% to 30% or more. The consequence in cost is huge and can make a line design become unacceptable to the utility. Large campaigns of pollution tests in dc are required to better document the actual performances.
